APPRAISAL REPORT

133, avenue de la Baie-de-Valois
Pointe-Claire (Quebec)

File No. 683089E

Subject	Demolition Assessment Report on the replacement cost as new and depreciated, as well as an estimate of the potential renovation costs of the building
Address	133, avenue de la Baie-de-Valois, Pointe-Claire (Quebec)
File No.	683089E

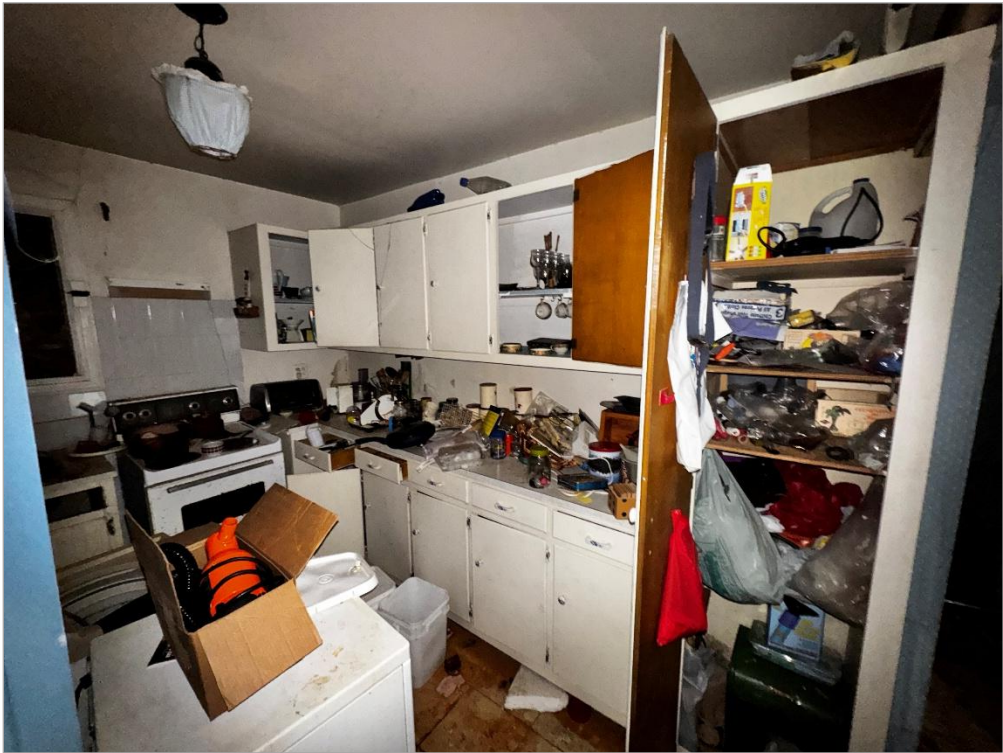
Kitchen

- **Flooring:** During the kitchen inspection, we noted that the floor covering consisted of tiles that may contain asbestos. Plan for the removal of the flooring following asbestos removal protocols and conduct an asbestos test.

- **Cabinets** : The kitchen cabinets are very old and in poor condition. Plan for a complete kitchen renovation.
- **Water infiltration**: Several signs of water infiltration were observed inside the house. Ensure the necessary repairs are carried out.
- **Insulation and ventilation**: An opening was made in the ceiling of the front bedroom on the upper floor to inspect the attic insulation. Fiberglass insulation was observed. The insulation is insufficient compared to current standards. For improved insulation, it would be ideal to insulate above the roof structure.

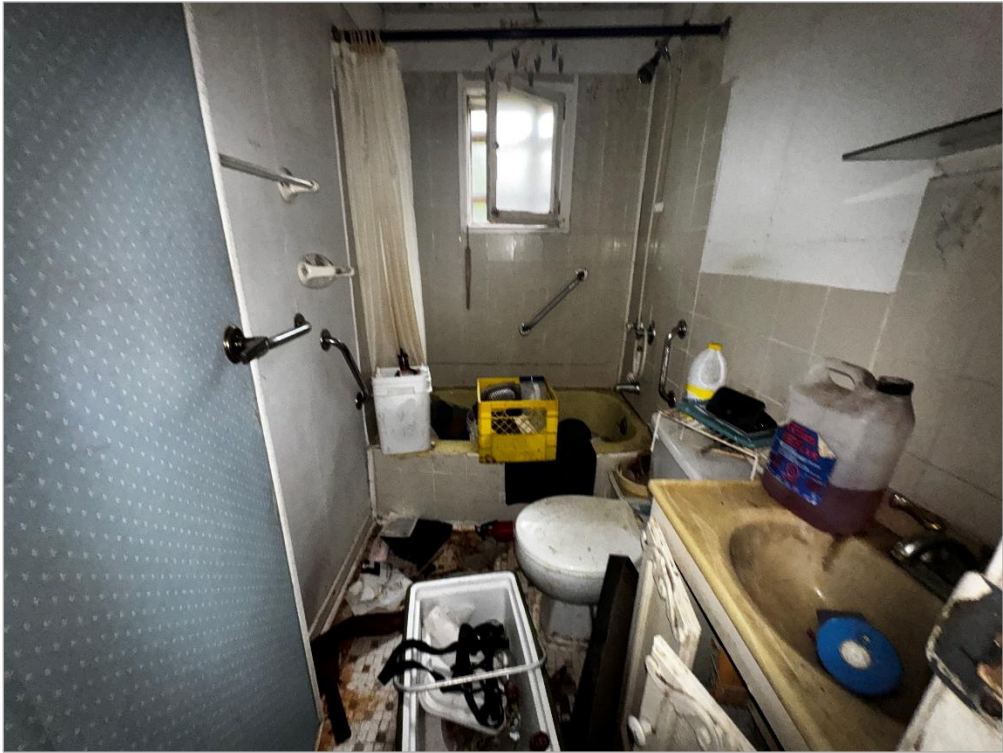
Bathroom

We observed that the P-trap under the bathroom sink has begun to leak. Replace the P-trap to prevent damaging leaks.

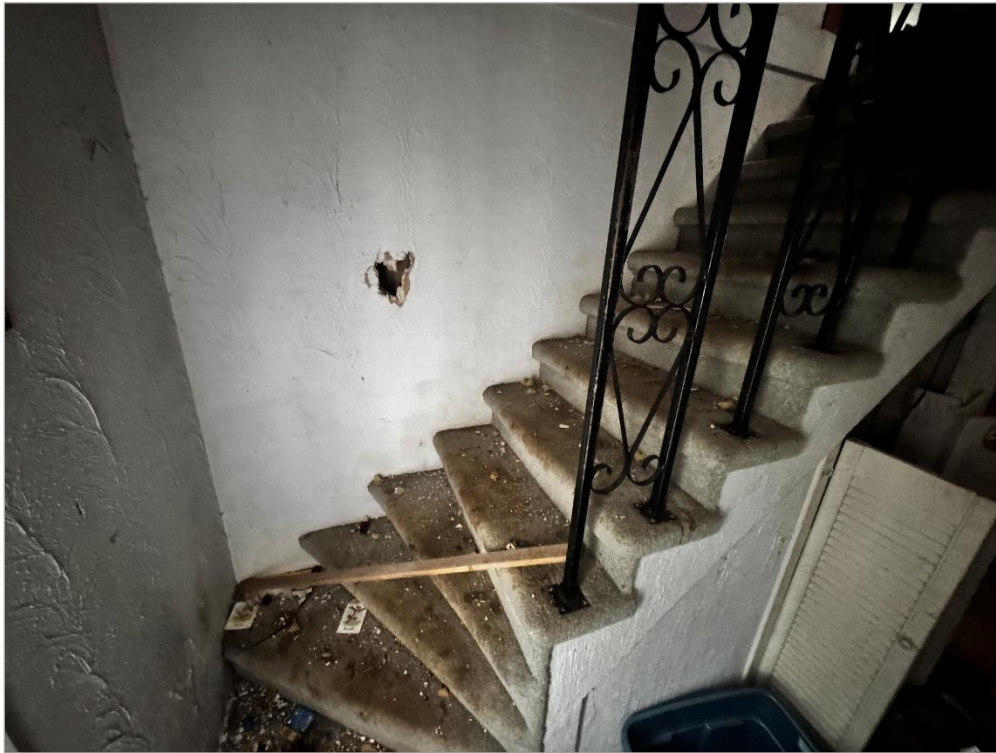
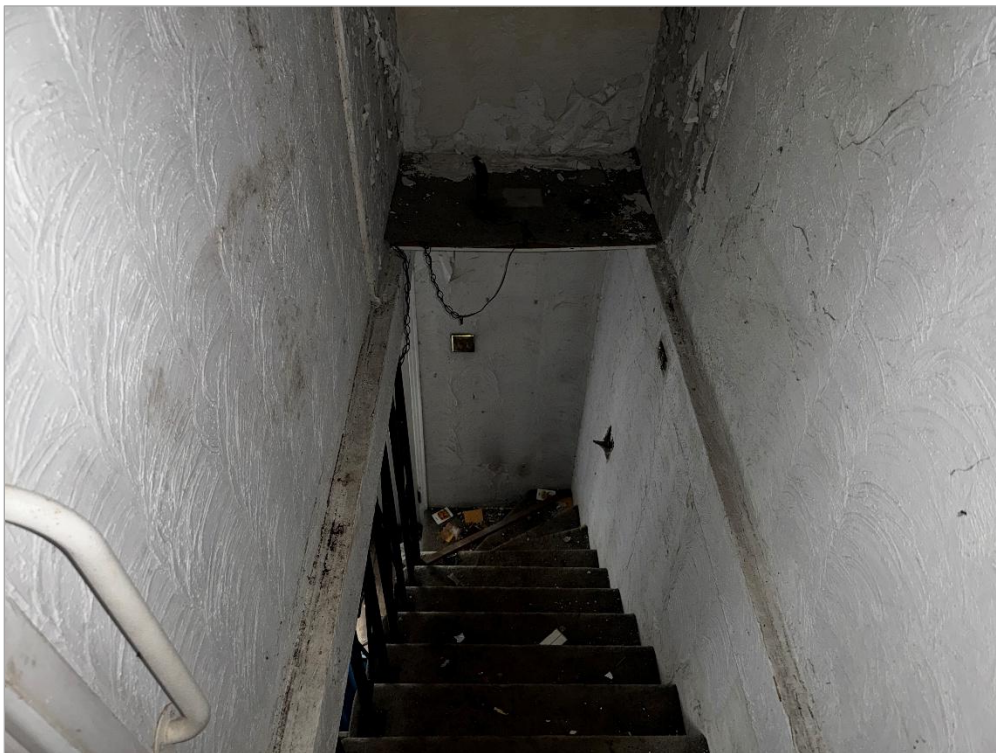
Staircase to the upper floor

- **Staircase:** We noted that there are no handrails on the upper floor staircase. Install handrails on the stair flights where they are missing.
