APPRAISAL REPORT

108 Pointe-Claire Avenue
Pointe-Claire (Québec)

O/File 683327E

Subject Demolition Assessment Report on the replacement cost as new and depreciated, as well as an estimate of the potential renovation costs of the building
Address 108 Pointe-Claire Avenue, Pointe-Claire (Québec)
File No. 683327E

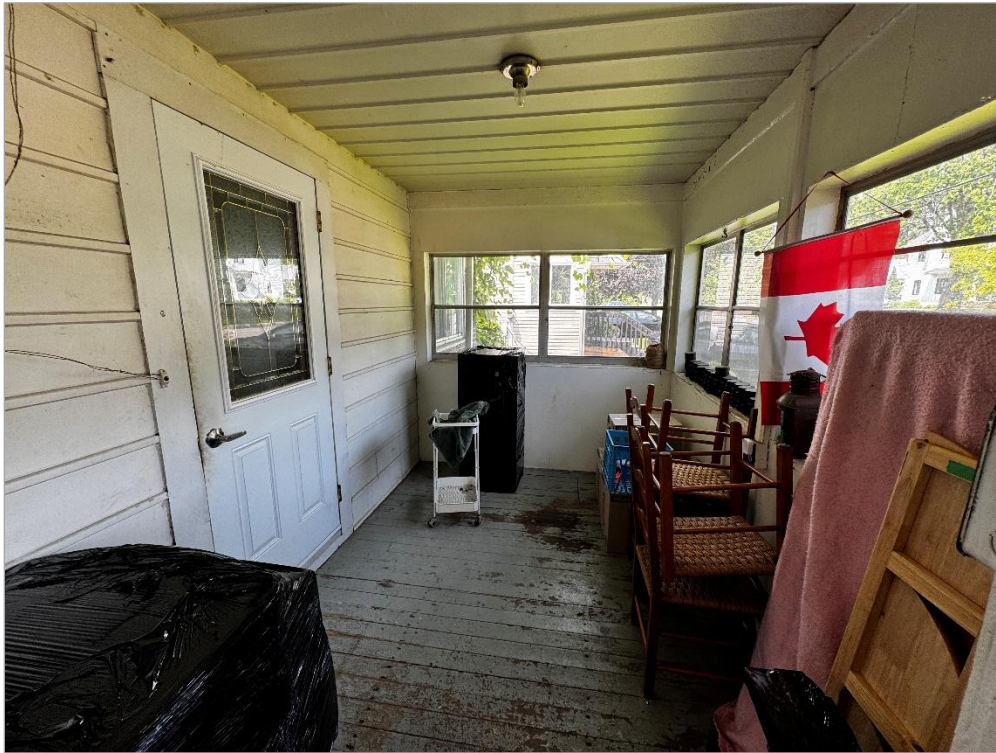
Front veranda

The threshold of the front veranda door sits at the level of the porch slab, creating a high risk of water infiltration. If water issues occur or during future renovations, reinstall the door 4 to 6 inches above the slab to ensure proper sealing under the threshold.

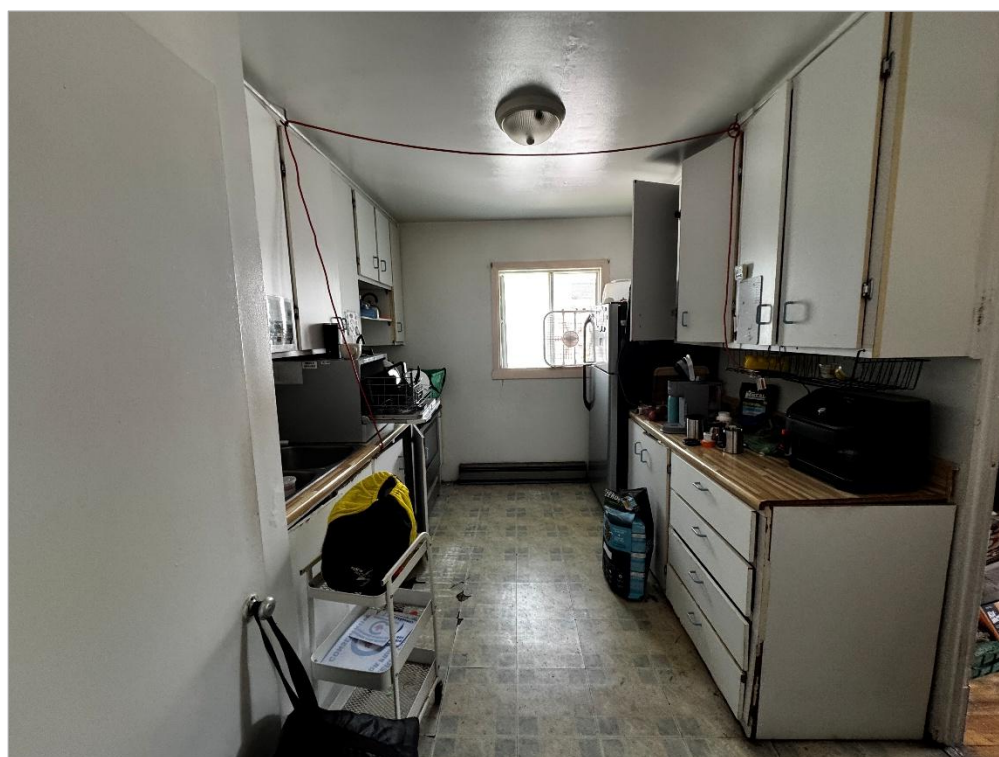
Upstairs kitchen

The upstairs kitchen has no range hood. Install a hood vented to the exterior.

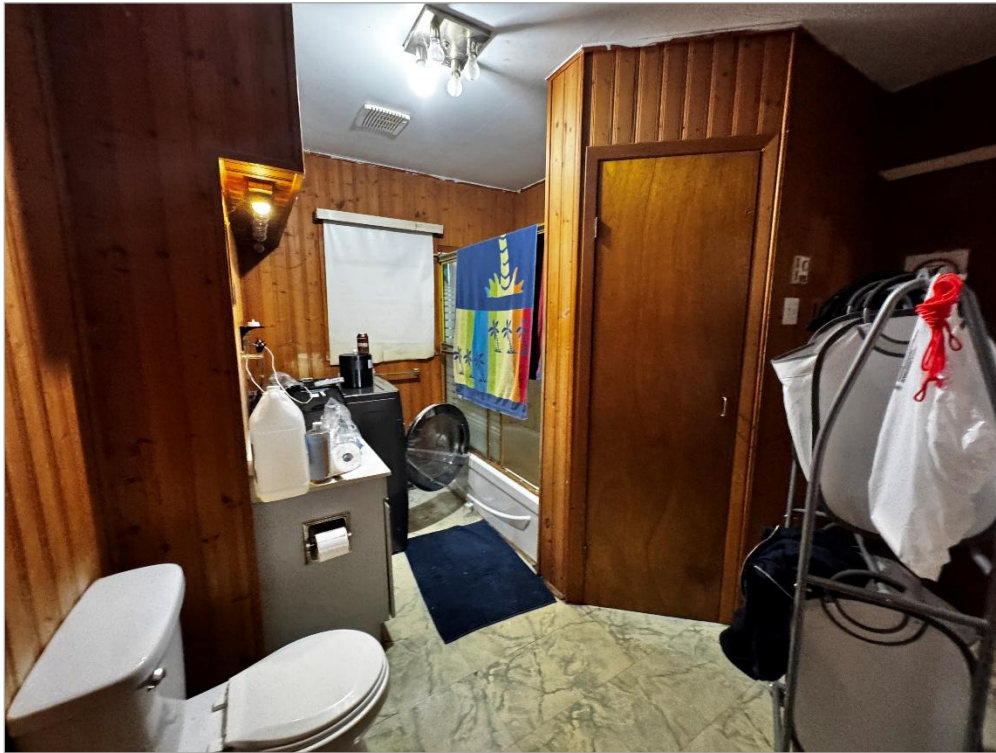
Upstairs bathroom

The trap under the upstairs bathroom sink shows signs of corrosion. Replace the trap to prevent water damage.

There is no electrical outlet in the upstairs bathroom. If required, install a GFCI-protected outlet to prevent electrical shock.

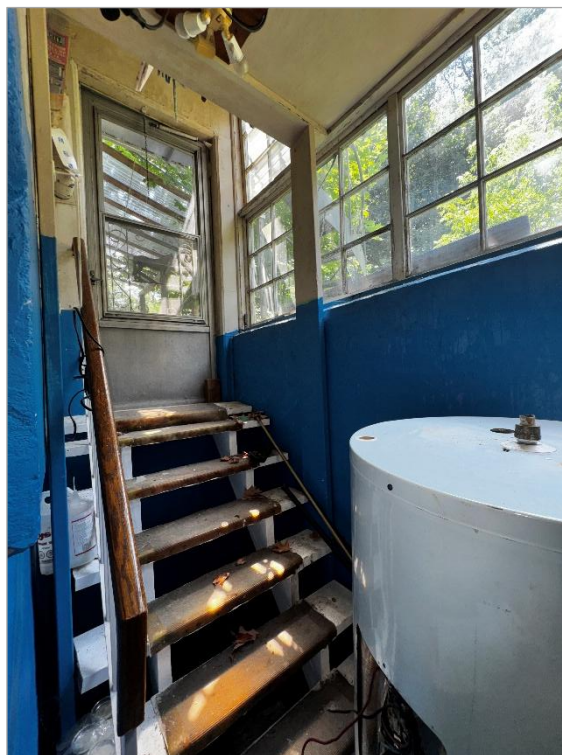
Exterior entrance leading to the basement

Excessive moisture was observed beneath and in front of the rear basement entrance door at the bottom of the covered staircase. Periodic water infiltration may occur; monitor the situation, consult an expert if needed, and ensure proper drainage of the landing.

The paving-stone landing in front of the basement staircase slopes toward the entrance, creating a negative grade. Regrade the area to direct surface water away from the exterior walls and door threshold.

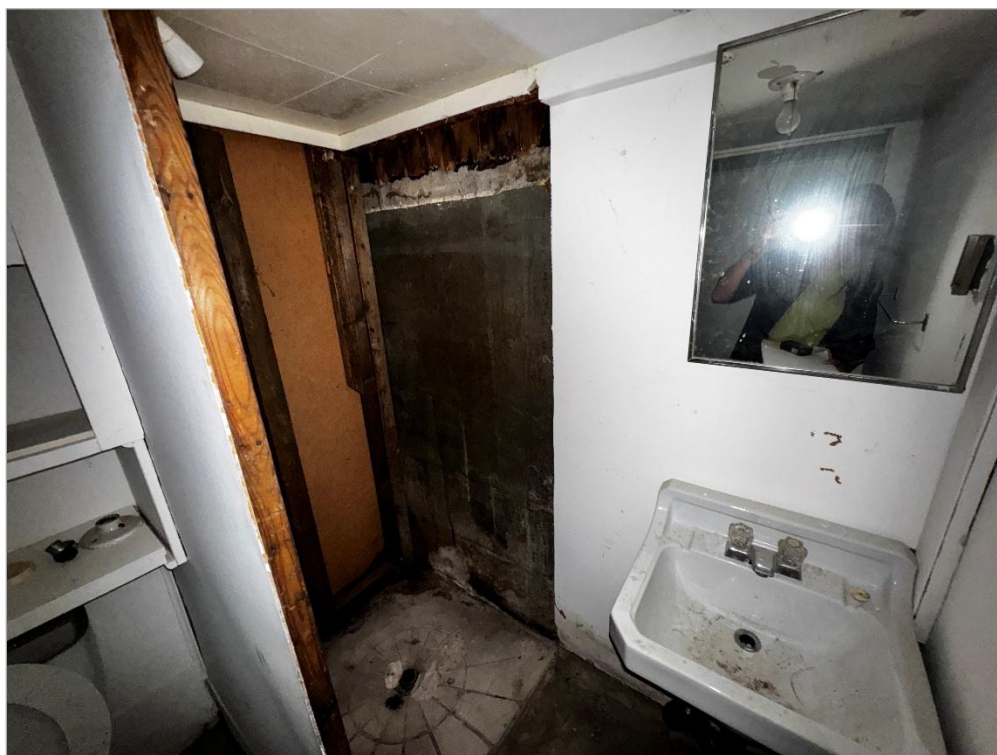
The basement toilet is not functional. Check the water supply and the toilet mechanism and replace the unit if necessary.

Non-functional basement bathroom
