APPRAISAL REPORT

130 Baie-de-Valois Avenue
Pointe-Claire (Québec)

O/File 684015E

Subject Demolition Assessment Report on the replacement cost as new and depreciated, as well as an estimate of the potential renovation costs of the building
Address 130 Baie-de-Valois Avenue, Pointe-Claire (Québec)
File No. 684015E

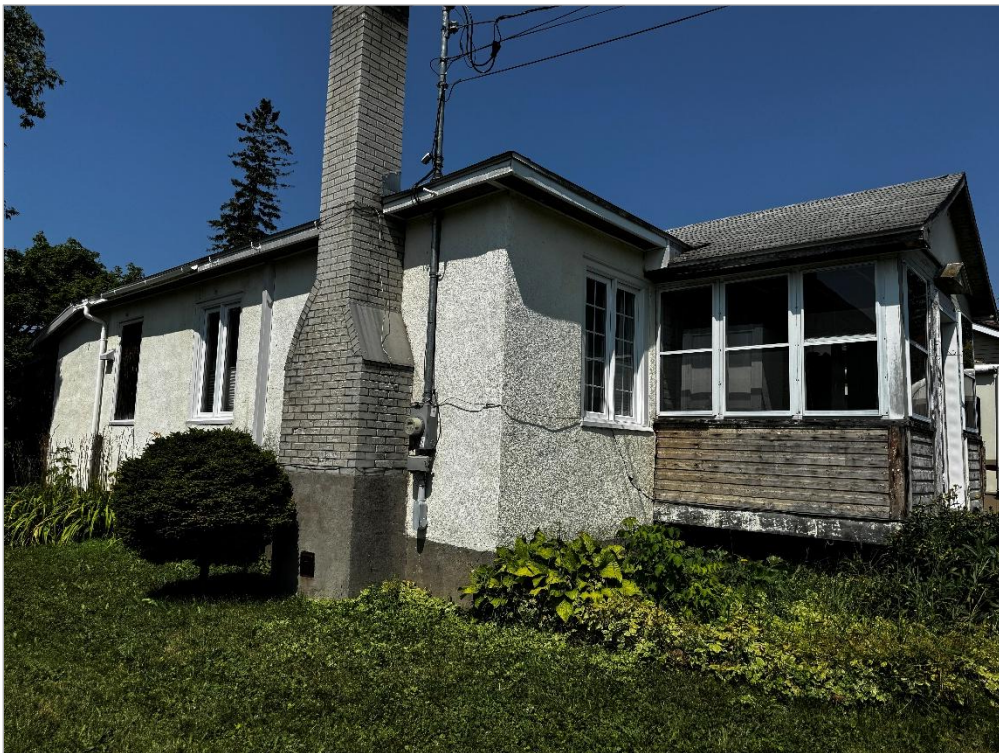
Left side elevation

The lower portion of the left-side foundation wall is crumbling. Follow recommendations for foundation wall waterproofing and French drain installation.

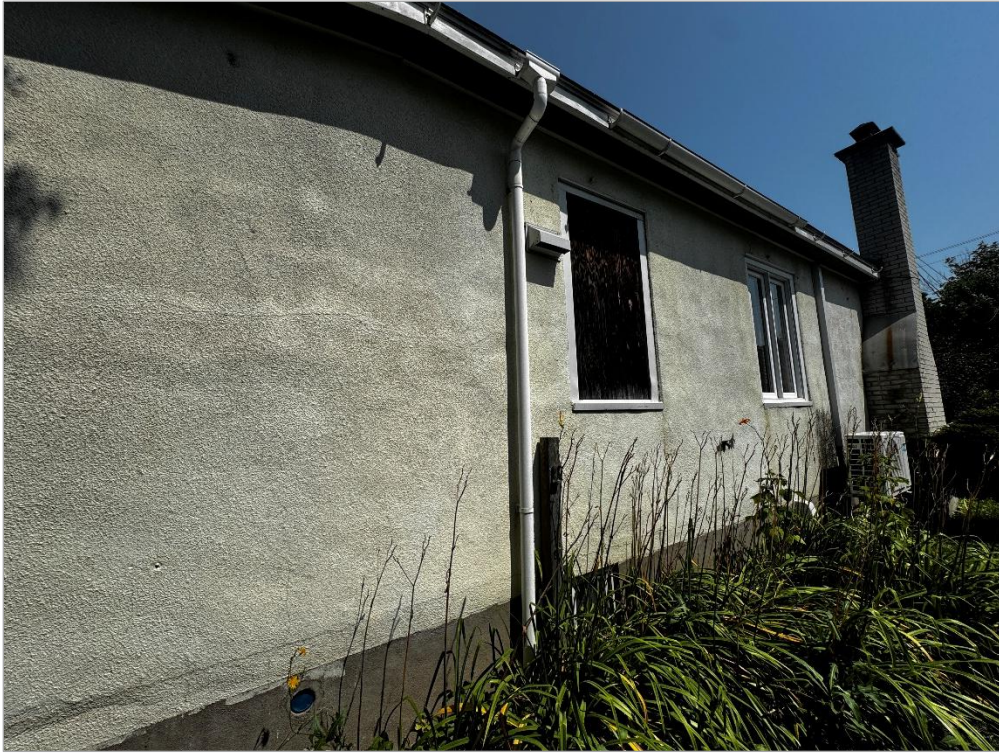
Right side elevation

A crack was noted on the right-side foundation wall at the corner of a window well. Regularly monitor the foundation and record any crack expansion. Repair visible cracks from the exterior.

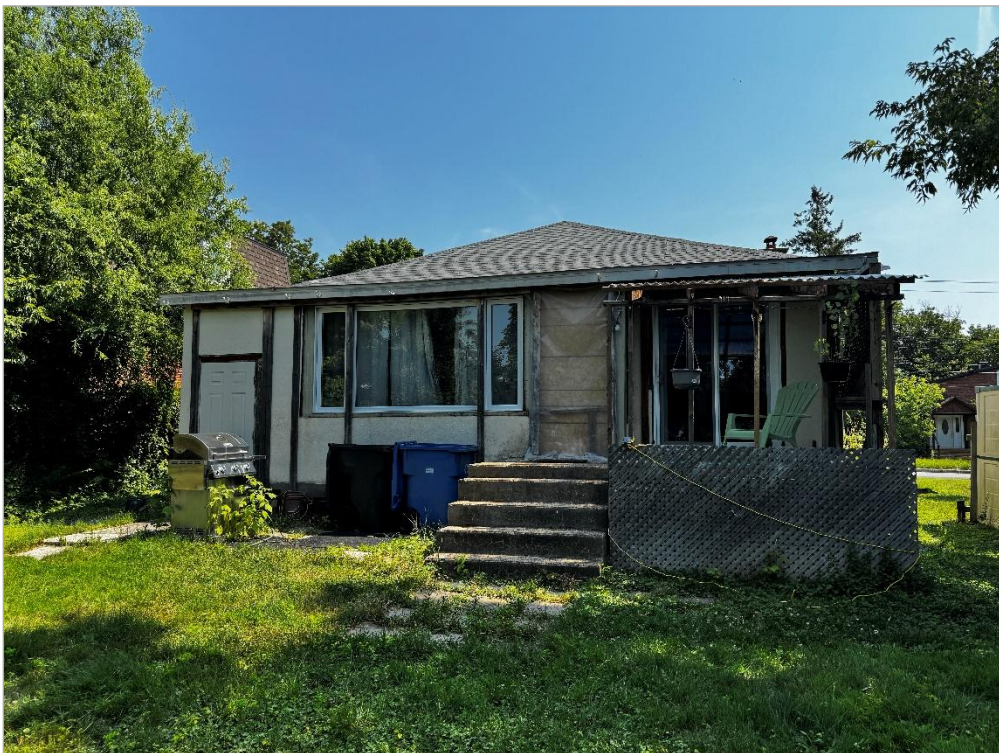
Rear view

We noted that the guardrails around the rear balcony are non-compliant and unsafe. There is also no handrail on the staircase. It appears that the supporting posts rest directly on the ground, which can accelerate rot. Plan stabilization work and install compliant guardrails and handrails.

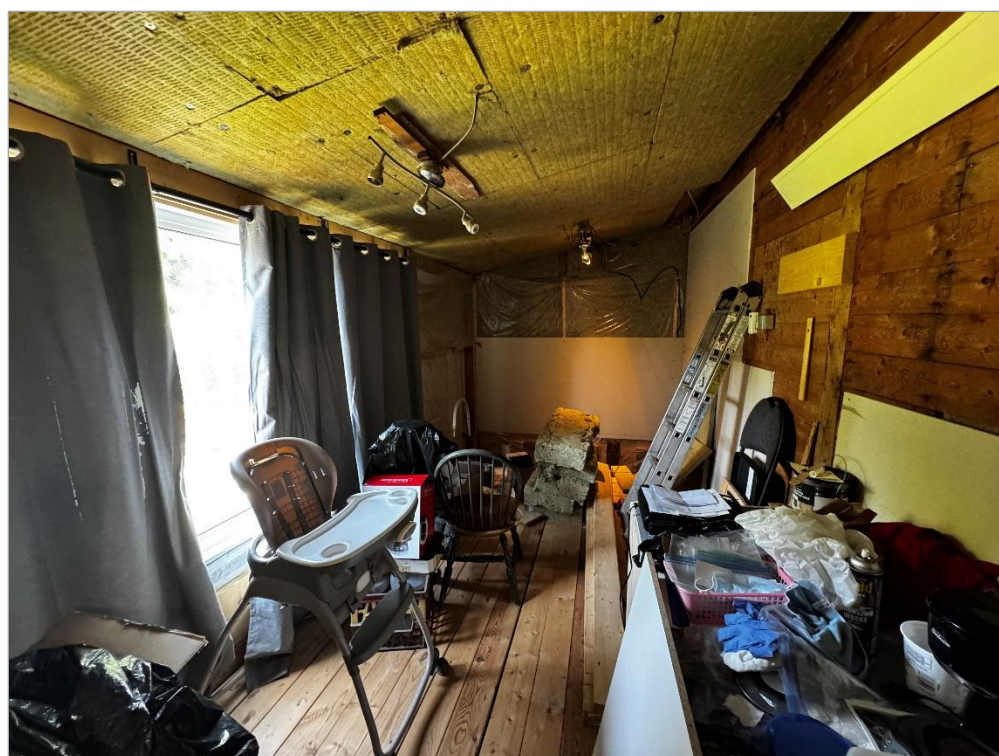
Dining room (currently under renovation).

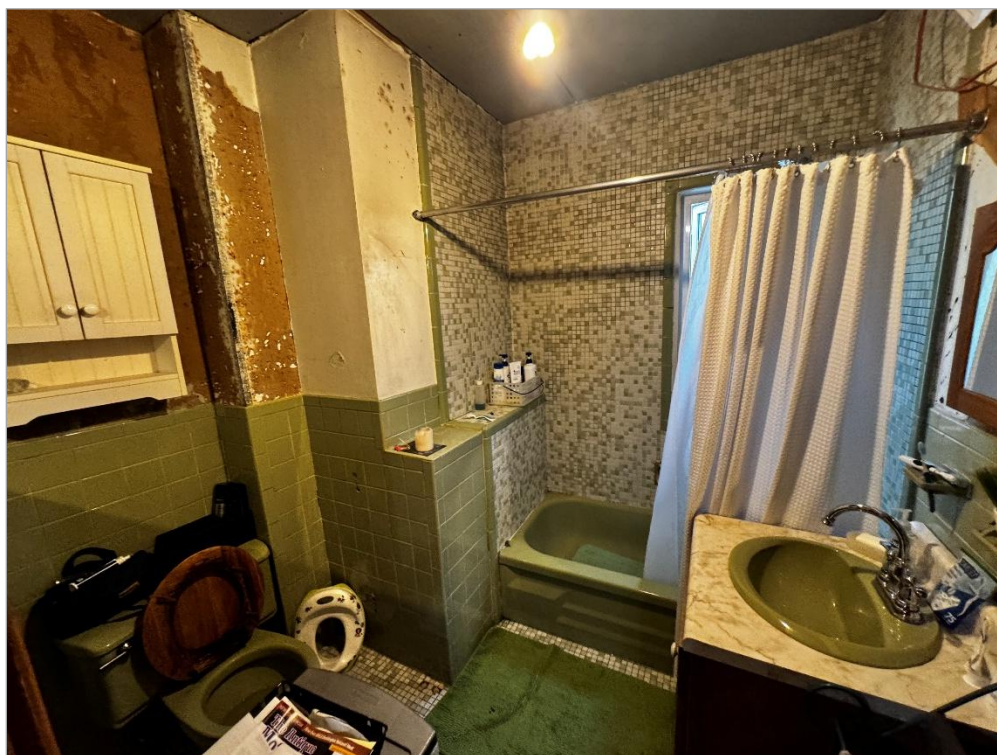
Bathroom

The bathtub enamel is worn. Plan for replacement of the bathtub in the short to medium term.

Many construction works are ongoing and appear abandoned. Significant work will be required to achieve a proper finish in the various rooms of the building. The ceramic tiles around the bathtub are not watertight. Replace the tiles around the bathtub as part of the broader bathroom renovation.

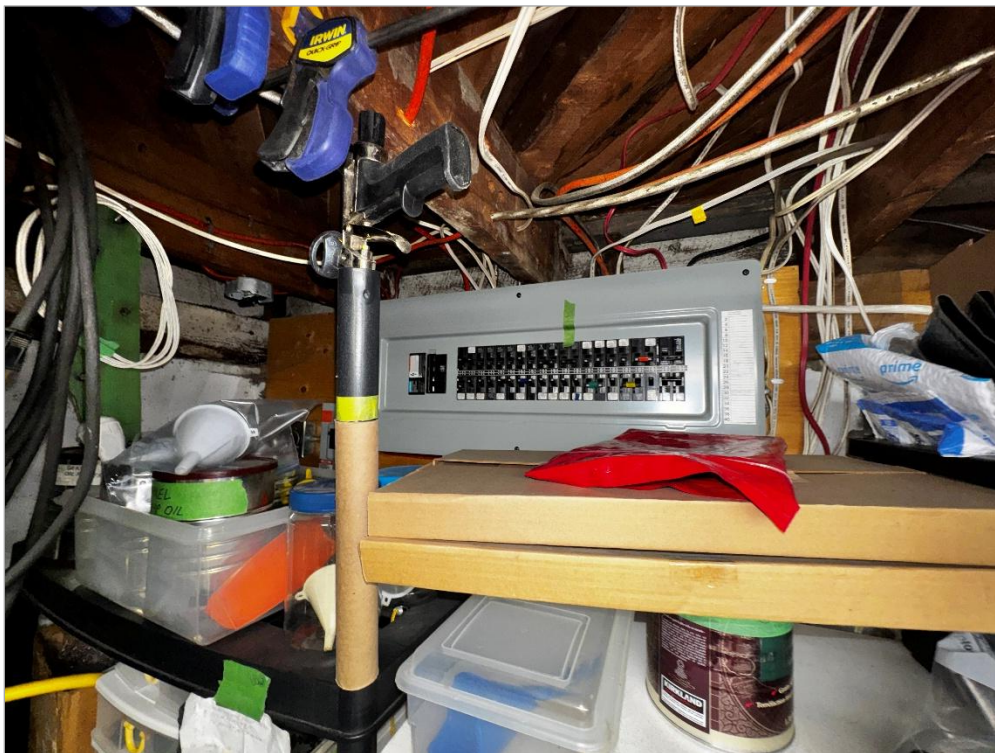
- **ELECTRICAL:** The clearance in front of the electrical panel is less than 39 inches. Ensure the required clearance is maintained.

Electrical panel (basement)
