APPRAISAL REPORT

42, avenue du Golf
Pointe-Claire (Quebec)

O/ File 688055E

Subject Demolition Assessment Report on the replacement cost as new and depreciated, as well as an estimate of the potential renovation costs of the building
Property located 42, avenue du Golf, Pointe-Claire (Quebec)
O/File 688055E

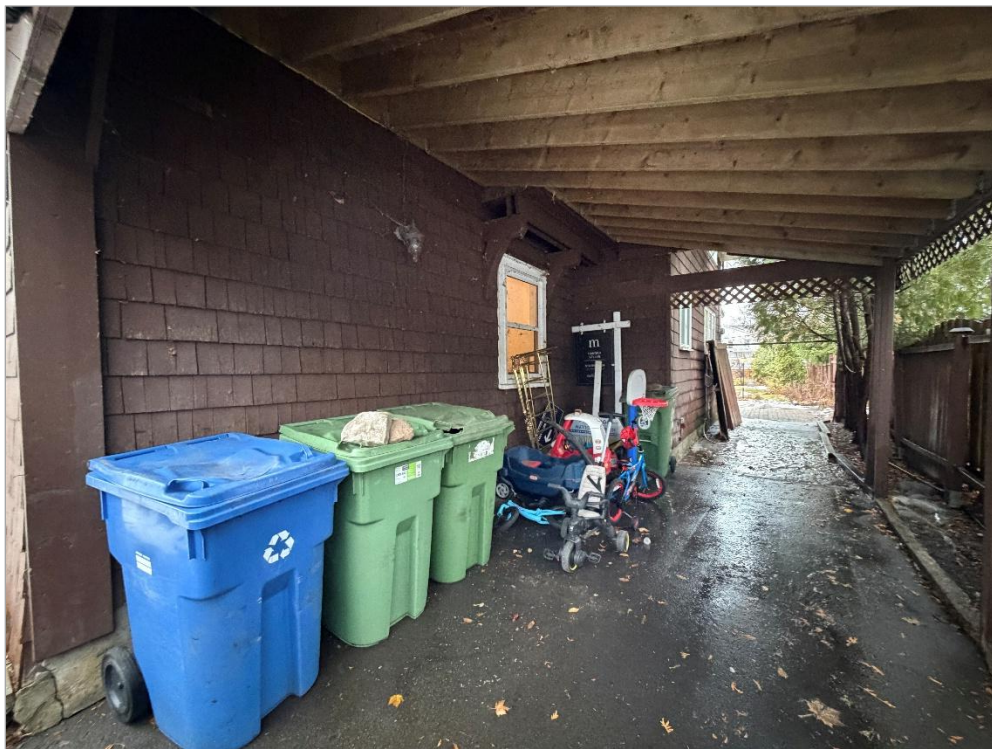
Carport

A carport is located on the right-hand side. The supporting posts on the right-side rest directly on the ground. Raise the wood approximately 18 inches above the ground to prevent rot from soil moisture.
