## APPRAISAL REPORT

138, chemin du Bord-du-Lac-Lakeshore  
Pointe-Claire (Quebec)

O/File 687911E

| Subject | Demolition Assessment Report on the replacement cost as new and depreciated, as well as an estimate of the potential renovation costs of the building |

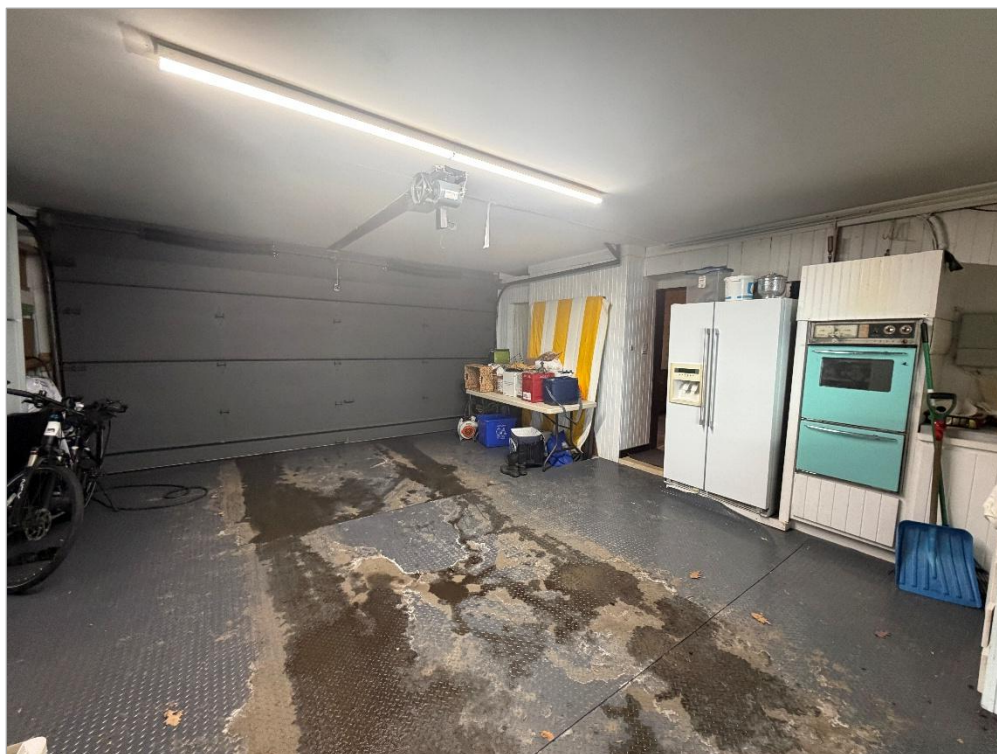
**Garage**

The garage has settled toward the rear right side. If the garage is to be retained, it should be reviewed by a structural engineer to obtain appropriate stabilization recommendations.

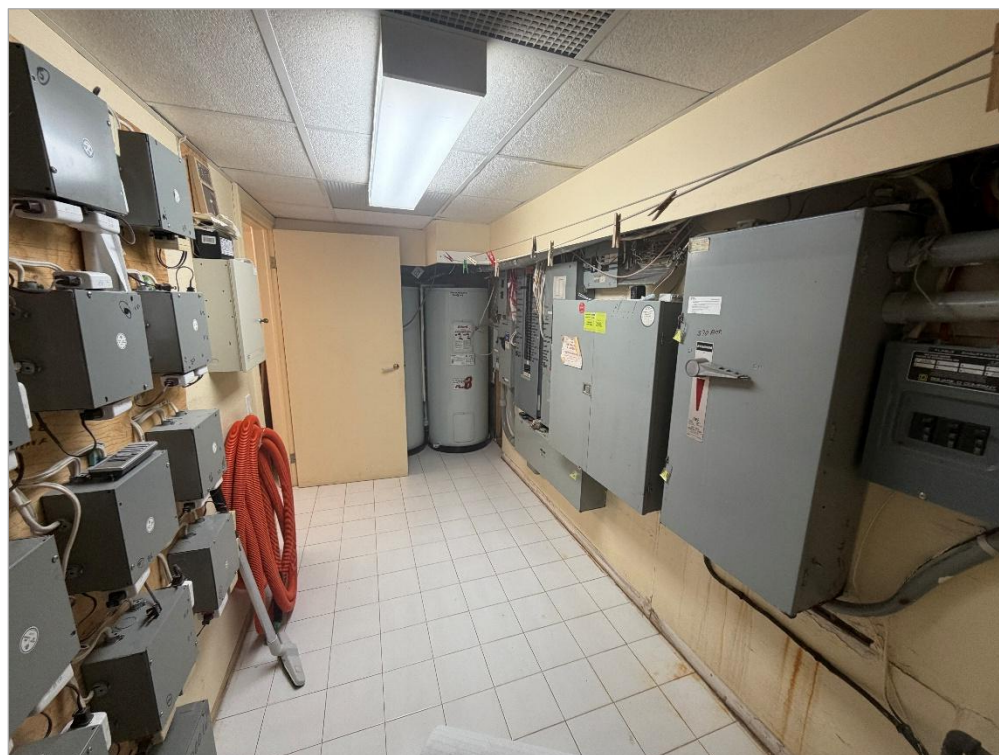
**Electrical and mechanical room**

The Giant brand water heater was manufactured in 2010. Replacement should be anticipated in the short term, as it has reached the end of its useful life.
