## APPRAISAL REPORT

429, avenue Saint-Louis  
Pointe-Claire (Québec)

O/File 693267E

| Subject | Demolition Assessment Report on the replacement cost as new and depreciated, as well as an estimate of the potential renovation costs of the building |

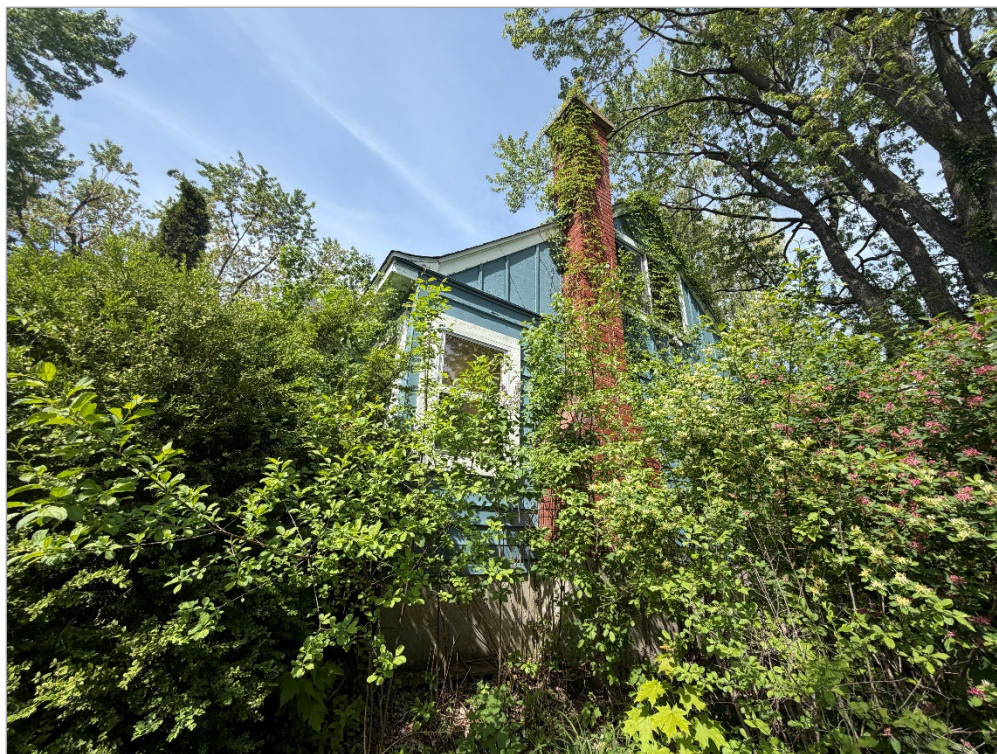
**Right side elevation**

Several bricks on the chimney located on the right side elevation were broken, damaged or missing.

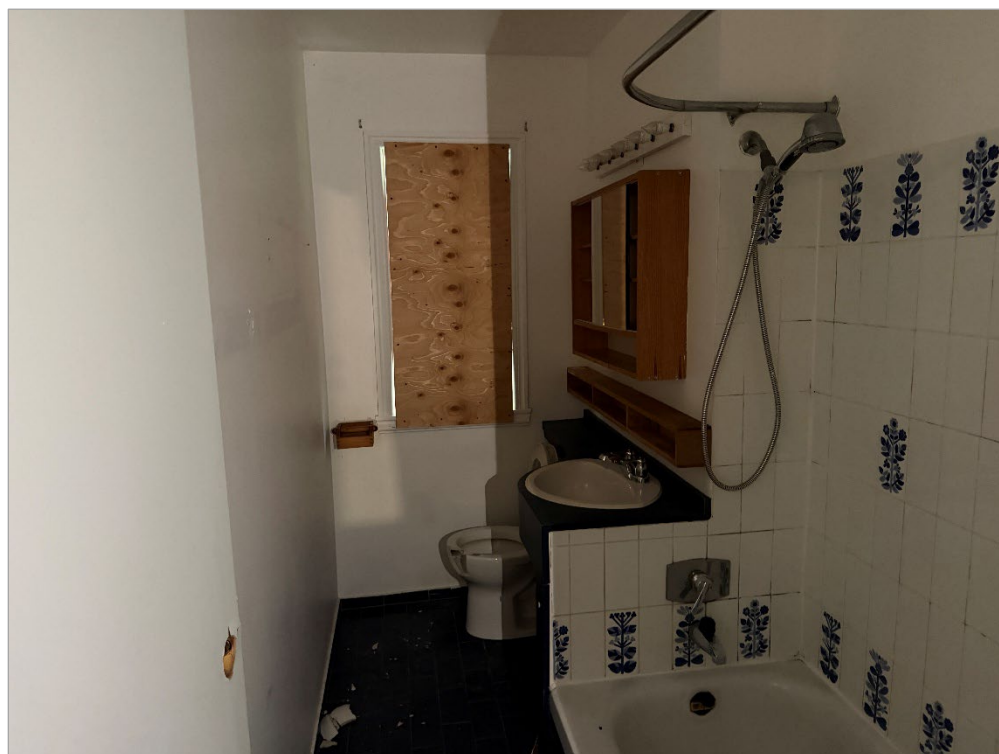
**Bathroom**

The kitchen and bathroom are original and in poor condition. Plan for renovation work in the bathrooms and kitchen.

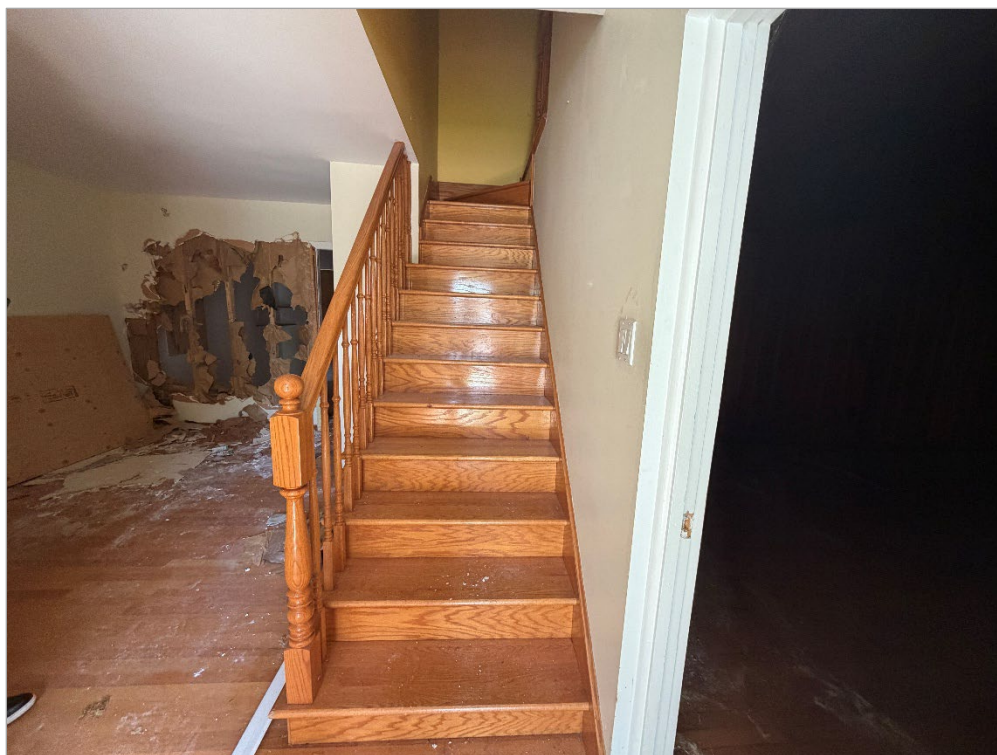
**Staircase to the second floor**

The staircase to the second floor is made of varnished wood and is in good condition, with a guardrail on one side only. A continuous handrail is missing, as required by code.

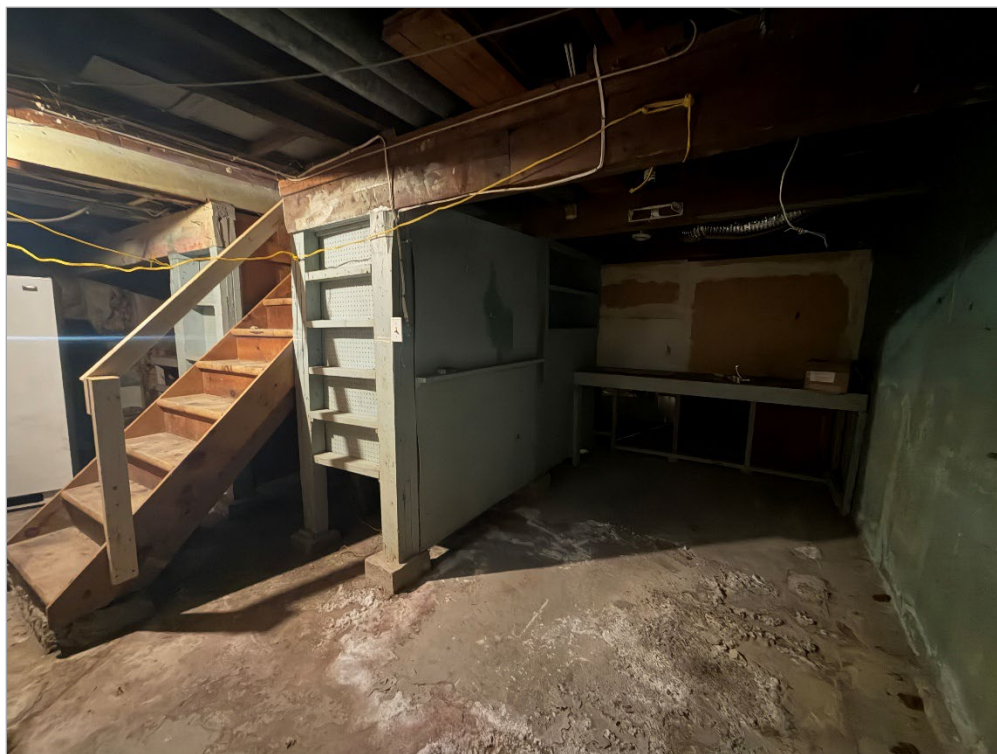
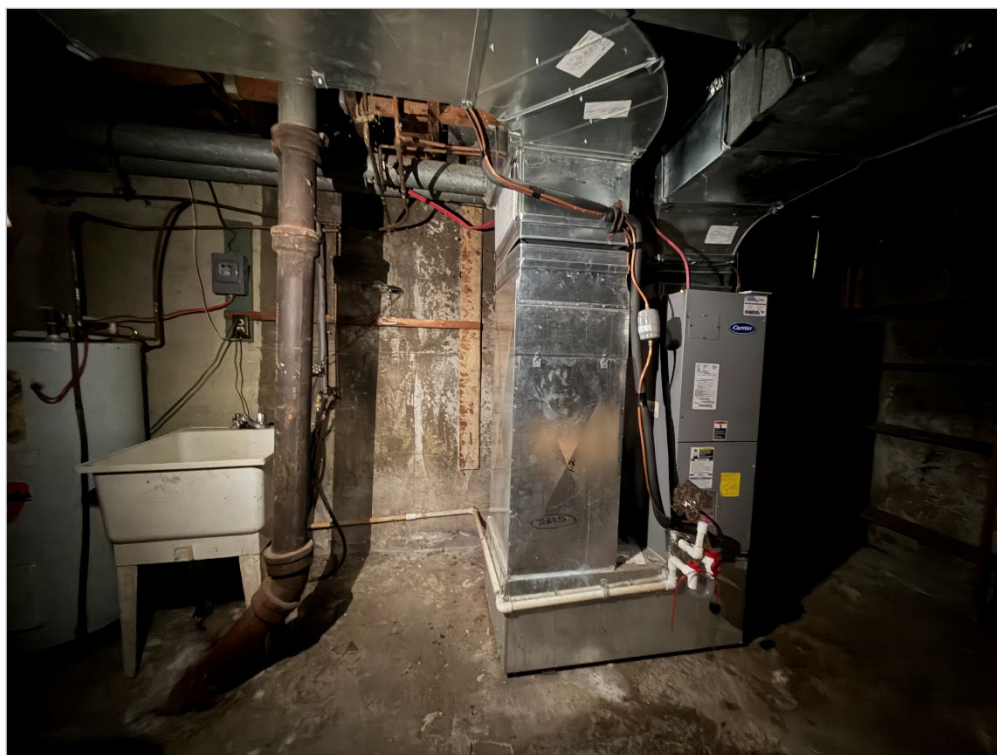
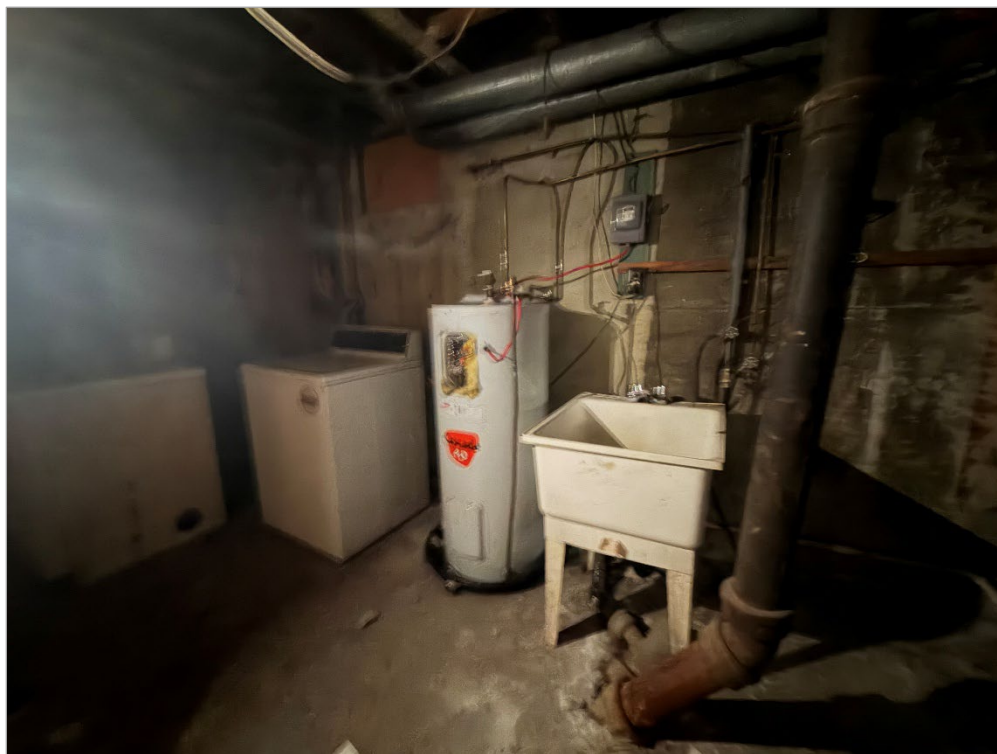
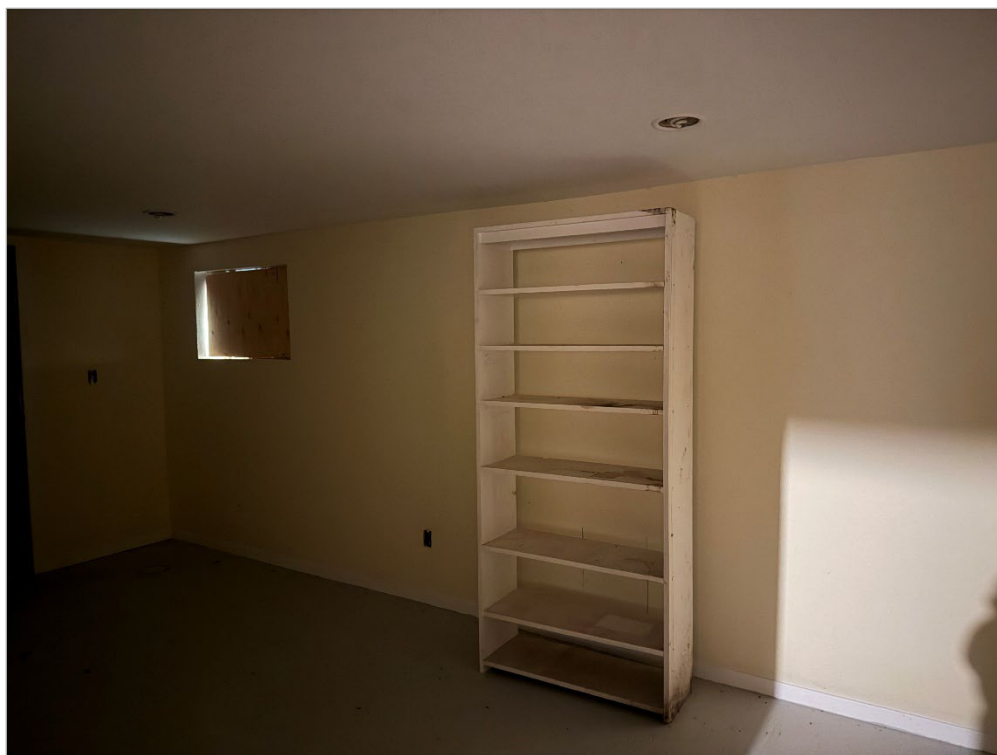
Basement

Significant structural cracks were observed in the foundation wall, with sections of concrete severely deteriorated.

Signs of moisture and water infiltration were observed on the interior face of the concrete basement walls, as well as signs of efflorescence and cracks in the basement concrete slab, indicating significant water infiltration.

Water infiltration and the age of the building have worsened the deterioration of the concrete walls, and mold was observed in several locations on the concrete walls and floor.

The insulation on the basement foundation walls consists of rigid insulation panels approximately 1 inch thick. Several insulation panels are damaged, missing or not properly fastened to the wall. The insulation in the gypsum walls and roof was not accessible for verification.

Due to the age of the building, it is likely that no French drain is present. This situation may be corrected by installing a French drain and a waterproofing membrane on the exterior face of the foundation wall. Current energy-efficiency requirements also call for the addition of rigid insulation on the exterior side of the foundation wall, which should further improve the wall's watertightness.

Replace the rigid insulation panels on all foundation walls and plan for exterior insulation of these walls in order to improve the comfort and thermal efficiency of the house.
