## APPRAISAL REPORT

10, Claremont Avenue  
Pointe-Claire (Quebec)

O/File 630662E

Subject Demolition Assessment Report, covering the new and depreciated replacement cost, as well as the estimated potential renovation costs of the building located at 10, Claremont Avenue, Pointe-Claire (Quebec).

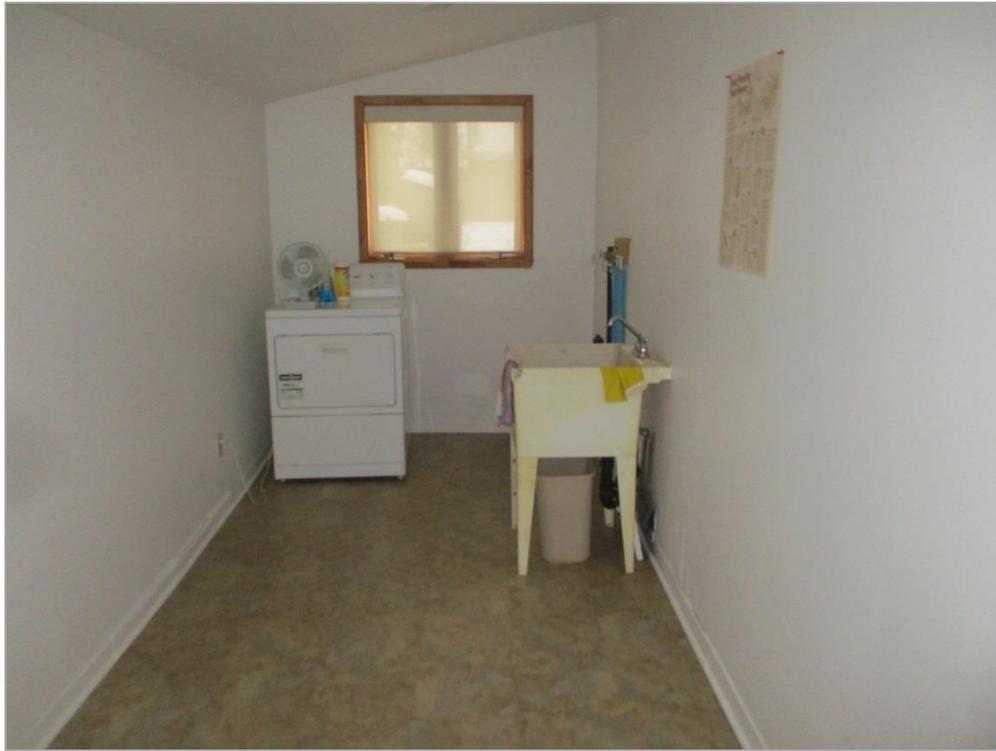
**Laundry Room**

The floor of the laundry room sags under the steps. Call in an engineer to check the condition of the structure and crawl space. Reinforce the floor if necessary.

- **Wall and ceiling:** Control water infiltration into the laundry room before repairing the walls. In addition, grout joints around the bathtub are cracked. Replace the seals to ensure watertightness. Seal the ceiling around the plumbing vent in the enclosed room above the upstairs bathroom.
- **Cabinets and countertops:** There are traces of water infiltration under the kitchen countertop and around the bathroom sink. Plan to replace the kitchen countertop and ensure that the bathroom countertop is watertight.

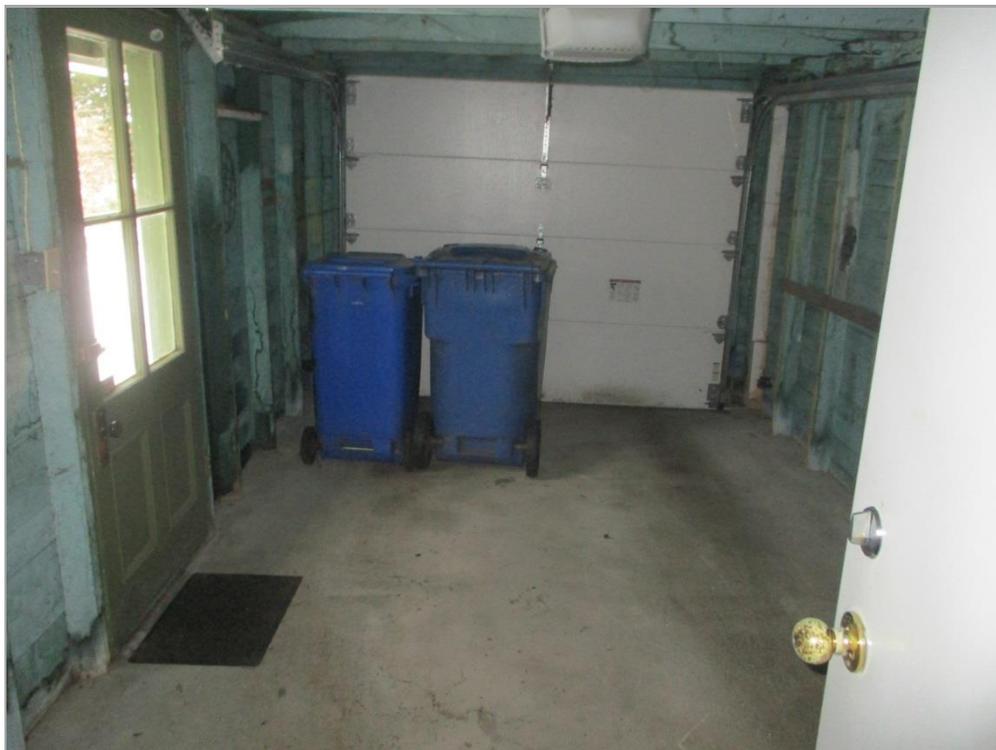
**Garage**

We note traces of water infiltration on the garage slab. Monitor the slope of the floor in front of the garage and replace the weatherstripping.

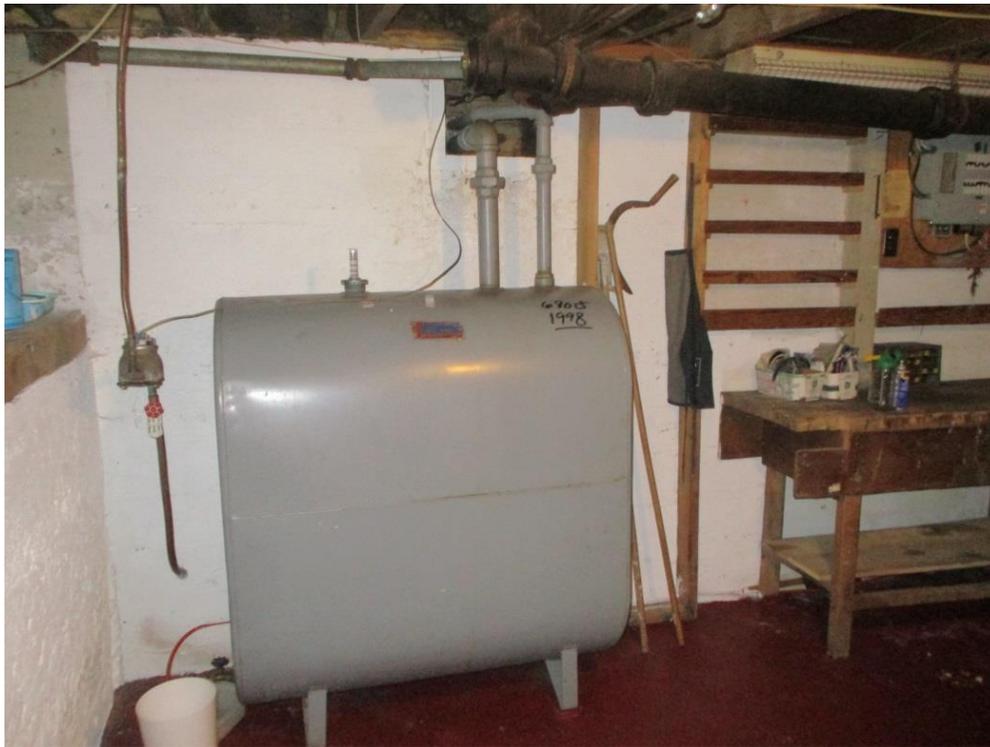
Basement

- **Foundation:** We note traces of blooms and moisture on the front right wall in the basement. It is possible that there is no French drain or that the existing one is deteriorated. It may be wise to install a French drain, waterproof the foundation and insulate it from the outside if necessary. Call in a specialist.

We note the presence of what could be mold on the floor joists in the basement. Proceed with a test and estimate the cost of cleaning.

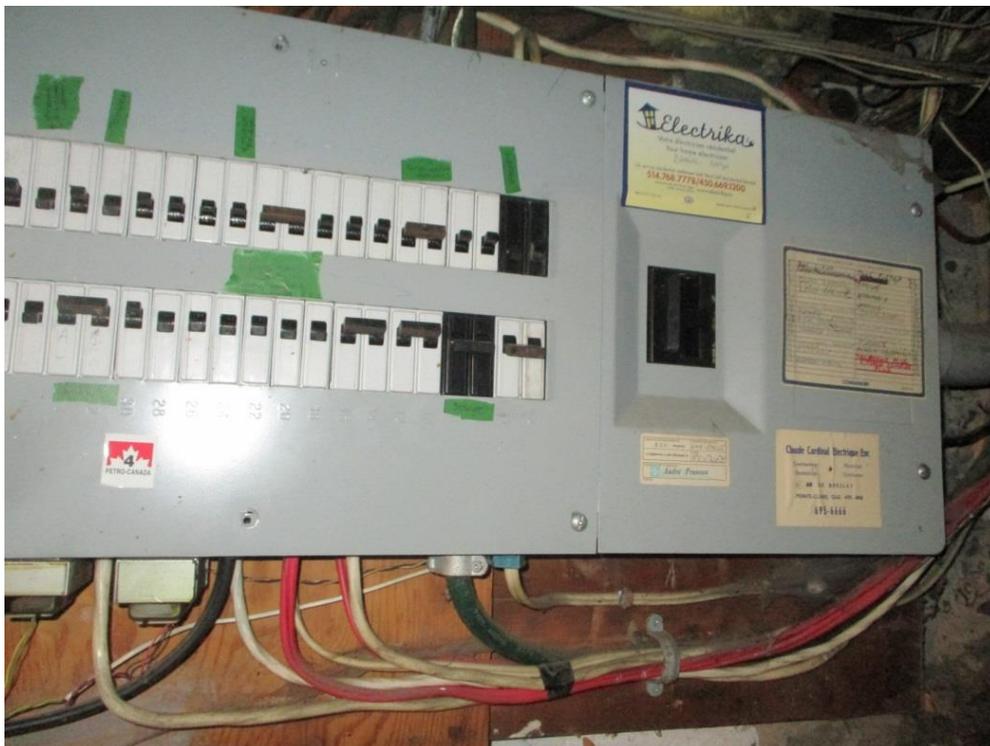
Electric Panels

- **Electricity:** The grounding of the electrical system is not properly secured. Have a master electrician modify the installation. Joints have been made using a marrette inside the panel, which is prohibited. Correct the situation. Have an electrician inspect the electrical installations to ensure proper installation methods. Cables are connected together without junction boxes in the basement. Have this corrected. An electrical outlet in the bathroom is poorly secured to the wall. Some outlets have no grounding. Fix the bathroom light fixture.
