APPRAISAL REPORT

275, Hymus Boulevard
Pointe-Claire (Québec)

O/File 647949E-1

Subject	Valuation report for demolition purposes, relating to the new and depreciated replacement cost, as well as the estimate of the potential renovation costs of the building
Location	275, Hymus Boulevard, Pointe-Claire (Québec).
O/File	647949E-1

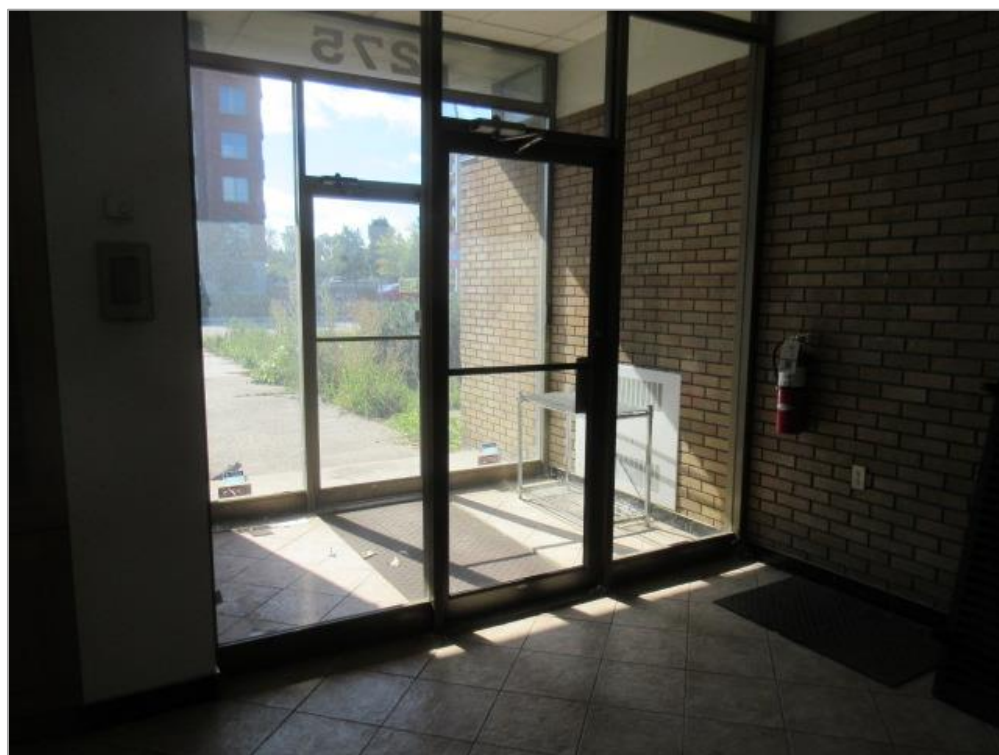
EXTERIOR DOORS	The two main entrance doors (front and left side) are original and single-glazed. The doors have largely reached their useful life. Plan to replace doors and adjacent glazing.
WINDOWS	The windows are original (1960-1970). They are well past their useful life. Plan to replace them in the very short term to seal the exterior walls and also avoid the formation of harmful condensation.

Main entrance on Hymus Boulevard

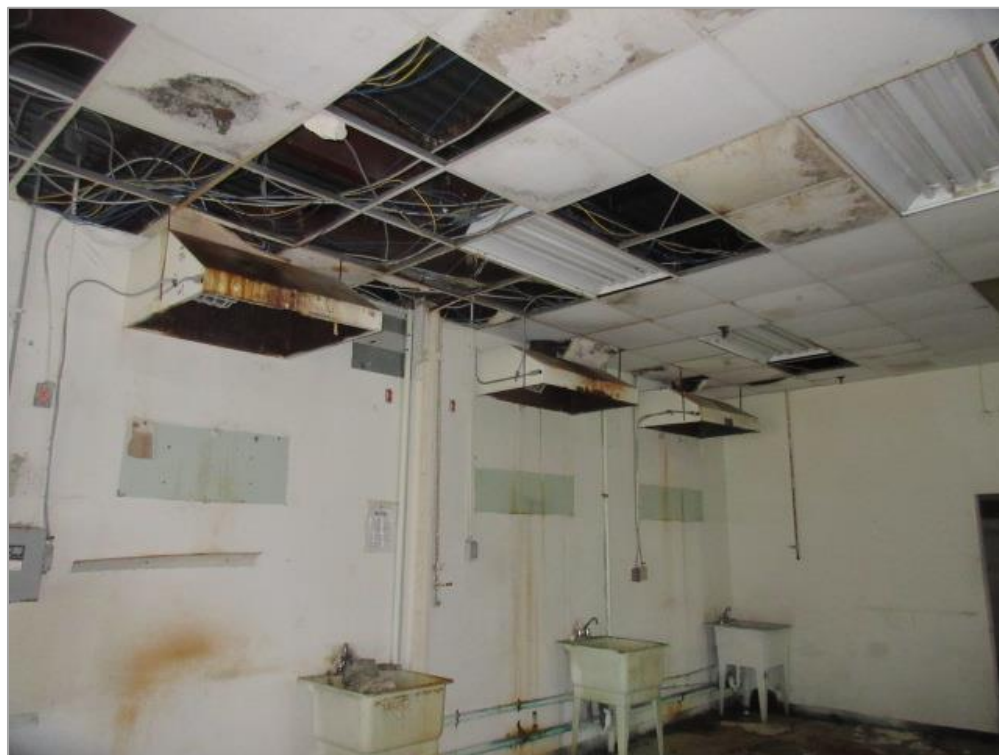
EAVES, FASCIAS AND SOFFITS	The soffits of the right roof overhang are subject to significant water infiltration from the roof. Some sections have been torn out. Plan for a quick repair at the same time as the roof repair.
OUTDOOR LAYOUT	We noticed that trees were too close to the building and the roof. It is essential to carry out the pruning in such a way as to clear the facades and the roofs to allow them to dry out properly through good air circulation. The humidity retained by the presence of trees can contribute to the premature deterioration of facade components in contact with the trees.
ROOF CLADDING	<p>The roof consists of two basins. The membrane of the rear basin is very old and has not benefited from maintenance work. Negative slopes cause significant water retention, and water infiltration, just as significant, has been observed from the interior causing massive deterioration.</p> <p>The front roof membrane is more recent, but significant negative slopes also cause water infiltration.</p> <p>Due to major deficiencies and active water infiltration, an emergency repair must be carried out. Attention should be paid to the condition of the roof structure and decking and corrective action should be taken where necessary. The slopes of the roof basins must be corrected for adequate evacuation of surface water to the roof drains. Anticipate the significant cost of this work.</p>

Water infiltration through the roof

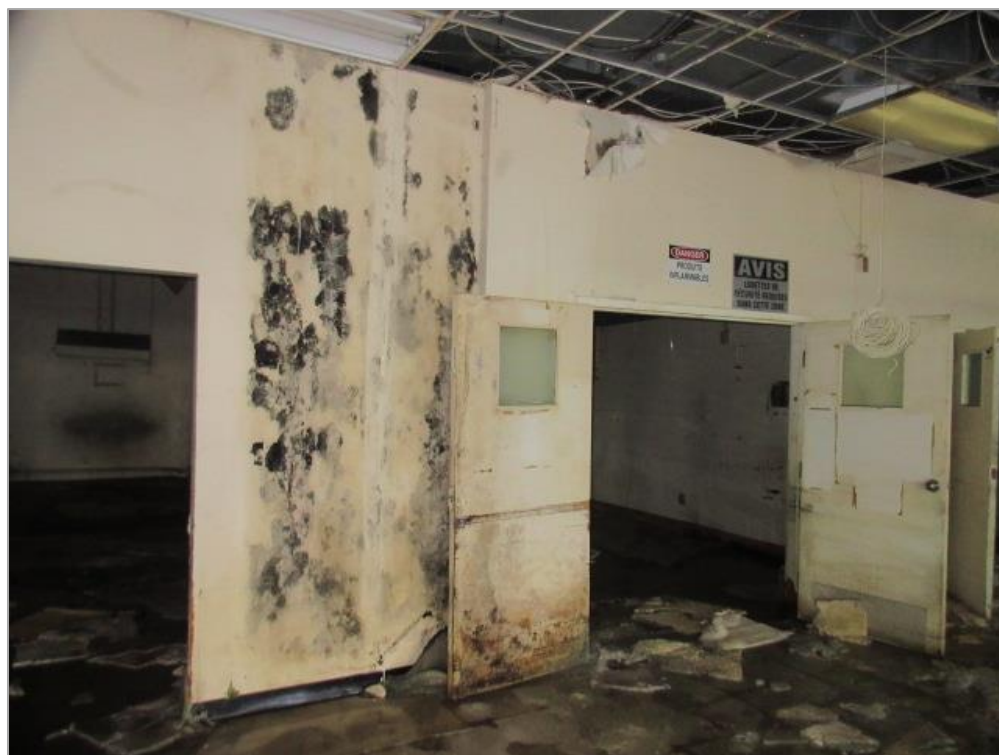
WALLS AND CEILINGS	<p>Due to the age of the building, it is likely that condensation has caused the formation of mold in the exterior walls which cannot be determined on inspection. If necessary, perform an air quality test and follow the expert's recommendations.</p>
INTERIOR DOORS	<p>The doors to the mechanical/electrical room are not compliant. These doors cannot be made of wood. Steel doors must be installed instead with a minimum fire resistance of 45 minutes.</p>
ASBESTOS RISK	<p>Possible presence of asbestos in floor covering tiles.</p>

Traces of mold

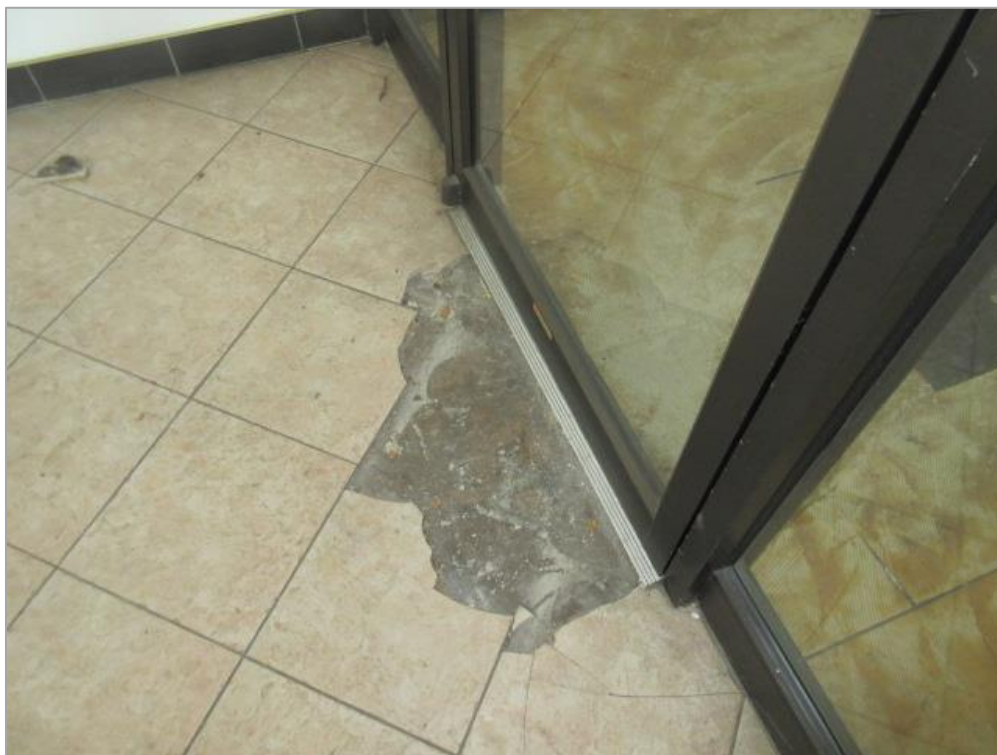
FOUNDATIONS	Inspection limited by the ground level
FLOOR SLAB	We noted significant uplifts and cracks. Only a petrographic index test of the IPPG swelling potential can make it possible to know the nature of the backfill under the concrete slab and its swelling potential associated with the presence of pyrite.
FRAME	We observed shortcomings in the fire resistance between the uses of the building. The building is abandoned. If the building is rehabilitated, carry out a general upgrade in terms of fire resistance.
ROOF STRUCTURE	Significant deficiencies and active water infiltration are visible. An emergency repair must be carried out. Attention should be paid to the condition of the roof structure and decking, and corrective action should be taken where necessary. The slopes of the roof basins must be corrected for adequate evacuation of surface water to the roof drains.
EXTERIOR CLADDING	<p>Bricks are damaged and sections of siding cracked on the left side of the building near the unloading dock. We noticed cracks above the openings in the back wall. We were unable to identify any steel lintels to support the concrete block loads above the openings. Check whether or not there are lintels above the openings. If necessary, correct any shortcomings before repairing the cracks.</p> <p>The sealing joints have deteriorated in a few places and some touch-ups need to be done both around the openings and between various materials. In addition to replacing deteriorated sealants, we advise you to check the condition of the seals every year to prevent water infiltration into the building envelope and deterioration of internal components.</p>

Cracked ceramic slab and tiles

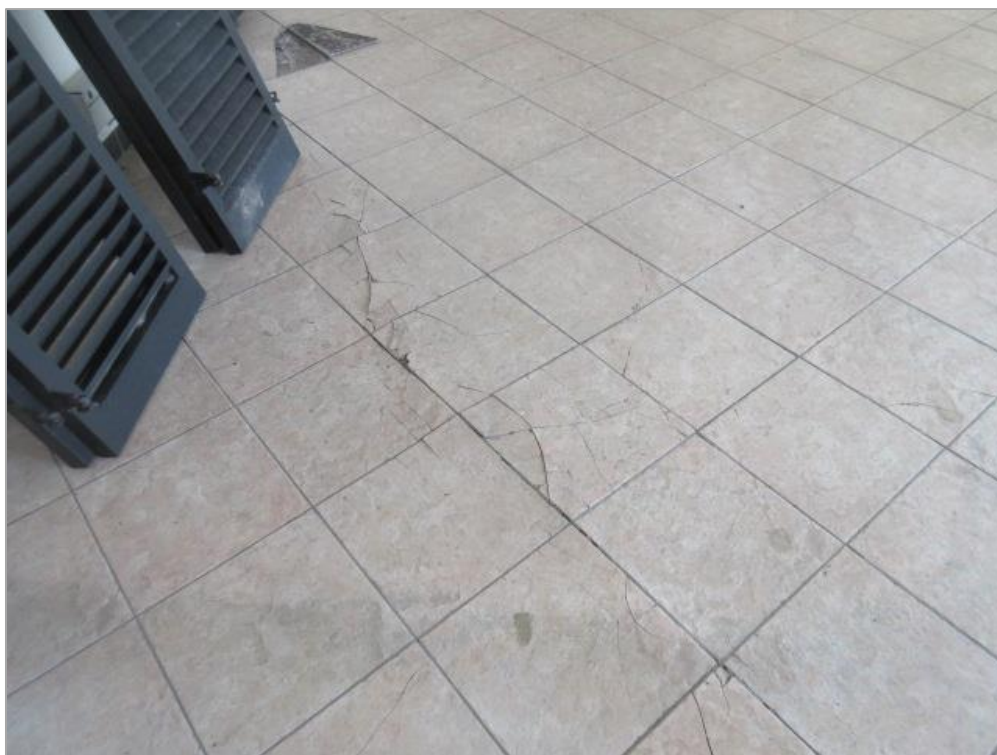
Cracked ceramic slab and tiles

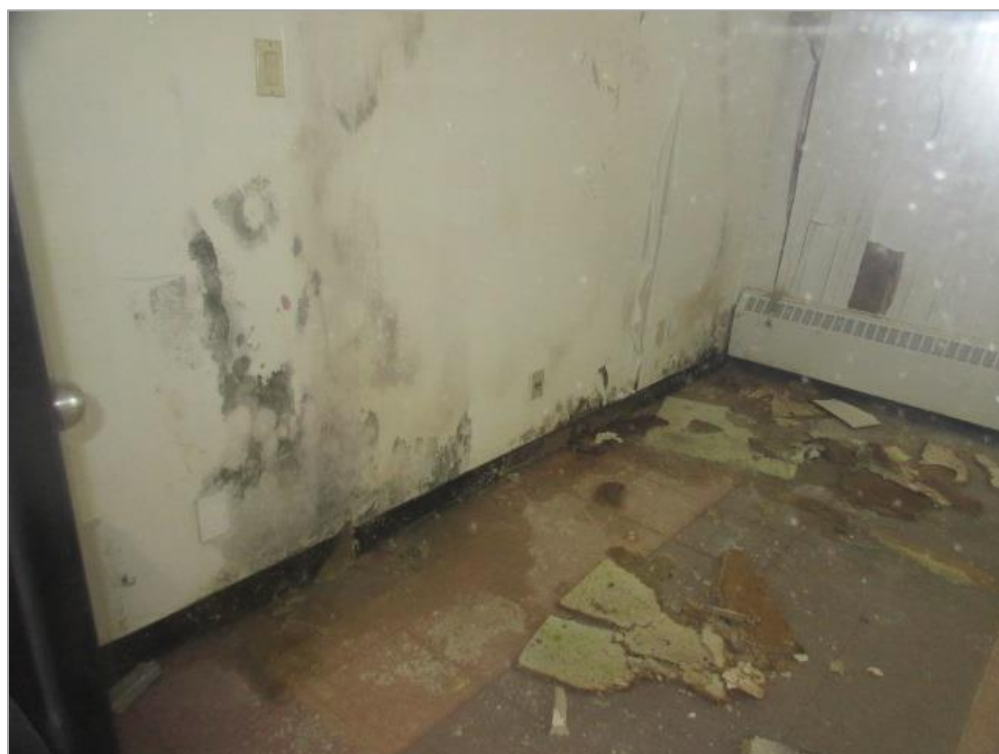
Mold in office space

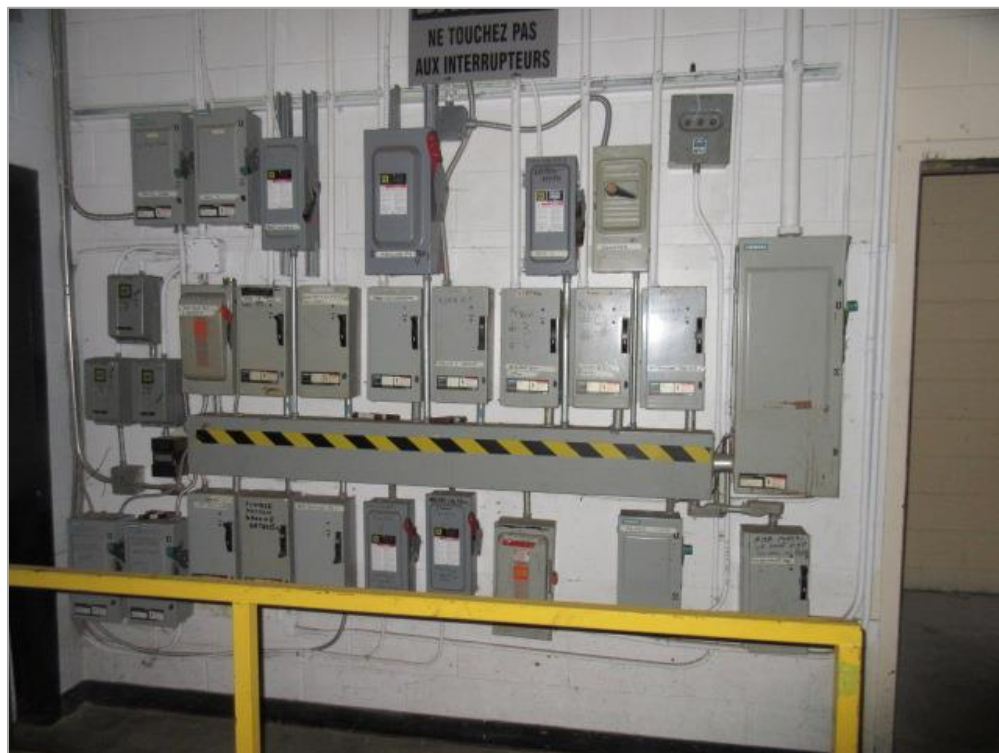
Electrical room

ELECTRICITY	<p>We noticed that the threshold of the access door to the electrical equipment room was inadequate. The Building Code states, in Section 3.6.2.7.8, that "The floor of the electrical equipment room referred to in paragraph 1 shall be liquid tight, and door sills and the bottom of walls all around shall be watertight to a height sufficient to retain all the liquid contained in the largest equipment, but not less than 100 mm.</p> <p>Electrical cables were left on the roof and in the water. Check the installation to ensure safety.</p>
HEATING AND AIR-CONDITIONING	<p>Have the heating systems checked by a specialist who will be able to plan the necessary replacements and maintenance.</p>
FLOOR FINISHES	<p>During the inspection, we noticed that the flooring in many rooms was made of tiles which could contain asbestos. Asbestos is harmful to health. Some tiles have started to break down, which can release asbestos into the air. Perform an asbestos test on each type of tile. If necessary, schedule the removal of the floor covering with the asbestos removal protocol, which is more expensive than the usual removal of a floor covering.</p>

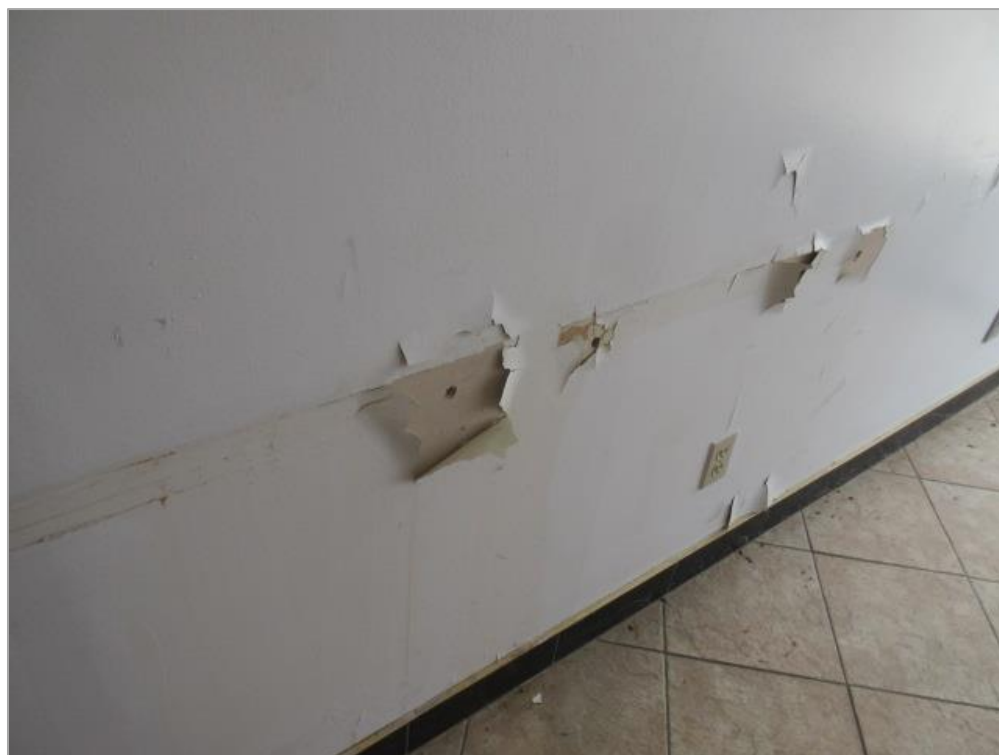
Mold on placoplatre
