APPRAISAL REPORT

21 Broadview Avenue
Pointe-Claire (Québec)

O/File 652288E

Subject	Valuation report for demolition purposes, relating to the new and depreciated replacement cost, as well as the estimate of the potential renovation costs
Location	21 Broadview Avenue, Pointe-Claire (Québec).
O/File	652288E

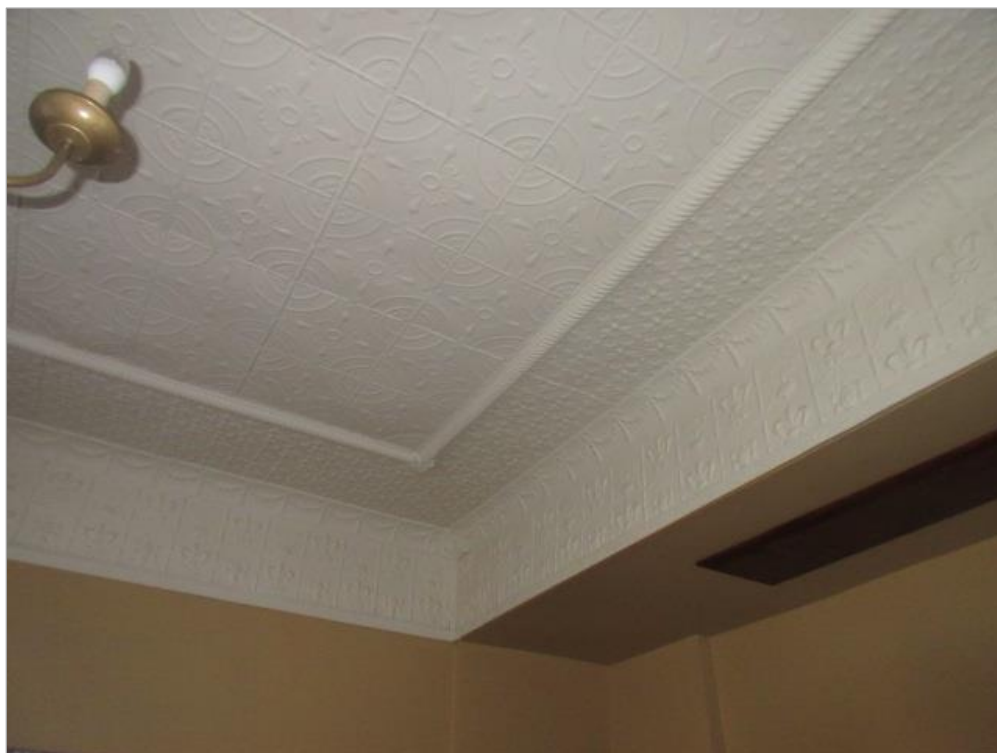
Ceiling finish in the living room

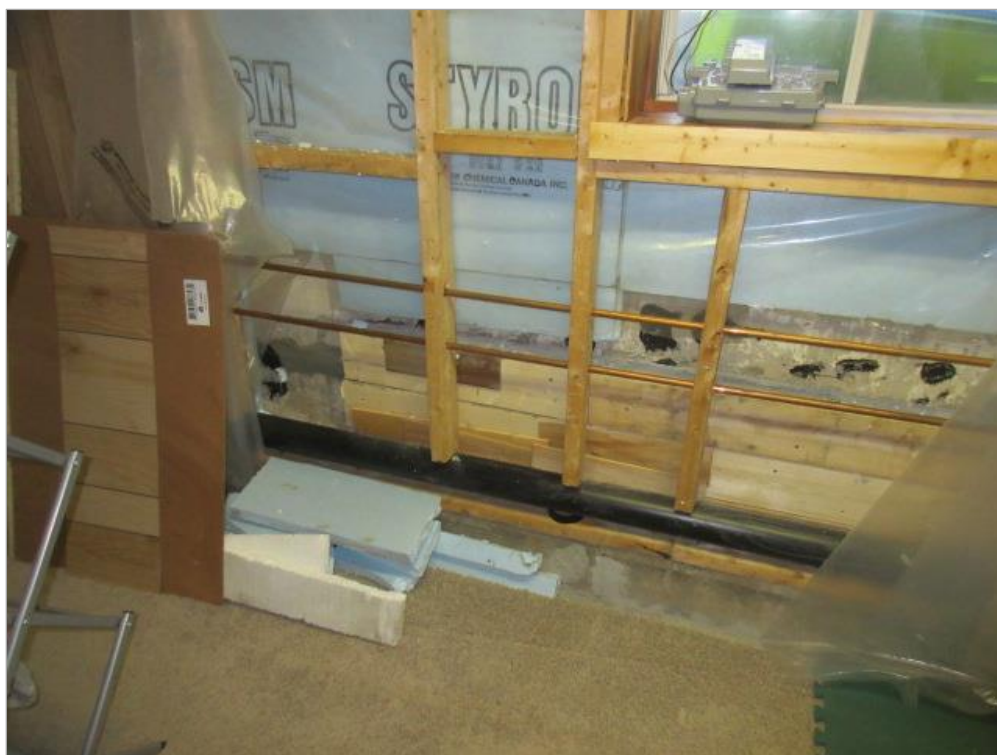
FOUNDATIONS	<p>We notice several cracks on the block and poured concrete foundation walls. Repair or replace these foundations.</p> <p>Water infiltration and stains are observed on the foundation walls. It is possible that there is no French drain or that it is old. Have the foundations inspected and proceed to install a French drain, if necessary.</p>
FLOOR SLAB	<p>The slab is thinner than usual and should be replaced.</p>
FLOOR JOISTS	<p>Possible traces of mold are observed on joists and floor decking in the basement. Perform a mold test.</p> <p>Mold traces are observed on the floor structure along some exterior walls.</p> <p>Unevenness can be caused by deflection of structural elements.</p> <p>A broken joist was observed, reinforce it.</p>
GARAGE STRUCTURE	<p>The garage was not inspected.</p>
EXTERIOR CLADDING	<p>Vinyl cladding covers the exterior walls. We believe that this facing must be replaced.</p>

Foundation wall

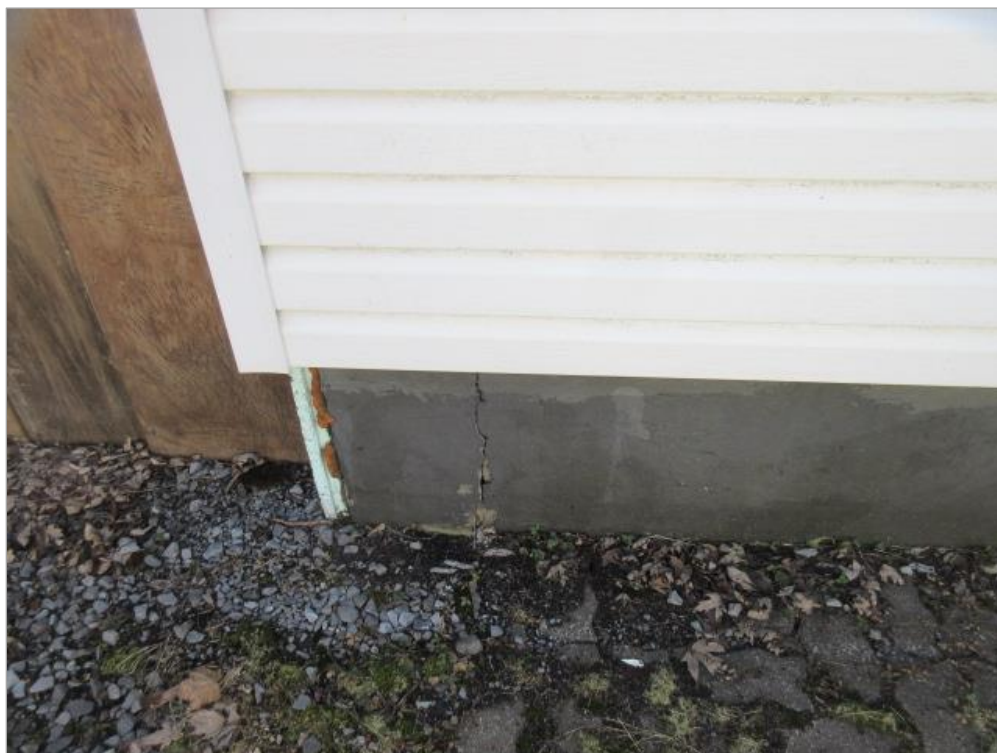
The building under study, of standard quality, is in poor condition and requires several upgrades. Several significant components are at the end of their useful life (windows, exterior cladding, etc.) and will have to be replaced. Similarly, several building deficiencies were noted and will have to be corrected. Note, in particular, the major cracks in the concrete block foundation walls.

Foundation crack

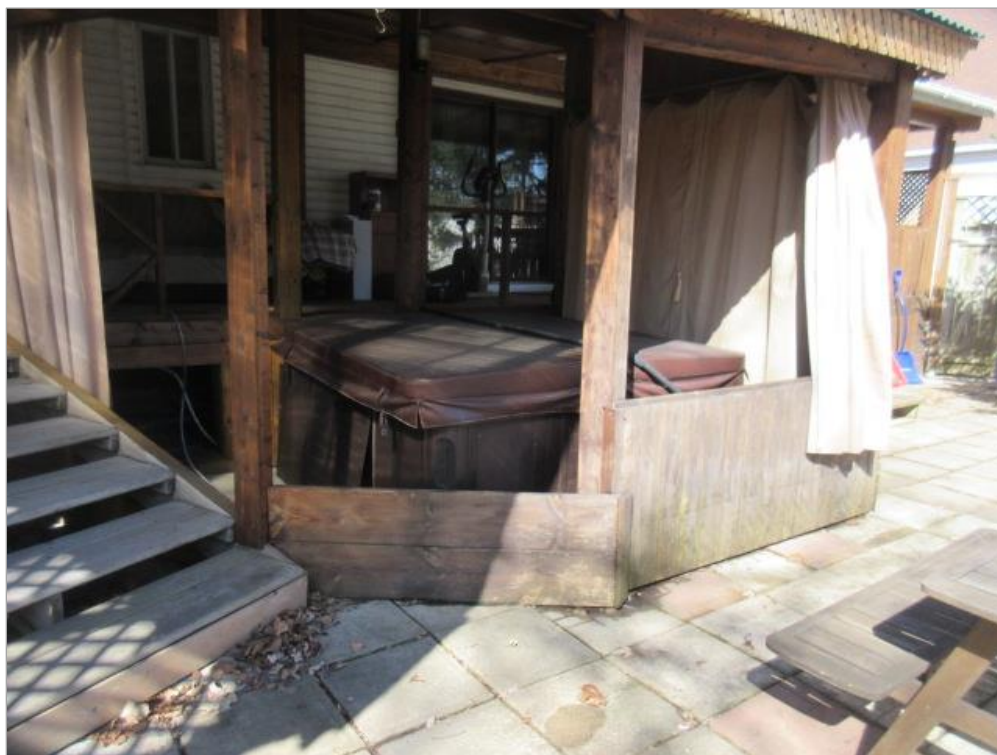
Rear terrace with roof
