APPRAISAL REPORT

158 Broadview Avenue
Pointe-Claire (Québec)

O/File 652632E

| Subject | Valuation report for demolition purposes, relating to the new and depreciated replacement cost, as well as the estimate of the potential renovation costs |

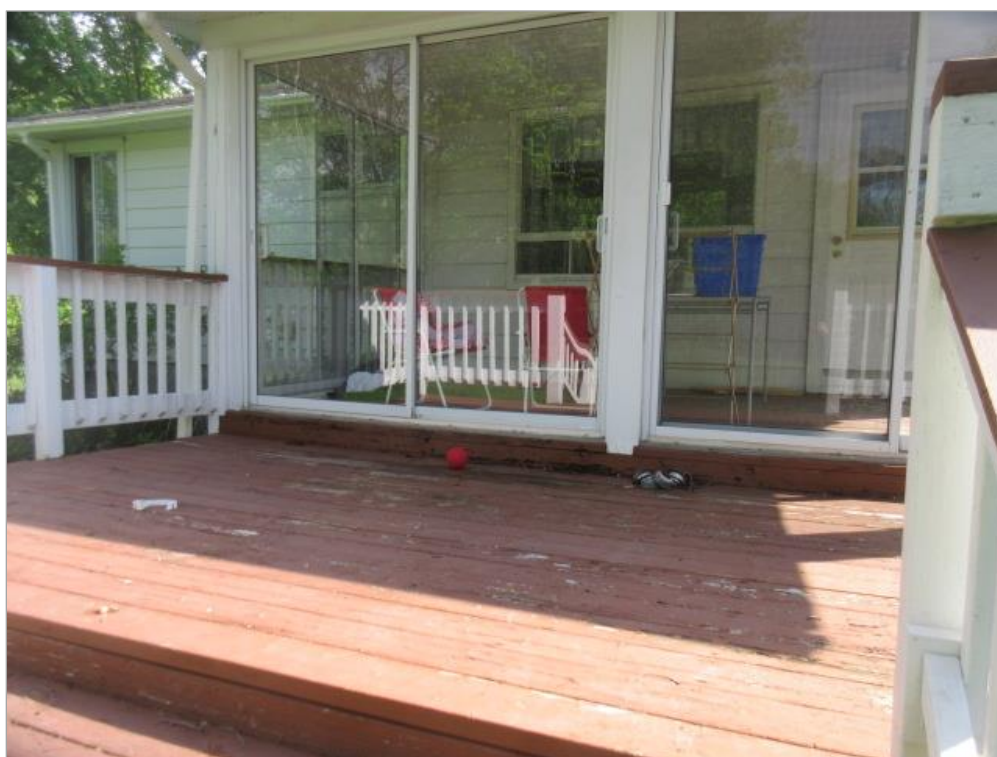
| TERRACES, BALCONIES AND PORCHES | The rear terrace is poorly supported, including its roof. The terrace leans a lot towards the house (negative slope). Provide for a short-term repair of the whole. |

Back porch

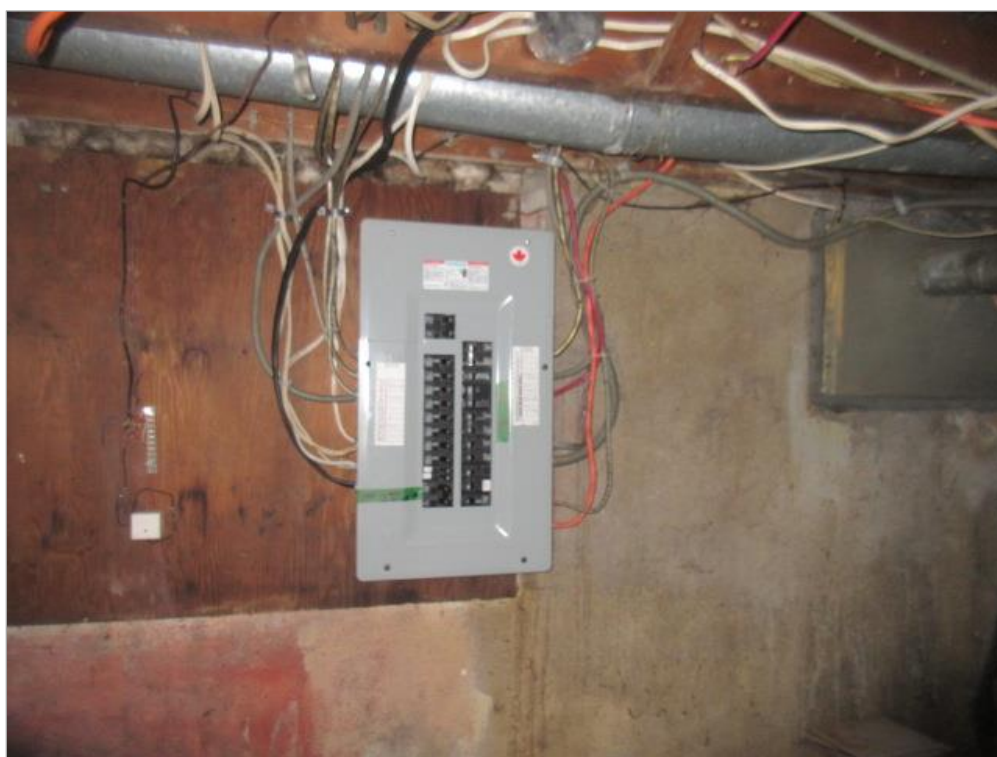
Electrical inputs

| ELECTRICITY | <p>Replace the electric pole.</p> <p>We noticed electrical cables without a protective cover. Remove the cables or insert them into junction boxes. Plan an upgrade. Attach the free junction box to a structural element. Replace unprotected outlets with GFCI outlets. Have the outlets and grounding checked by an electrician.</p> |

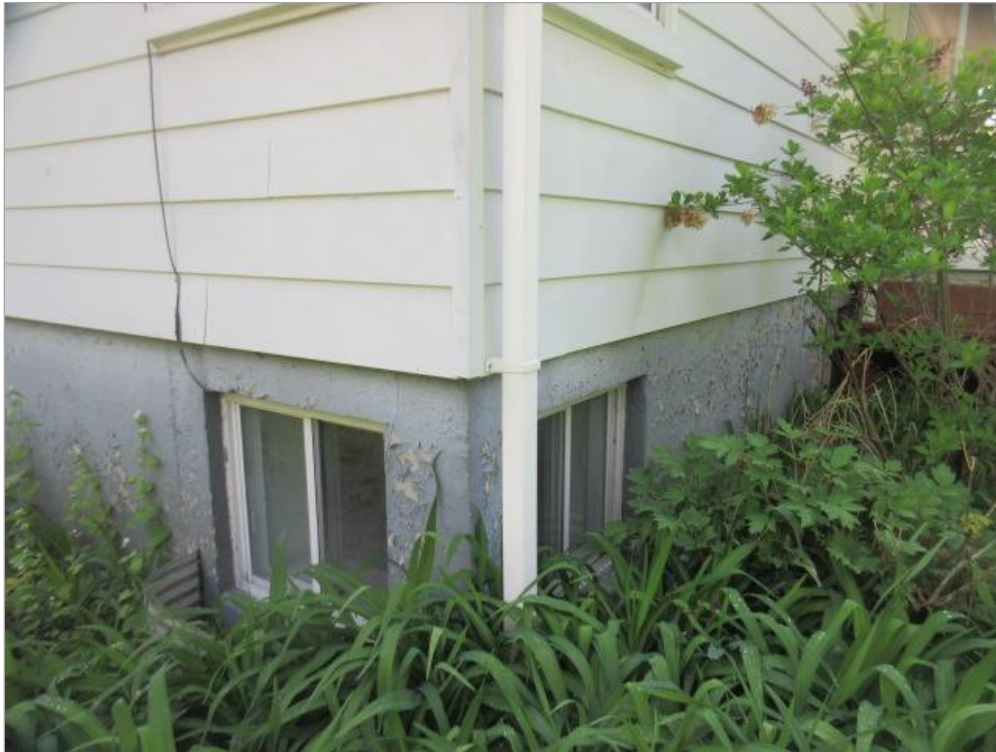
| FOUNDATIONS | <p>several cracks are observed on the poured concrete foundation walls. Repair or replace these foundations.</p> <p>Water infiltration and stains are observed on the foundation walls. It is possible that there is no French drain or that it is worn. Have the foundations inspected and install a French drain, if necessary.</p> |

The building under study, of standard quality, is in poor condition and requires several upgrades. Several significant components are at the end of their useful life (windows, exterior cladding, heaters, etc.) and will have to be replaced. Similarly, several building deficiencies were noted and will have to be corrected. Note, in particular, the major cracks found in the foundation and structure walls.

Foundation crack

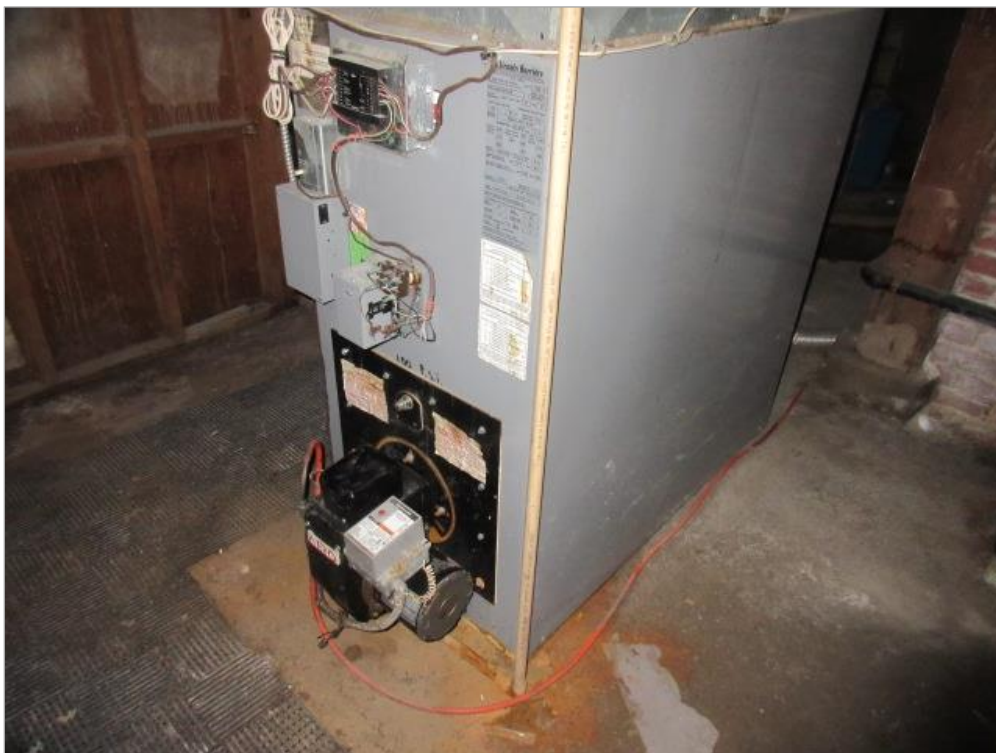
Heating system

| HEATING AND AIR-CONDITIONING | <p>Plan to replace the oil-fired forced-air furnace.</p> <p>Plan to replace the heat pump.</p> |

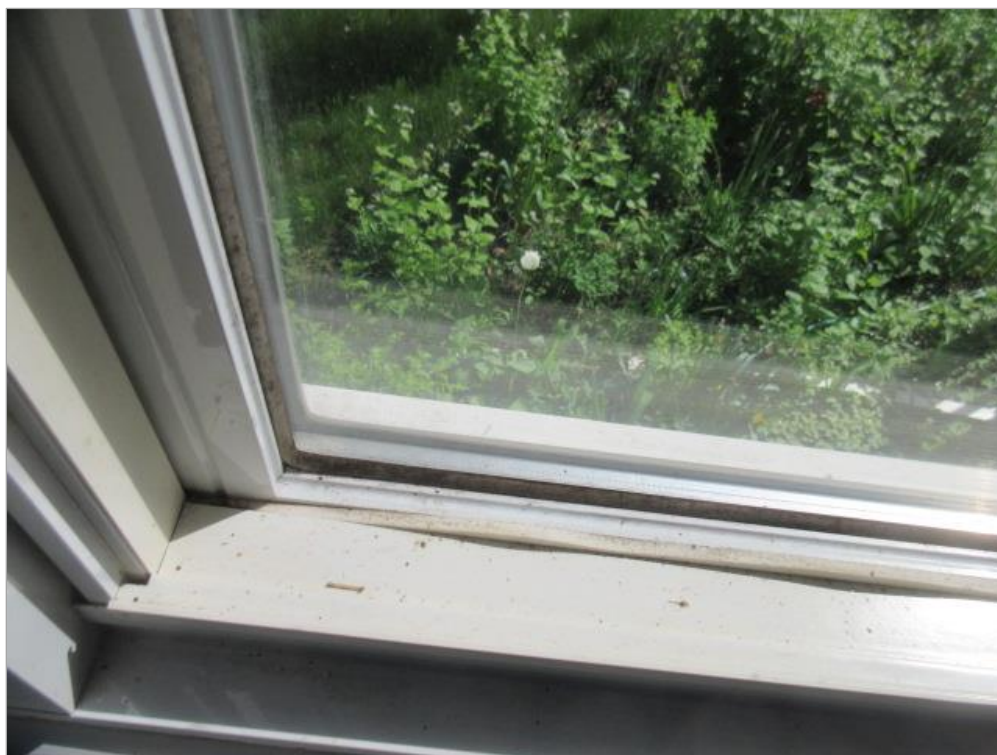
| DOORS AND WINDOWS | The windows were manufactured in 1990. They have reached their useful life. Provide for a complete repair of windows and patio doors. |

Window

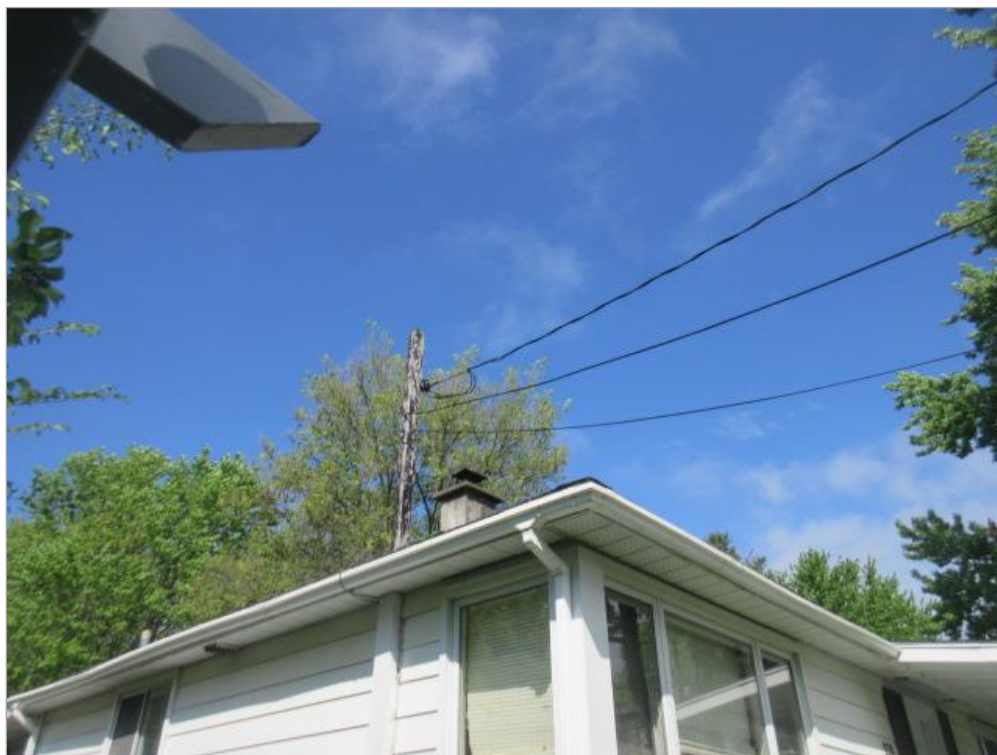
| ROOF CLADDING | The roof needs to be replaced shortly. Replace the electric pole located on the roof. |

Electric pole
