APPRAISAL REPORT

12 Hillside Avenue
Pointe-Claire (Québec)

August 17, 2022

Subject	Valuation report for demolition purposes, relating to the new and depreciated replacement cost, as well as the estimate of the potential renovation costs
Location	12 Hillside Avenue, Pointe-Claire (Québec)
O/File	656949E

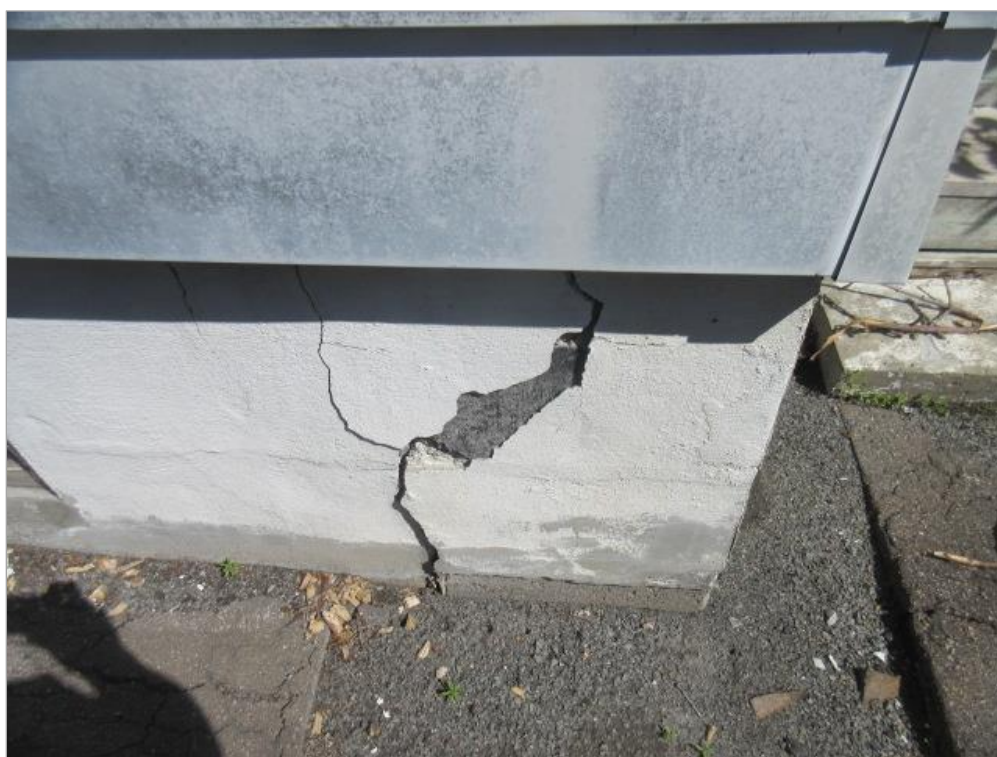
FOUNDATIONS	<p>Several major cracks are observed on the concrete blocks foundation walls. The left side wall is unstable and could collapse. Repair or replace the foundations.</p> <p>Water infiltration and stains are observed on the foundation walls. There may not be a French drain or it might be worn. Have the foundations inspected and install a French drain, if necessary.</p>
FLOOR SLAB	<p>Traces of moisture as well as water infiltration were noticed in several places.</p>
FLOOR JOISTS	<p>There are possible traces of mold on joists and floor decking in the basement. Perform a mold test.</p> <p>Joists have notches that can affect structural integrity.</p> <p>The basement's subfloor shows signs of sagging.</p>
STRUCTURE	<p>The structure undergoes subsidence. Have the structure of the building checked by a structural engineer to see if it can be preserved.</p> <p>The roof is sagging.</p> <p>The wooden piles are unstable.</p>

The building under study, of standard quality, is in poor condition and requires several upgrades. Several significant components are at the end of their useful life (foundation, structure, windows, exterior cladding, heaters, etc.) and will have to be replaced. As well, several building deficiencies were noticed and will have to be corrected. Consider, in particular, the major cracks found in the foundation walls.

Crack on the foundation wall
