APPRAISAL REPORT

25 Prince Edward Avenue
Pointe-Claire (Québec)

O/File 652289E

Subject	Valuation report for demolition purposes, relating to the new and depreciated replacement cost, as well as the estimate of the potential renovation costs
Location	25 Prince Edward Avenue, Pointe-Claire (Québec).
O/File	652289E

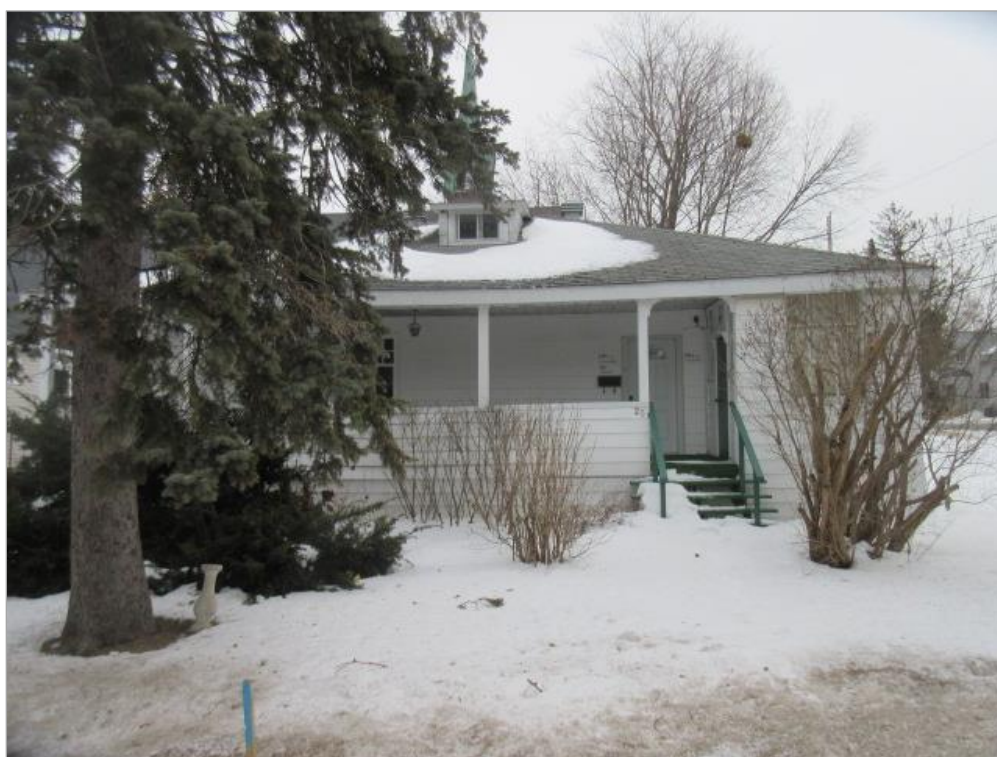
Front porch

DOORS AND WINDOWS	The windows have reached their useful life. Plan a complete repair of windows and patio doors.
TERRACES, BALCONIES AND PORCHES	The front gallery and the guardrail are collapsed. In addition, the gallery surface is made of painted OSB panels, which is not adequate for an exterior surface partially exposed to the weather. Furthermore, as the surface does not allow water to flow, it will deteriorate even more quickly due to water retention along the railing. Plan a repair of the whole.
SOFFITS	Clear soffits and check ventilation.
OUTDOOR LAYOUT	Plan to modify the slope of the land for drainage towards the street.
ROOF CLADDING	The roof needs to be replaced shortly.
GUTTERS	Roof overhangs are missing gutters. Have gutters installed at the bottom of each roof slope as well as outlets at the bottom of the gutters.
FLASHINGS	Proceed to install new flashings.
PLUMBING	Inspection of plumbing components was limited by the lack of running water in the system. Faults, not related in this report, may exist in the untested plumbing system. We suggest that you turn on all the plumbing to make sure the system is operational before rehabilitating the building,. The plumbing in an inhabited building tend to fail after a period of disuse.

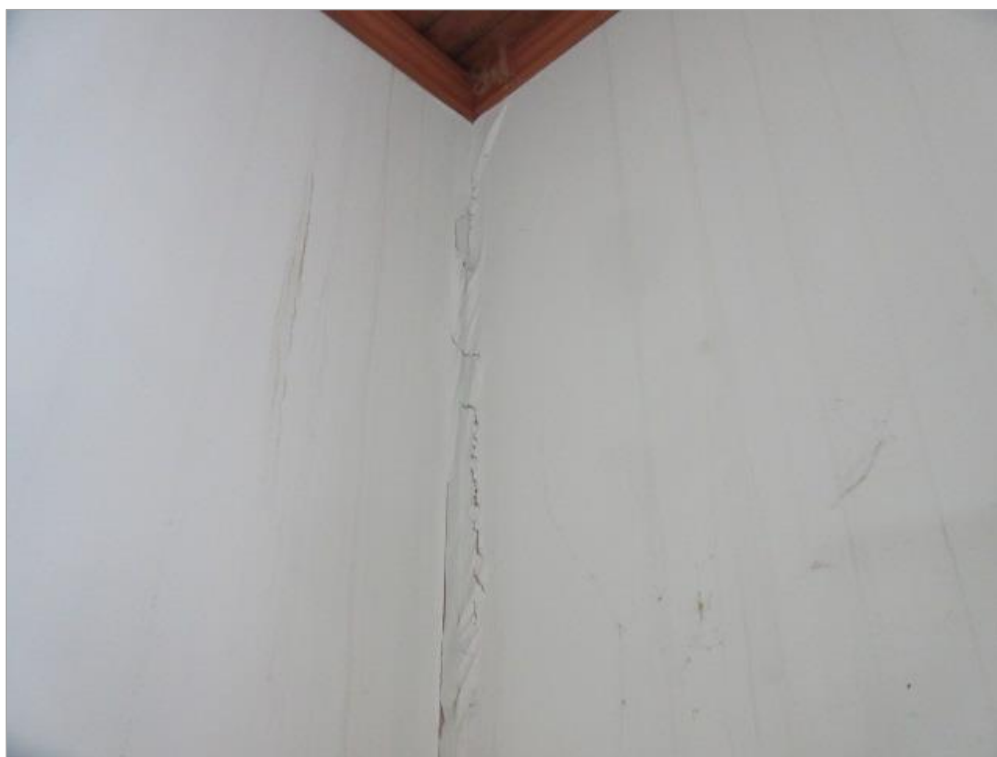
Water infiltration

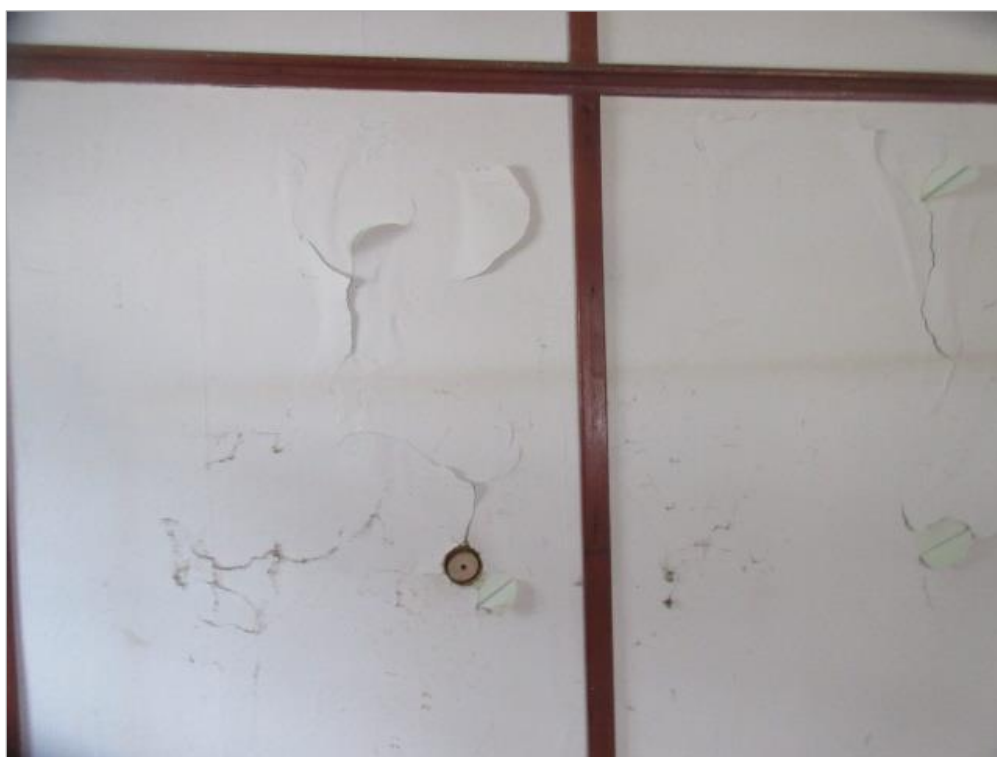
Water infiltration

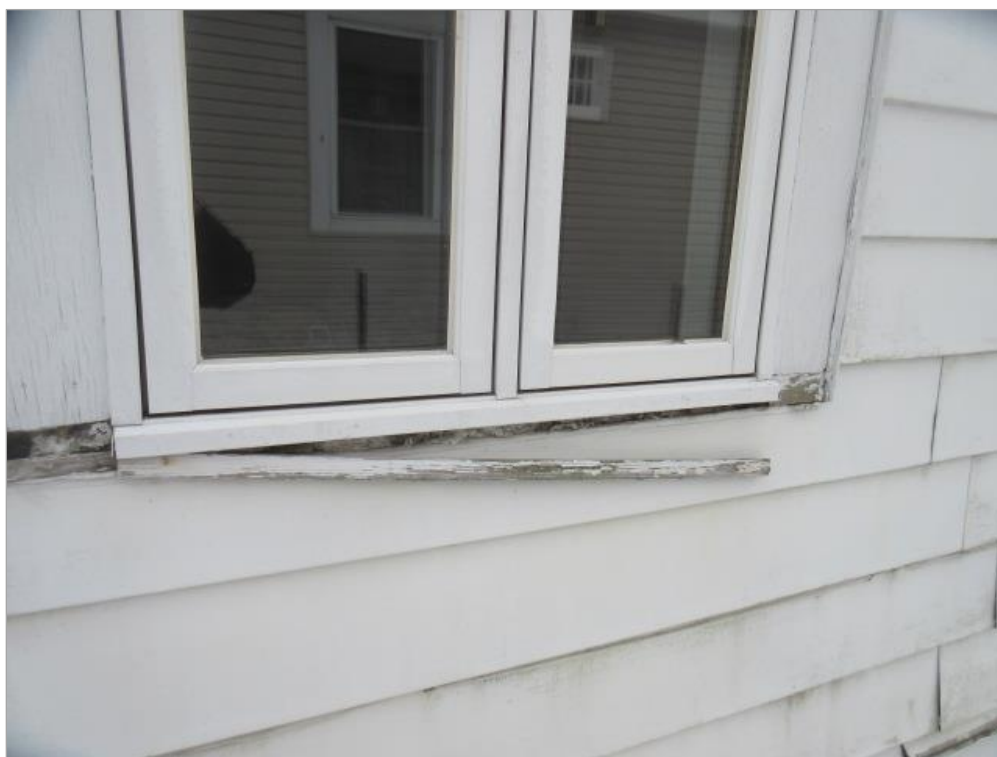
Window to replace
