APPRAISAL REPORT

10 Lakeside Avenue
Pointe-Claire (Quebec)

O/File 635113E

Subject	Demolition Assessment Report, covering the new and depreciated replacement cost, as well as the estimated potential renovation costs of the building located at 10 Lakeside Avenue, Pointe-Claire (Quebec).
O/File	635113E

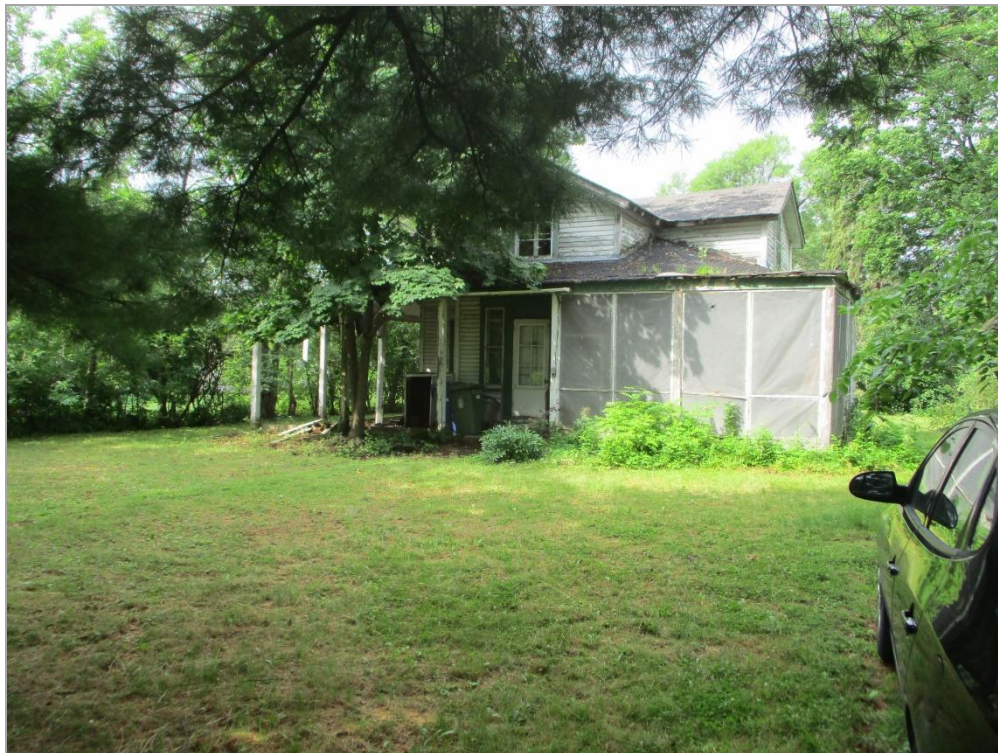
Building front view

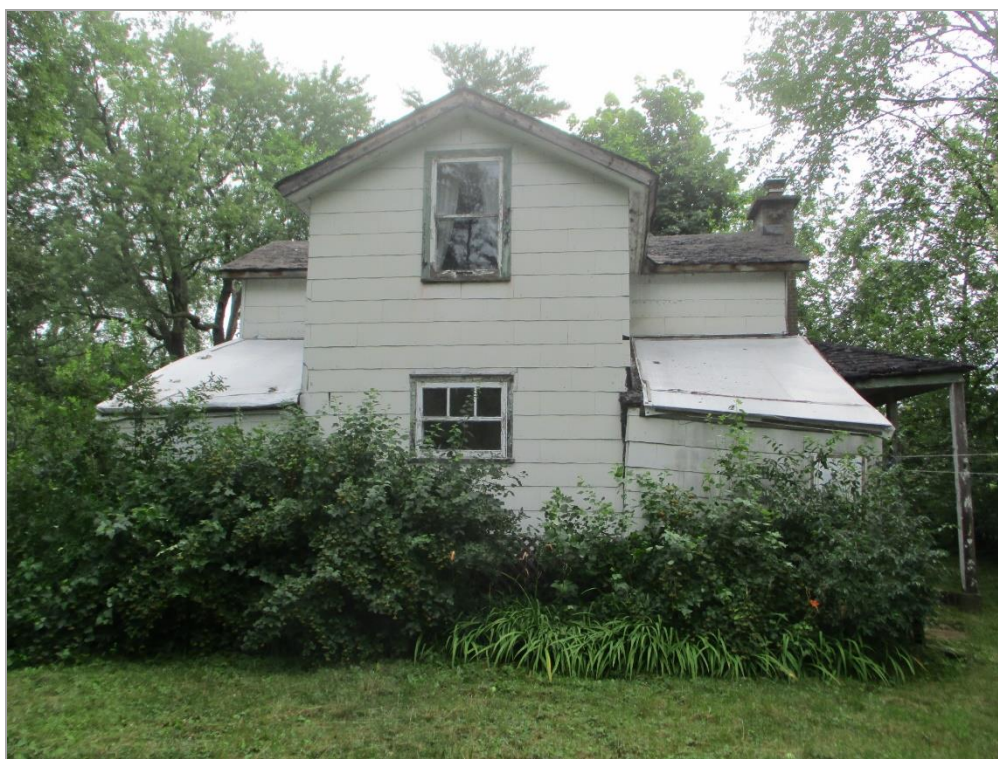
Building rear view

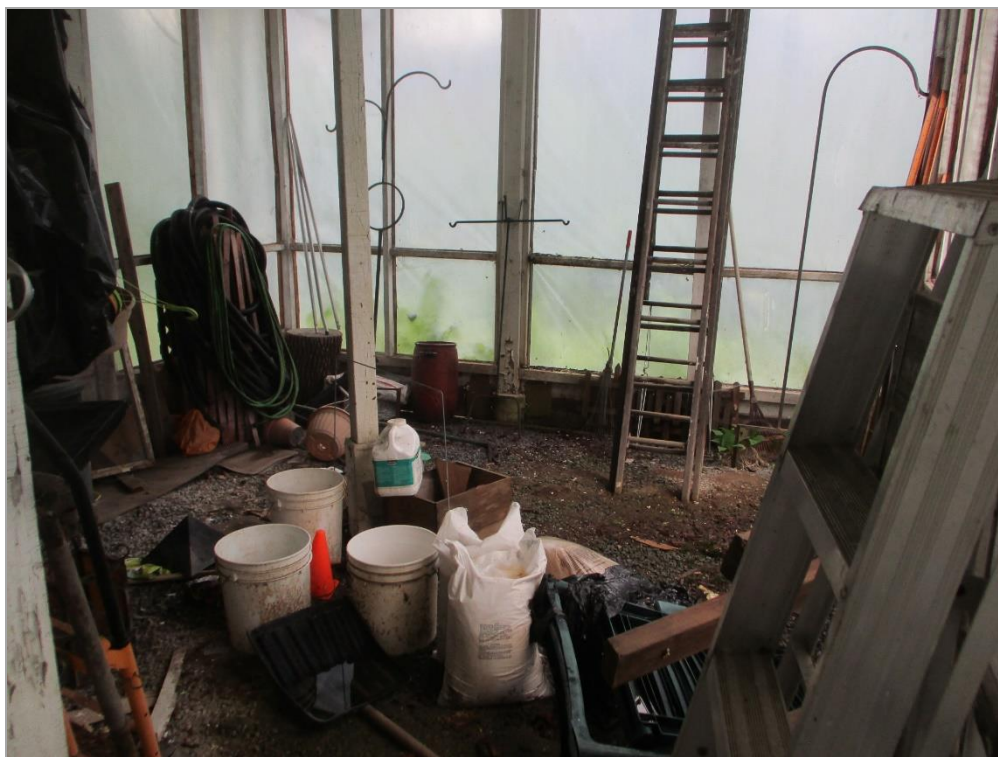
Greenhouse

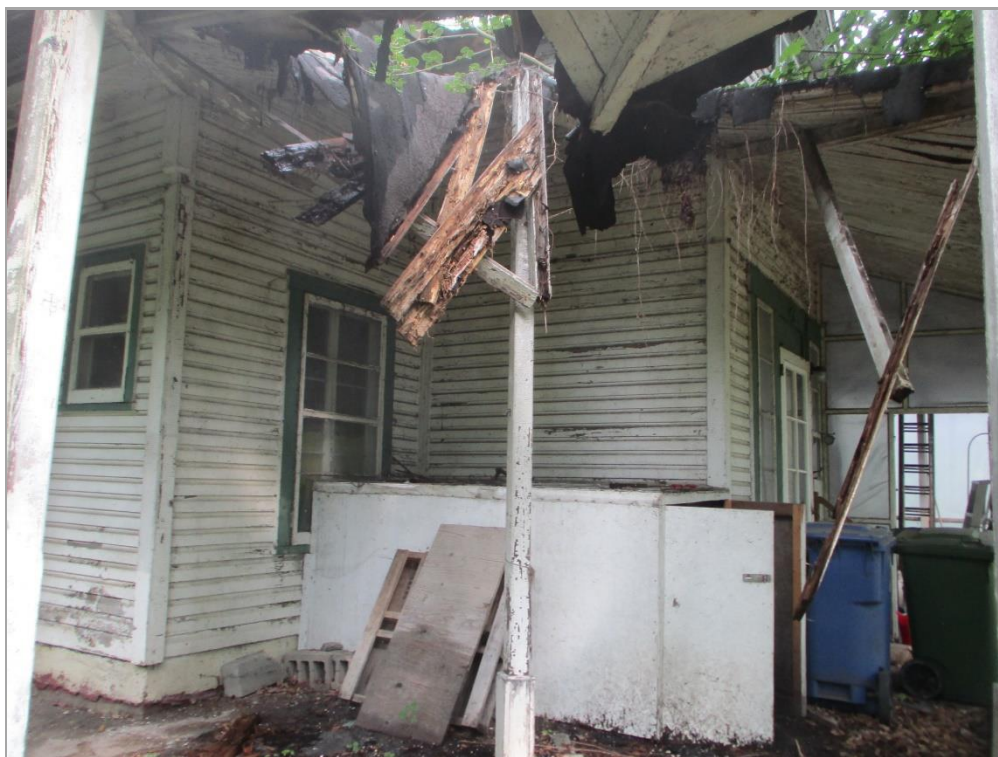
- **Roof structure:** limited inspection. On the other hand, sagging is noted in several places. The roof structures of the two extensions are weak. The left roof has collapsed and the right roof has deteriorated due to water infiltration.

Collapsed Roof
