APPRAISAL REPORT

10 Jervis Bay Avenue
Pointe-Claire (Québec)

O/File 658267E

Subject	Valuation report for demolition purposes, relating to the new and depreciated replacement cost, as well as the estimate of the potential renovation costs
Location	10 Jervis Bay Avenue, Pointe-Claire (Québec)
O/File	658267E

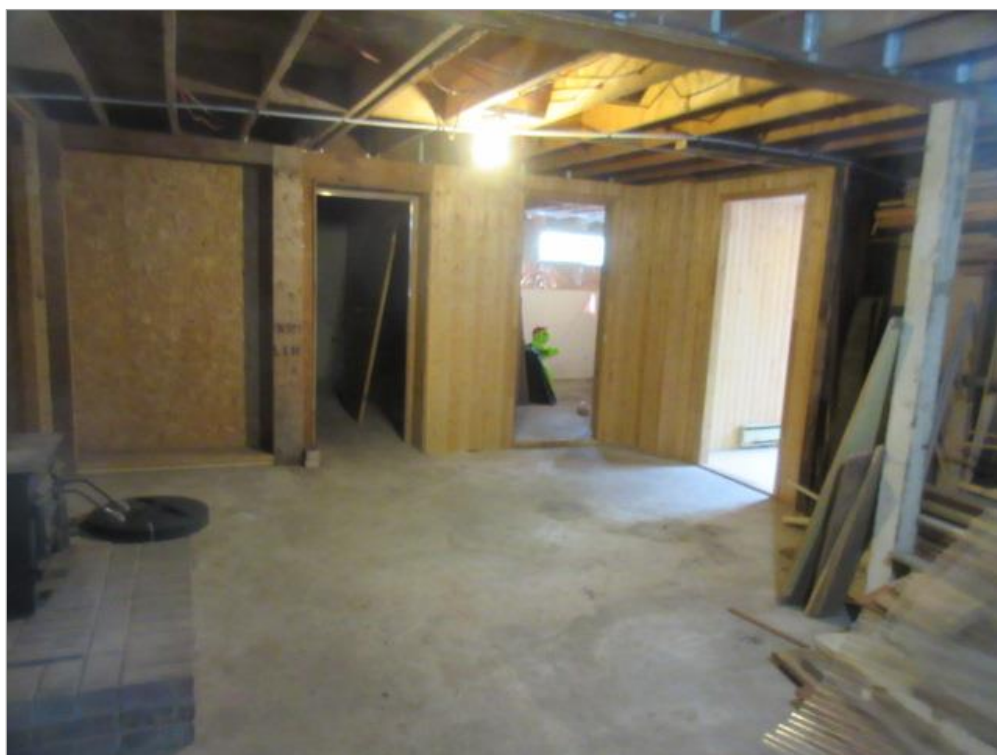
Basement

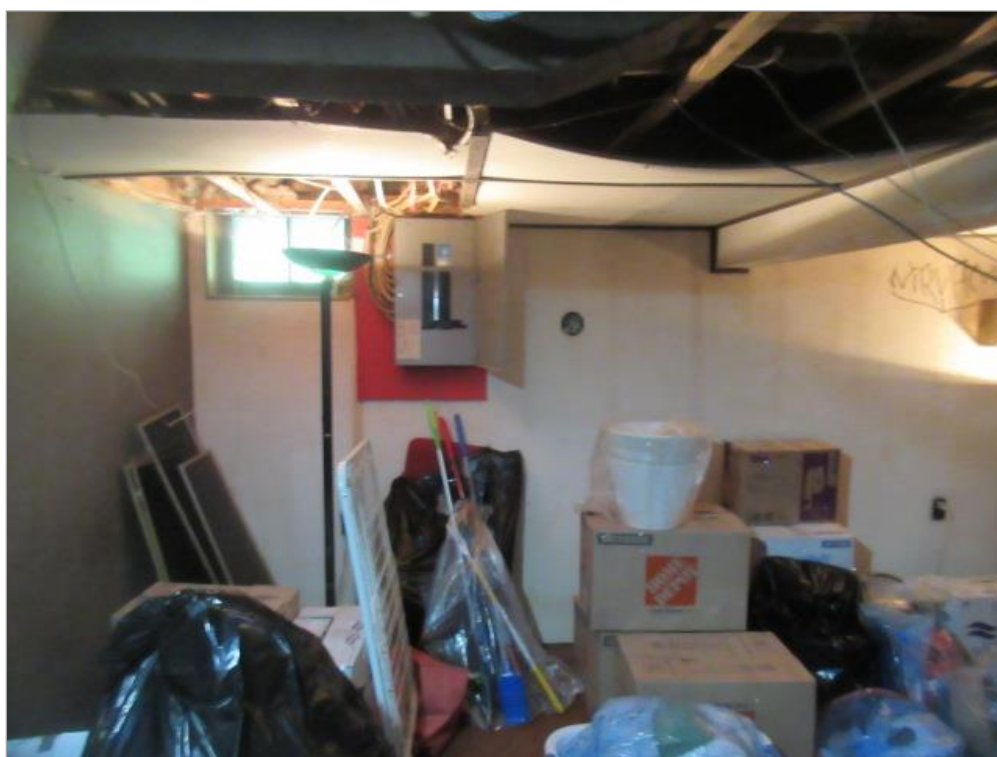
Basement

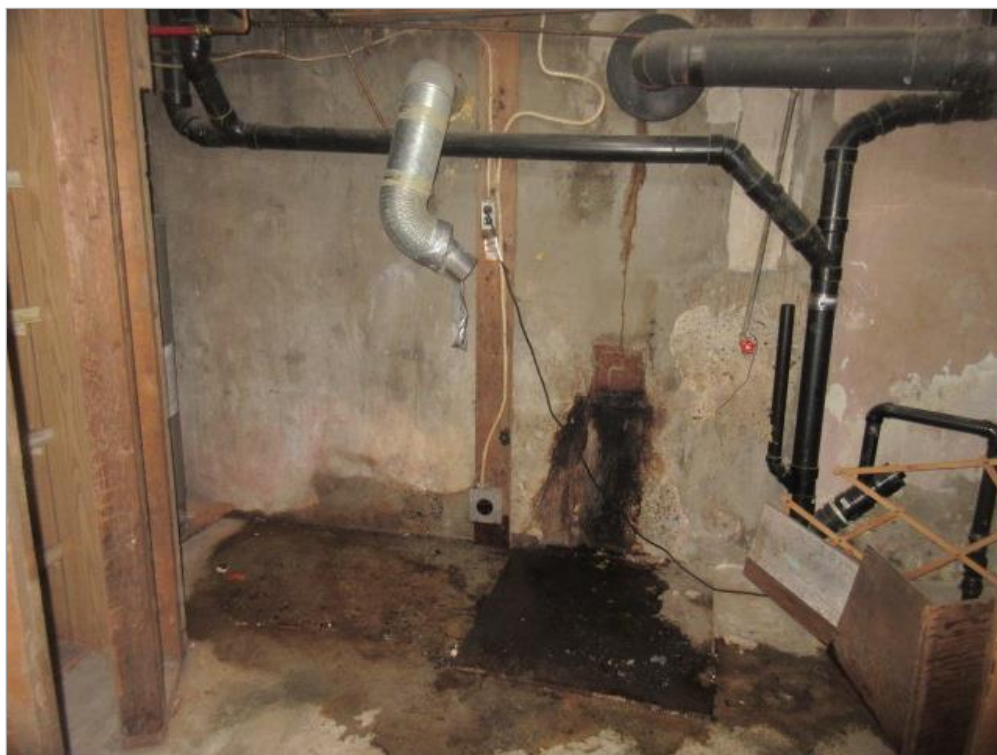
Mechanical room

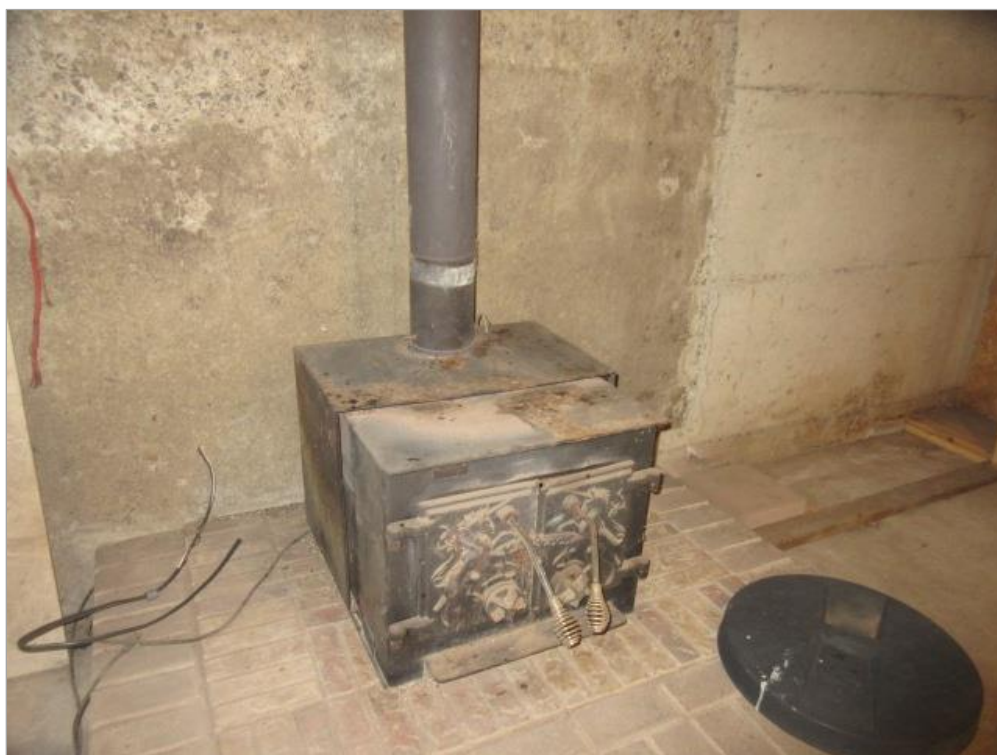
Wood stove
