APPRAISAL REPORT

133 Sunnyside Avenue
Pointe-Claire (Québec)

O/File 661655E

| Subject | Valuation report for demolition purposes, relating to the new and depreciated replacement cost, as well as the estimate of the potential renovation costs |

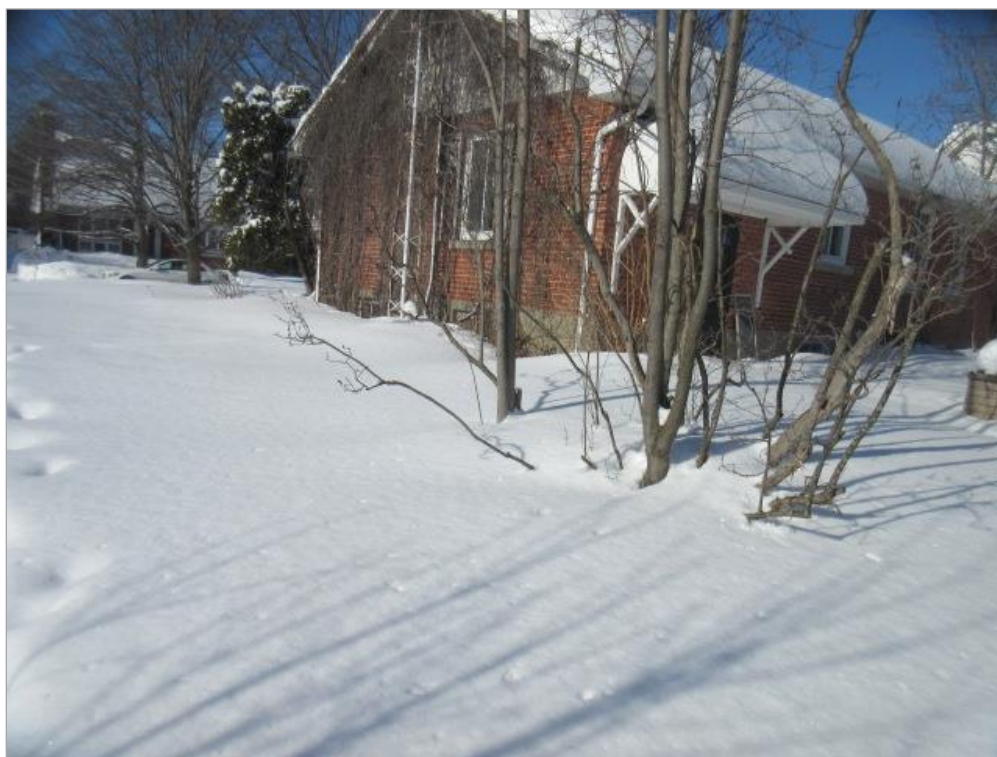
| SOFFITS | Clear soffits and check ventilation. There are sections of fascia soffit to be fixed. Some vegetation needs to be removed. |

Vegetation south side wall

| OUTDOOR LAYOUT | Some trees and shrubs are too close to the building. Proceed with pruning. |

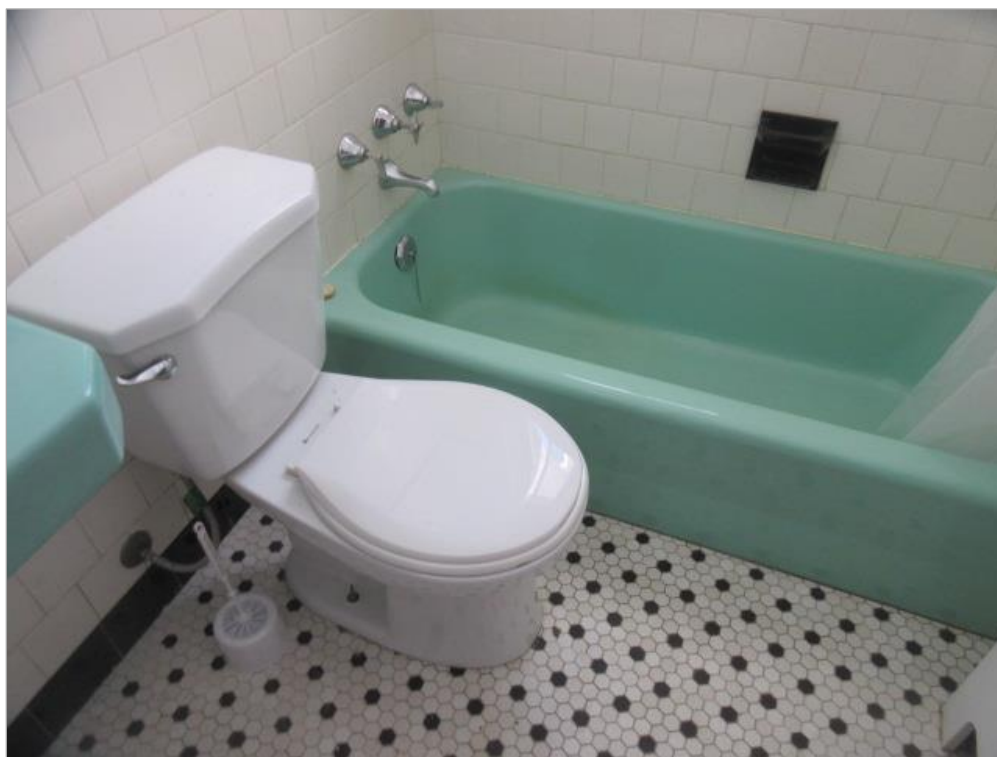
| PLUMBING | Several small plumbing jobs are needed to optimize water management properly. Provide for the replacement of the shut-off valve and the installation of anti-siphon devices under each plumbing fixture. Note the lack of a plug at the cleanout manhole. Have the plumbing lines checked by a qualified plumber as there are some deficiencies. The water heater should be replaced. |

Plumbing fixtures

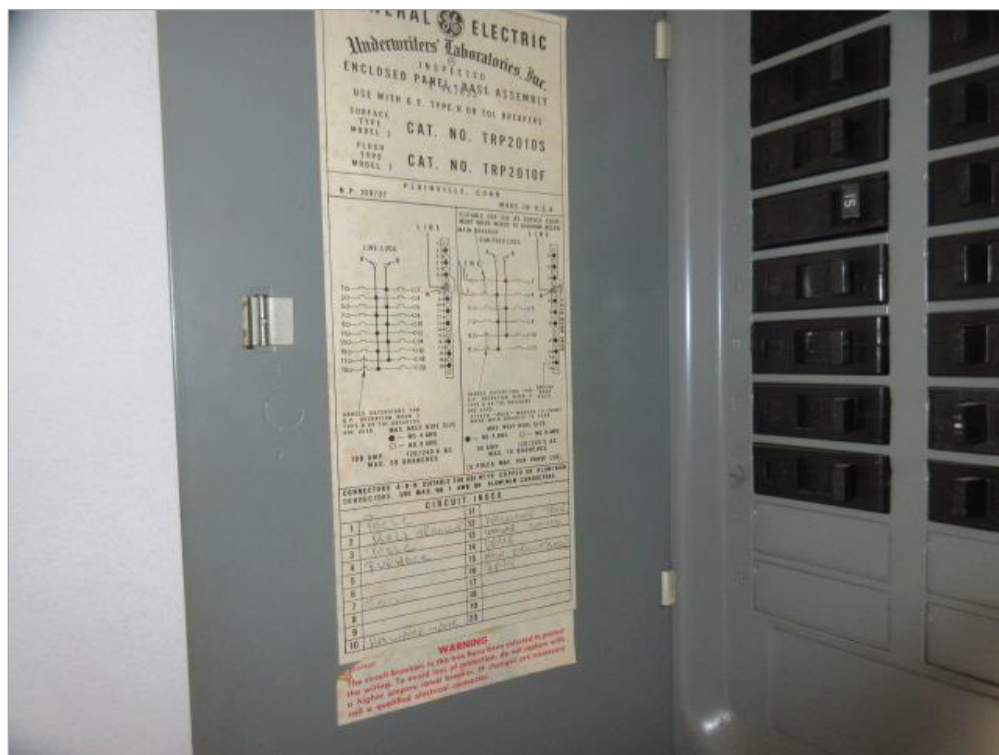
| ELECTRICITY | <p>Replace unprotected outlets with GFCI outlets. Have an electrician check outlets and grounding.</p> <p>The electrical distribution panel cover should be replaced.</p> |

Electrical distribution panel
