## APPRAISAL REPORT

12, Coolbreeze Avenue  
Pointe-Claire (Quebec)

Subject	Demolition Assessment Report, covering the new and depreciated replacement cost, as well as the estimated potential renovation costs of the building located at 12, Coolbreeze Avenue, Pointe-Claire (Quebec).
O/File	629581E

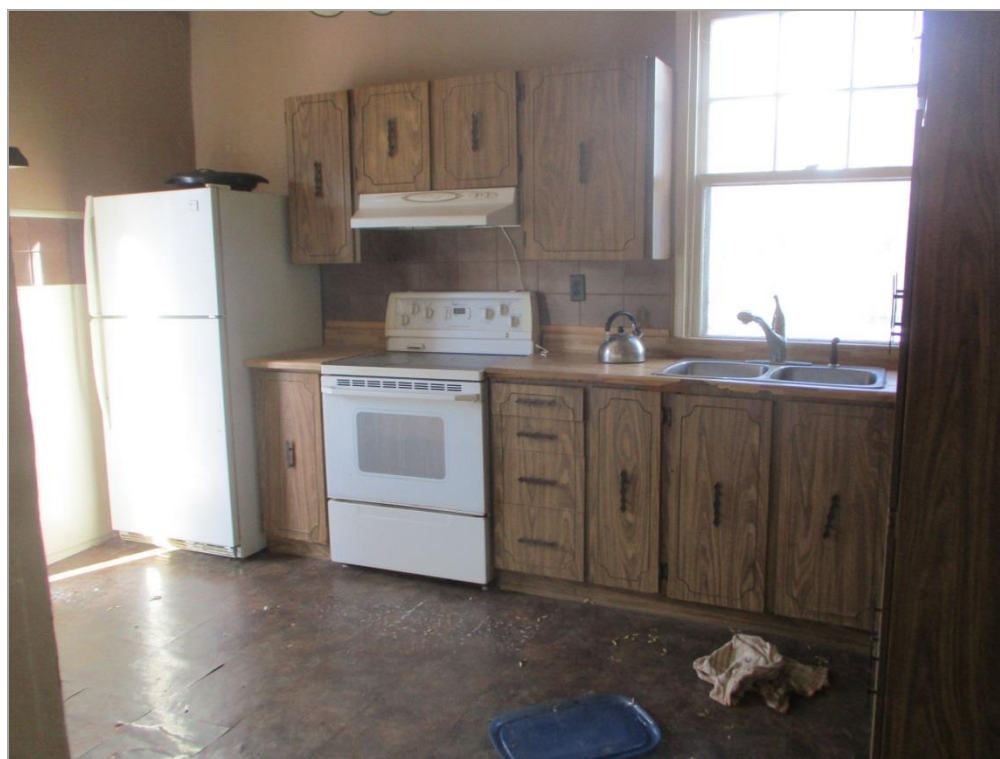
**Kitchen**

- **Stairs and rails :** The handrail on the stairs is incomplete and the railing is not compliant. Correct the situation.
- **Counters :** There are traces of water infiltration under the kitchen counter. Plan for its replacement.
- **Interior doors :** A closet door is missing. Plan to install a door.
- **Misc. :** We note debris in the crawl space. Clean the crawl space.

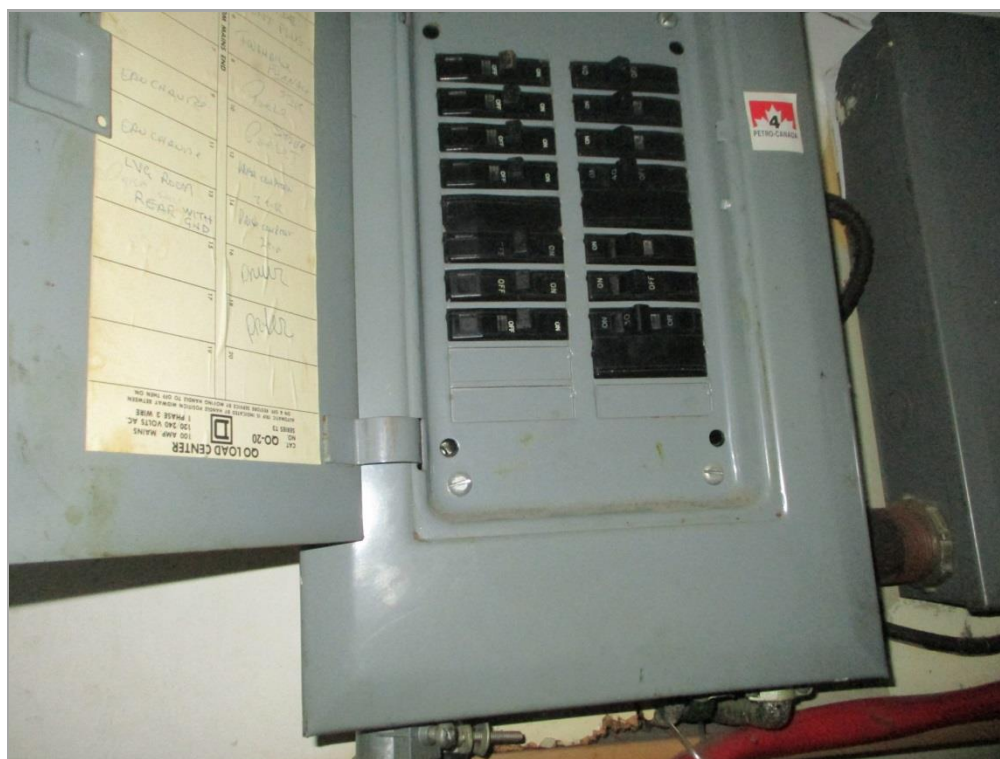
Electrical panel

- **Electricity :** Properly attach the conductor support to the building wall. The 100-amp main circuit breaker will have to be replaced by a 200-amp circuit breaker in the event that the oil heating system is replaced by an electrical system. Hide exposed wiring in the bedroom closet. Install an exterior power outlet with protection (GFCI) as well as the one in the kitchen. When renovating the kitchen, plan to add additional outlets in some of the rooms in the building. Quickly replace the extension that serves as the electrical outlet in the left front bedroom.
