APPRAISAL REPORT

46 Broadview Avenue
Pointe-Claire (Québec)

O/File 661736E

Subject	Valuation report for demolition purposes, relating to the new and depreciated replacement cost, as well as the estimate of the potential renovation costs
Location	46 Broadview Avenue, Pointe-Claire (Québec)
O/File	661736E

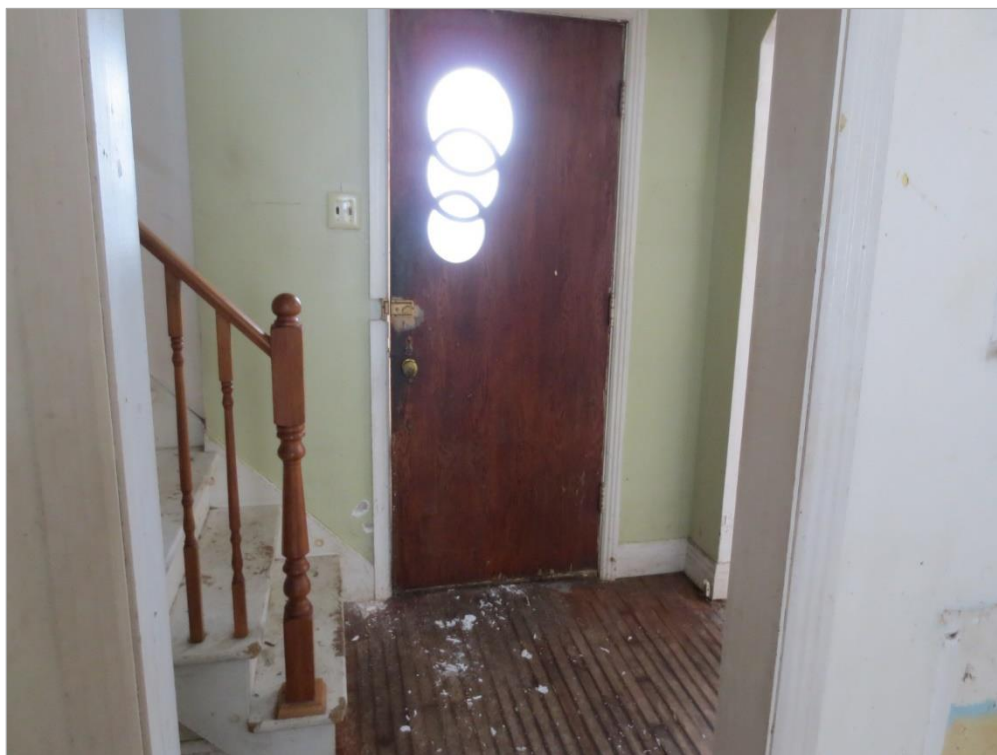
The floor of the entrance is covered with wooden slats, which is not watertight. It is in bad condition. Replace the slats with a waterproof surface such as ceramic.

Entrance of the building

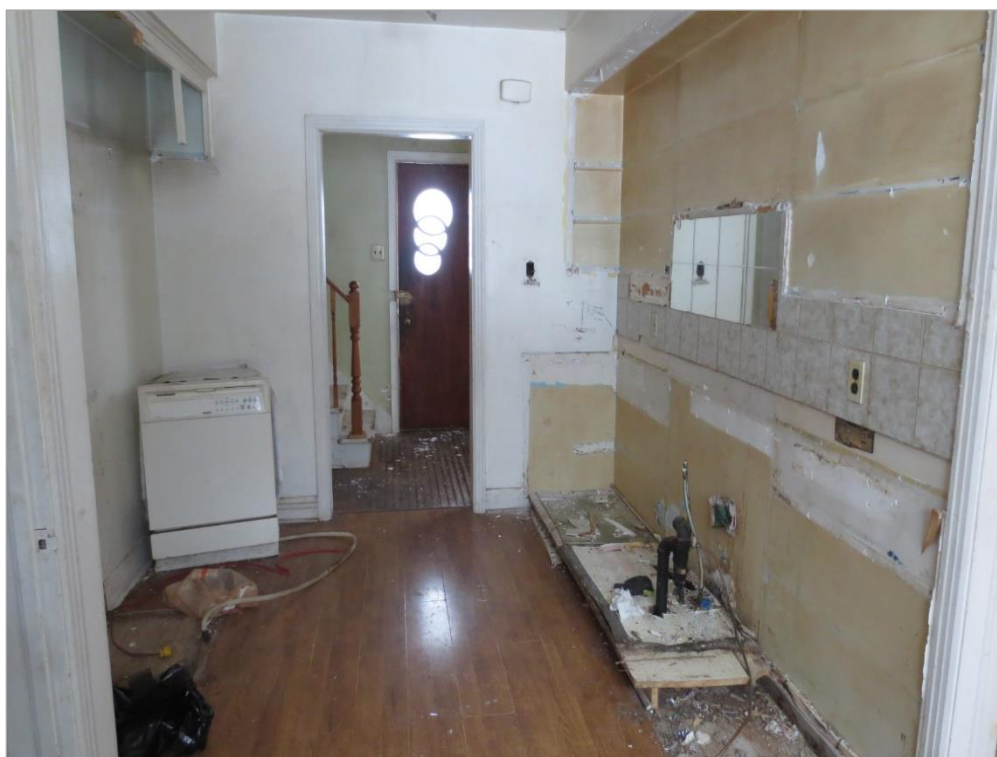
The kitchen cabinets were demolished. Replace the whole kitchen.

Kitchen

There is no kitchen hood. We recommend the installation of a hood during the reconstruction of the kitchen.

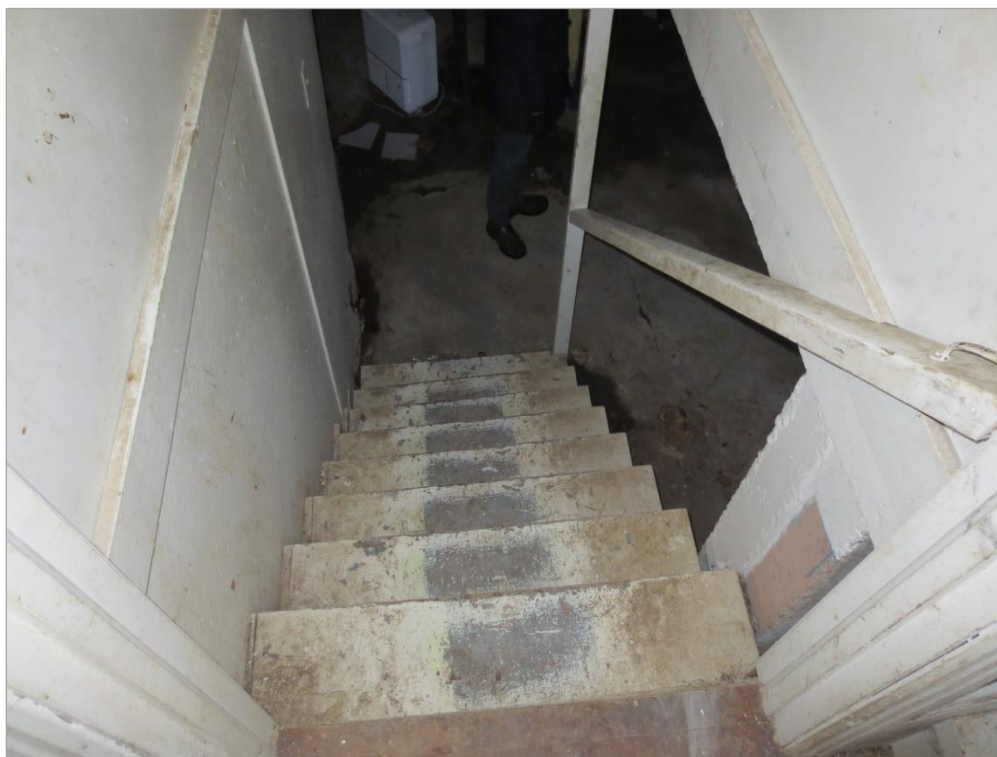
The floor from the landing to the basement is plywood in poor condition. Replace the plywood and install a floor covering.

Basement stairs

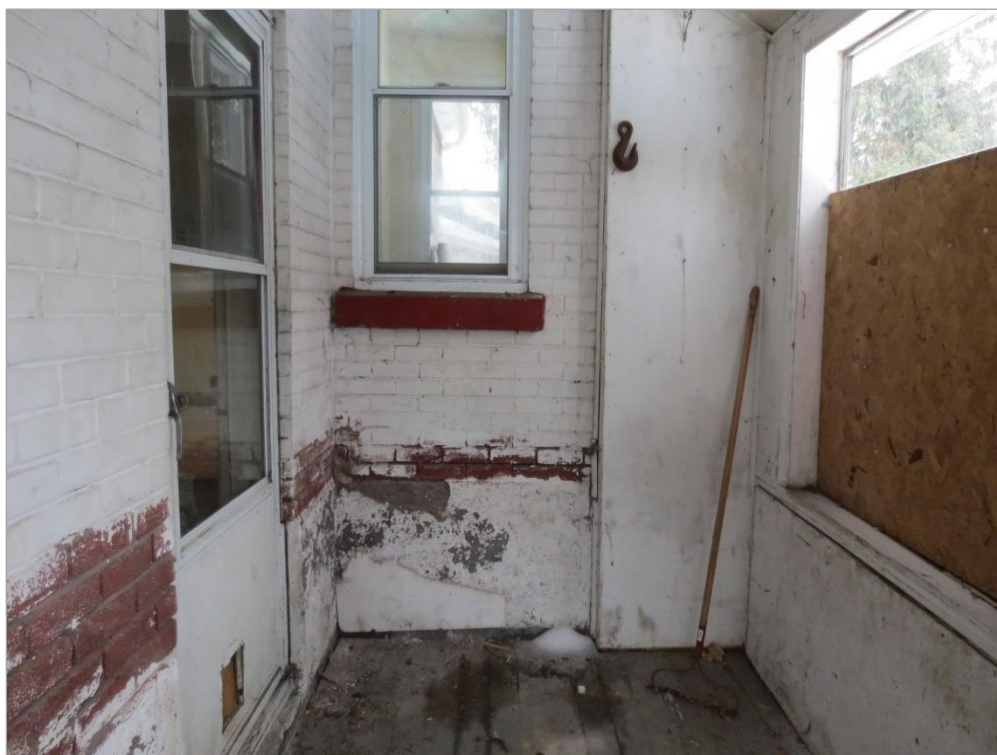
The rear extension was built by amateurs. The extension is collapsing and suffering from water infiltration. We recommend its complete reconstruction during the foundation work.

Veranda
