APPRAISAL REPORT

110 de Breslay Avenue Pointe-Claire (Québec)

O/File 658317E

Subject	Valuation report for demolition purposes, relating to the new and depreciated
	replacement cost, as well as the estimate of the potential renovation costs
Location	110 de Breslay Avenue, Pointe-Claire (Québec)
O/File	658317E

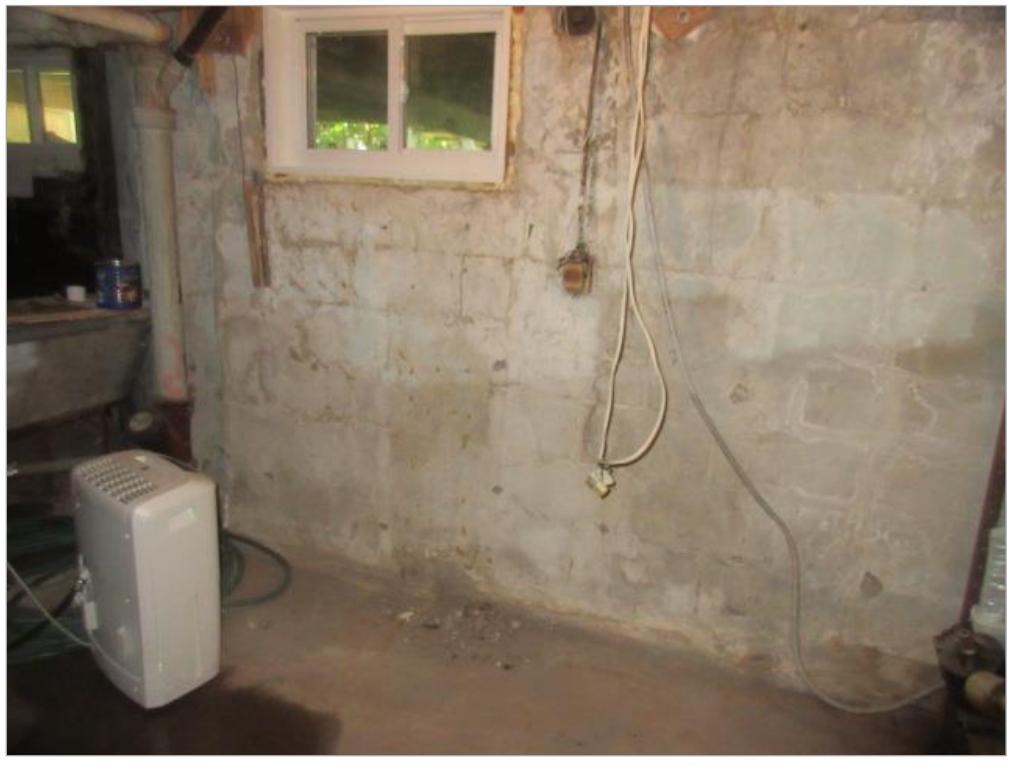
Foundation wall

Foundations	We observed several cracks on the foundation walls we could access. Some cracks were observed from the exterior, while others were observed from the interior of the basement. Have the cracks repaired by a mason skilled in this type of foundation work.
	We noticed that the left side foundation wall and the back wall were domed. Bulges are an indication of displacement of a foundation wall. Call on a structural engineer to check the situation and allow you to take the necessary reinforcement measures if necessary.
FLOOR SLAB	The inspection revealed that water infiltrates from the ground in several places, and that traces of humidity were present. It is likely that the groundwater level is high below the slab.
	Further expertise is recommended before undertaking renovation and finishing work in the basement.
	Also follow the recommendations made earlier in this report regarding the waterproofing of foundation walls and the installation of a French drain. Of course, when rebuilding the current slab, the new slab should include a granular drainage layer of at least five inches type DB for concrete slab, covered with rock wool or extruded polystyrene board insulation (thermal resistance of R 10 minimum), and a polyethylene membrane at least 0.300-millimeter-thick acting as a water-repellent screen. On the polyethylene, the new slab must be at least three inches thick and have slopes in the direction of the floor drains to be installed. Plan the cost of this work out of prudence.

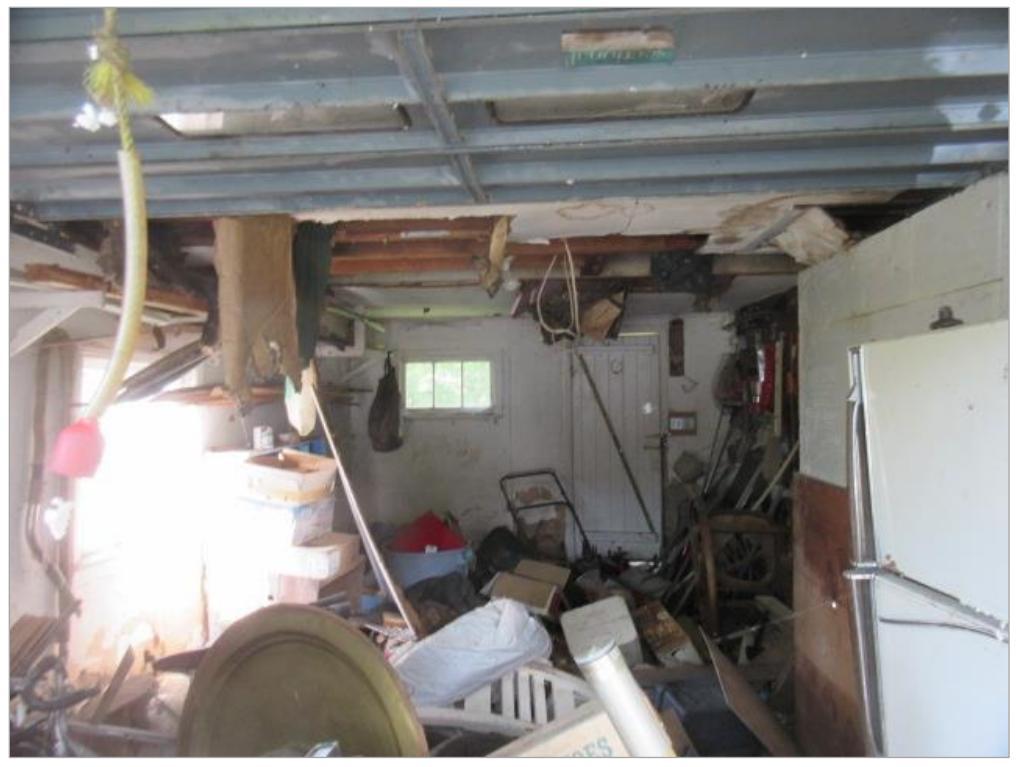
Garage

Exterior cladding	The left wall of the garage collapses. Have the wall inspected by the structural engineer if you keep the garage. We noticed that the vinyl siding was very warped in places. Remove the vinyl siding to check the condition of the walls and install the new siding to ensure the exterior walls are watertight. Call in an expert if necessary.
FLASHINGS AND SEALS	The sealing joints are damaged in several places. Redo the joints where required.
Doors and windows	All the doors have reached their useful life. Replace exterior doors.
	Most of the windows have also reached their useful life. Some windows are original with aluminum storm windows. The most recent windows were manufactured in 1988. Plan for window replacement in the short term.
TERRACES, BALCONIES AND PORCHES	The back patio is in a very bad shape. Plan for repair in the short term.
Soffits	No comments.
LANDSCAPING	Trees and shrubs are too close to the building. Have them pruned.
