APPRAISAL REPORT

150 Prince-Edward Avenue Pointe-Claire (Quebec)

Subject	Valuation report for demolition purposes, relating to the new and depreciated
	replacement costs, as well as an estimate of the potential renovation costs
Location	150 Prince-Edward Avenue, Pointe-Claire (Quebec)
O/File	667039E

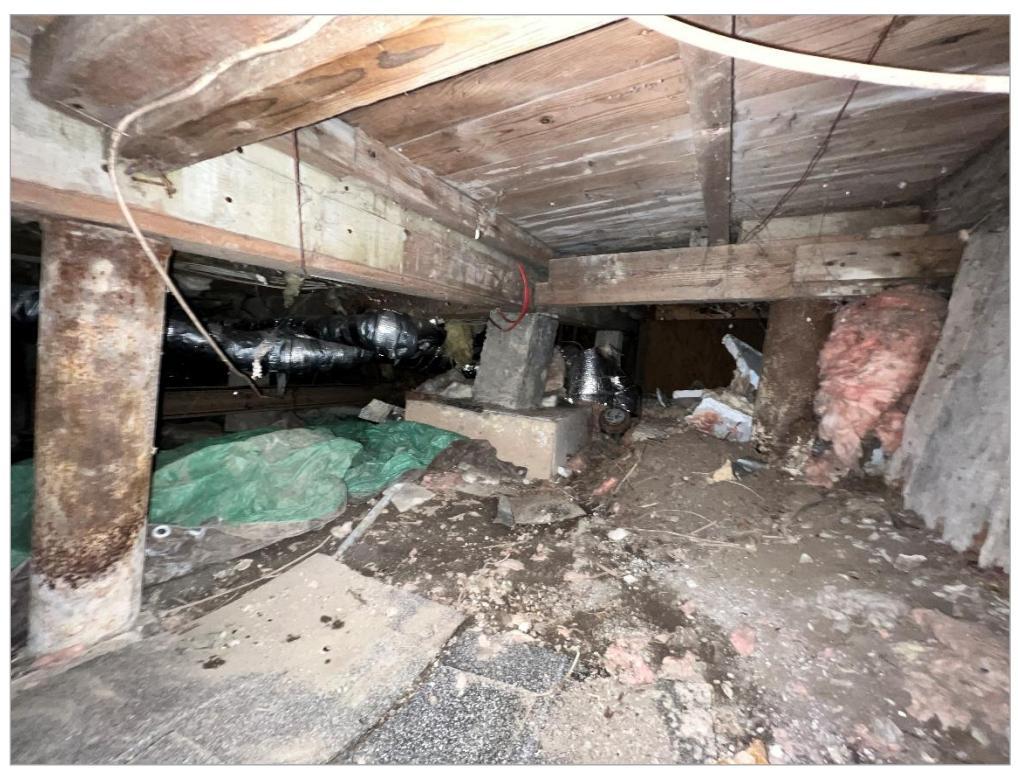
Crawl space

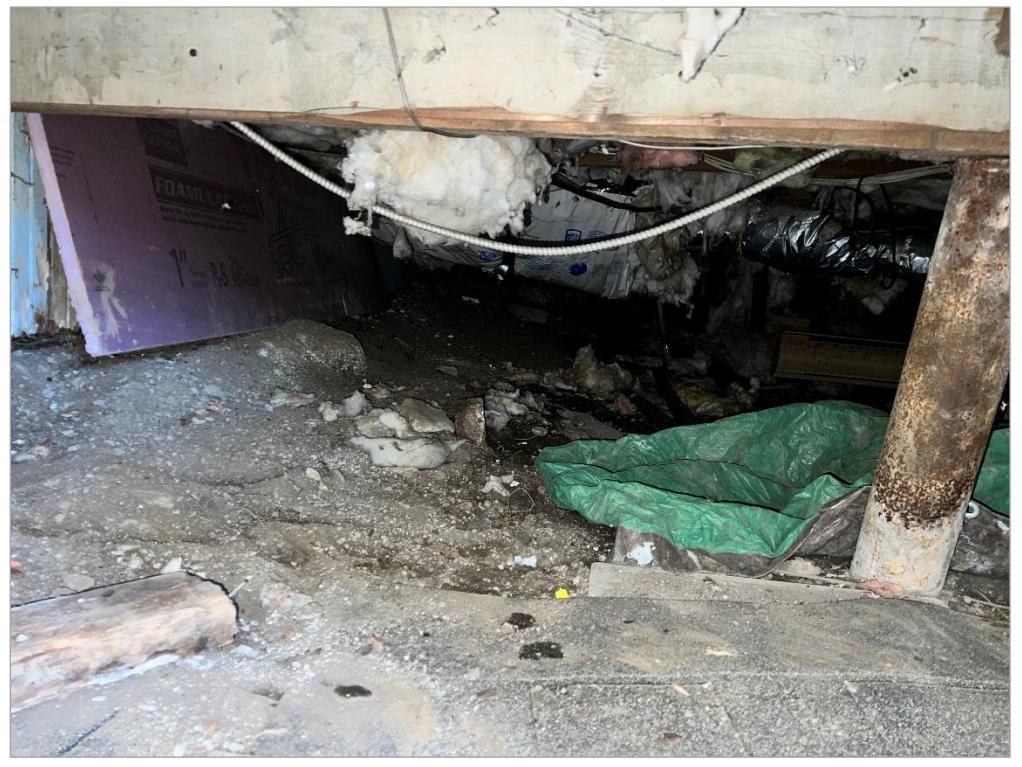
Crawl space
