APPRAISAL REPORT

108 Pointe-Claire Avenue
Pointe-Claire (Québec)

O/File 683327E

Subject Demolition Assessment Report on the replacement cost as new and depreciated, as well as an estimate of the potential renovation costs of the building
Address 108 Pointe-Claire Avenue, Pointe-Claire (Québec)
File No. 683327E

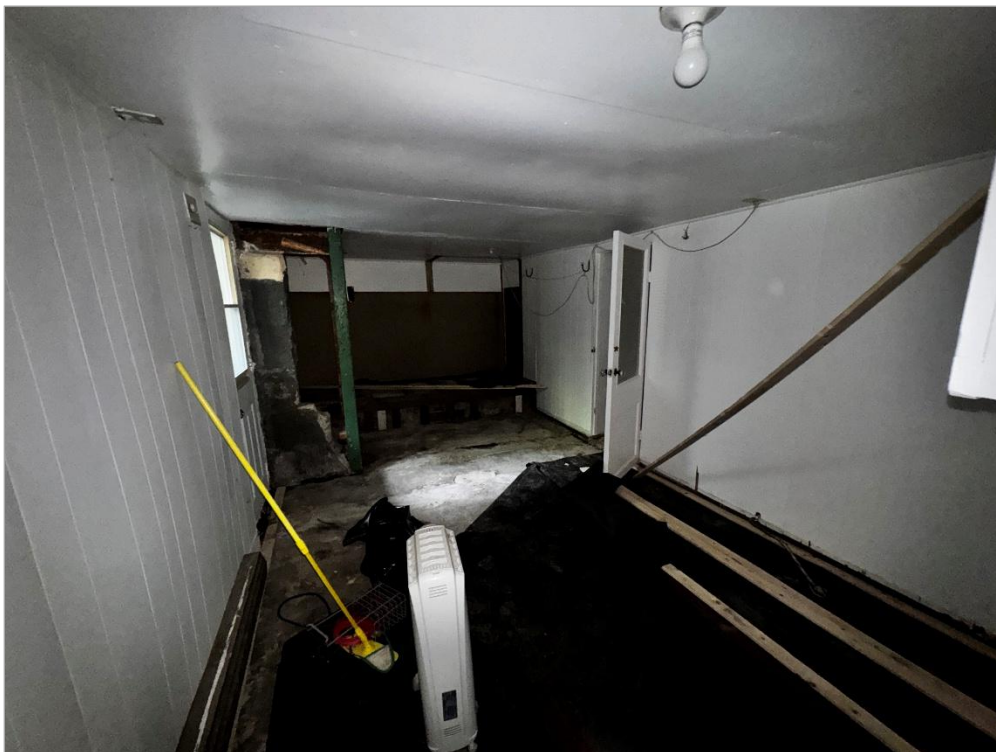
Basement

Several signs of excessive moisture and possible water infiltration were noted on the basement concrete slab. Follow recommendations in the "Structure and Foundation" sections to control water infiltration and excess moisture.

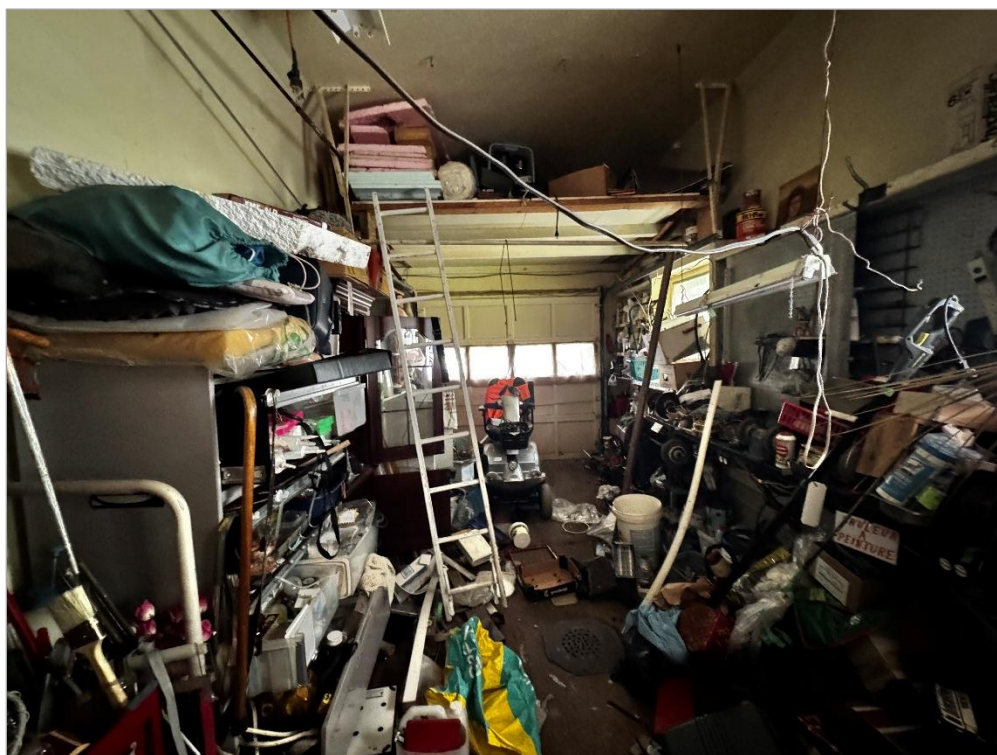
Garage

Peeling paint was observed on the foundation wall near the garage, likely due to moisture. Given the building's age, there may be no French drain around the footings, or any existing drain may be old and non-functional. Engage a specialized contractor for partial excavation around the building, install a French drain, and re-waterproof the foundation walls.
