APPRAISAL REPORT

158 Broadview Avenue
Pointe-Claire (Québec)

O/File 652632E

| Subject | Valuation report for demolition purposes, relating to the new and depreciated replacement cost, as well as the estimate of the potential renovation costs |

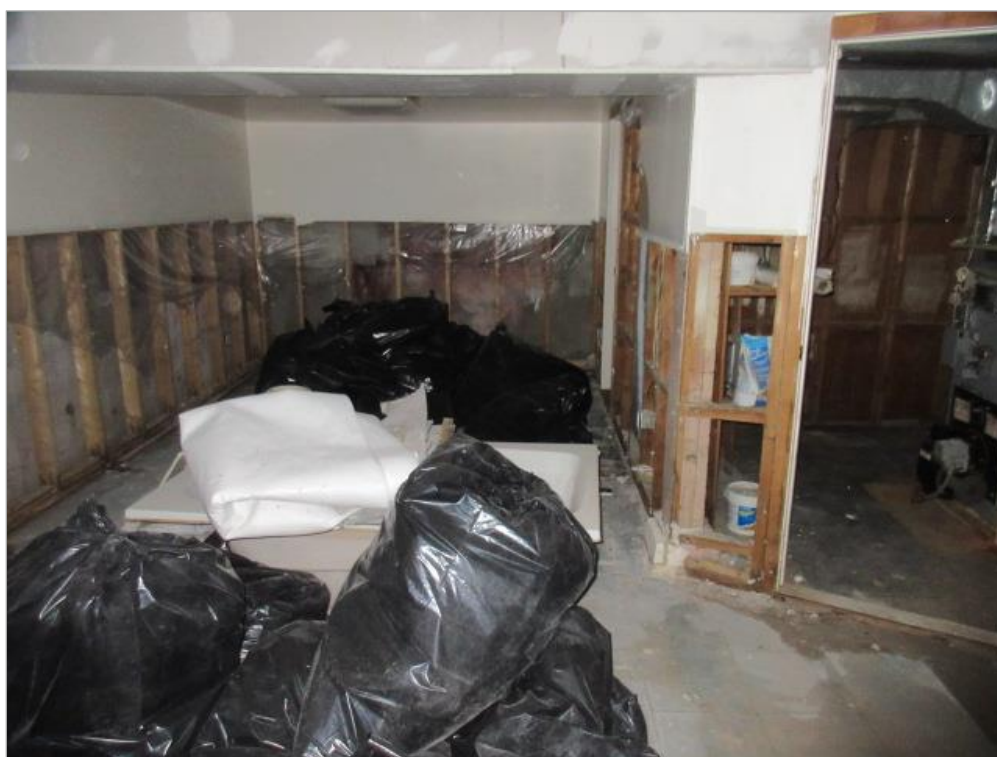
Basement

| FLOOR JOISTS | <p>There are possible traces of mold on joists and floor decking in the basement. Perform a mold test.</p> <p>Unevenness can be caused by deflection of structural elements.</p> |

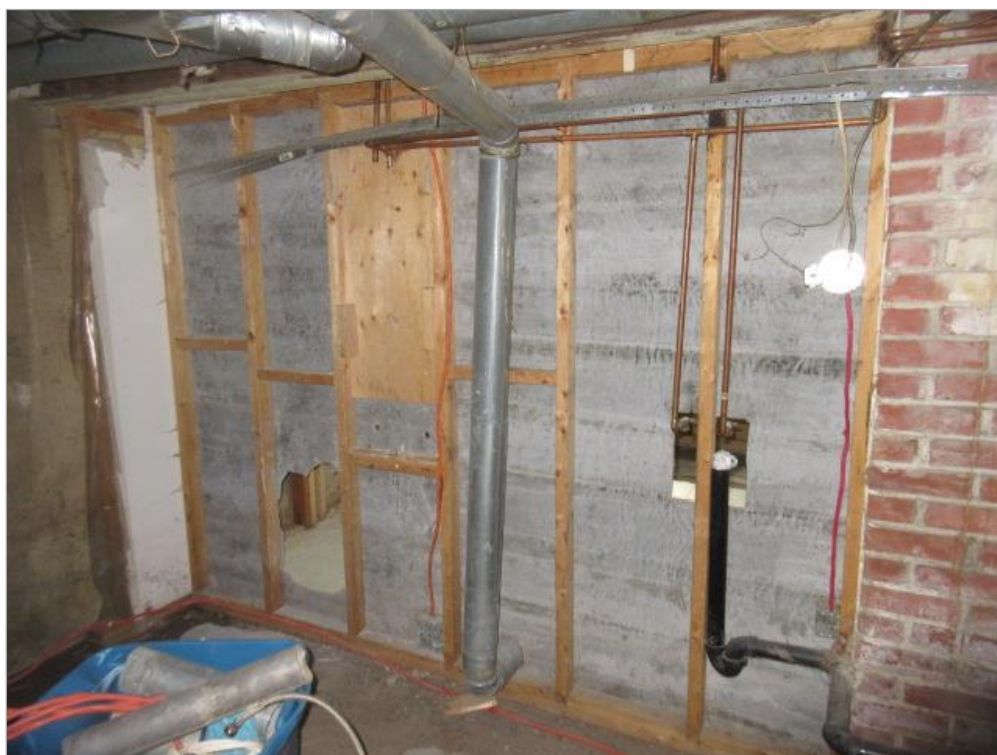
Basement

| FOUNDATIONS | <p>several cracks are observed on the poured concrete foundation walls. Repair or replace these foundations.</p> <p>Water infiltration and stains are observed on the foundation walls. It is possible that there is no French drain or that it is worn. Have the foundations inspected and install a French drain, if necessary.</p> |
