APPRAISAL REPORT

133 Sunnyside Avenue
Pointe-Claire (Québec)

O/File 661655E

| Subject | Valuation report for demolition purposes, relating to the new and depreciated replacement cost, as well as the estimate of the potential renovation costs |

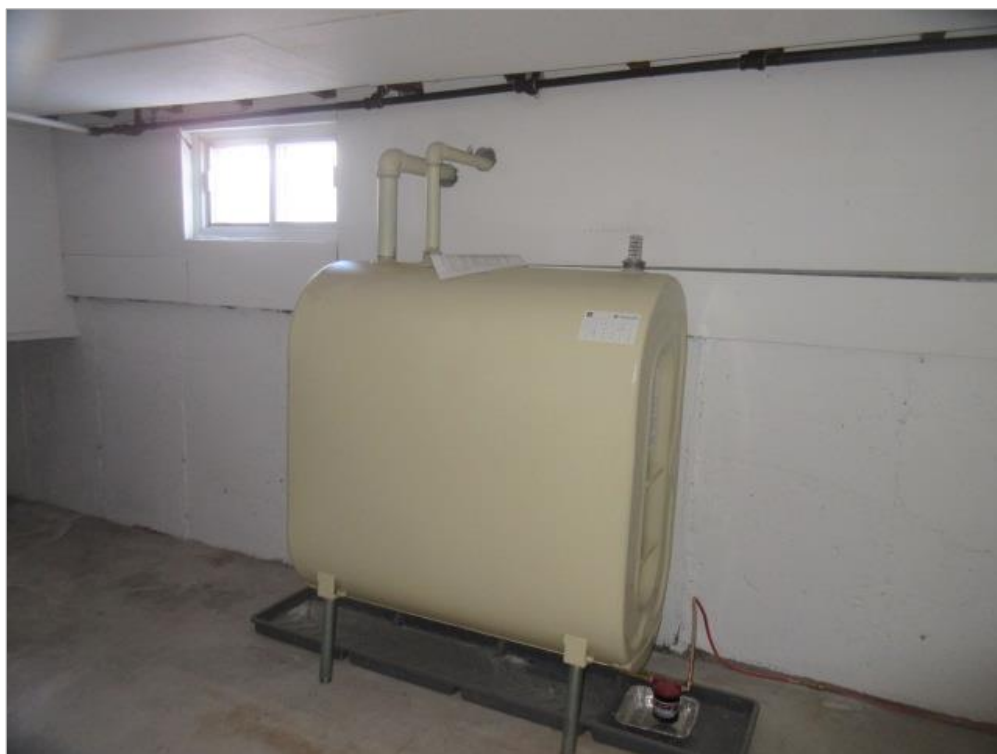
Basement

| FOUNDATIONS | There are several traces of humidity and efflorescence on the walls. The French drain might be missing or used. Have the foundation inspected and proceed with a French drain installation if necessary. |

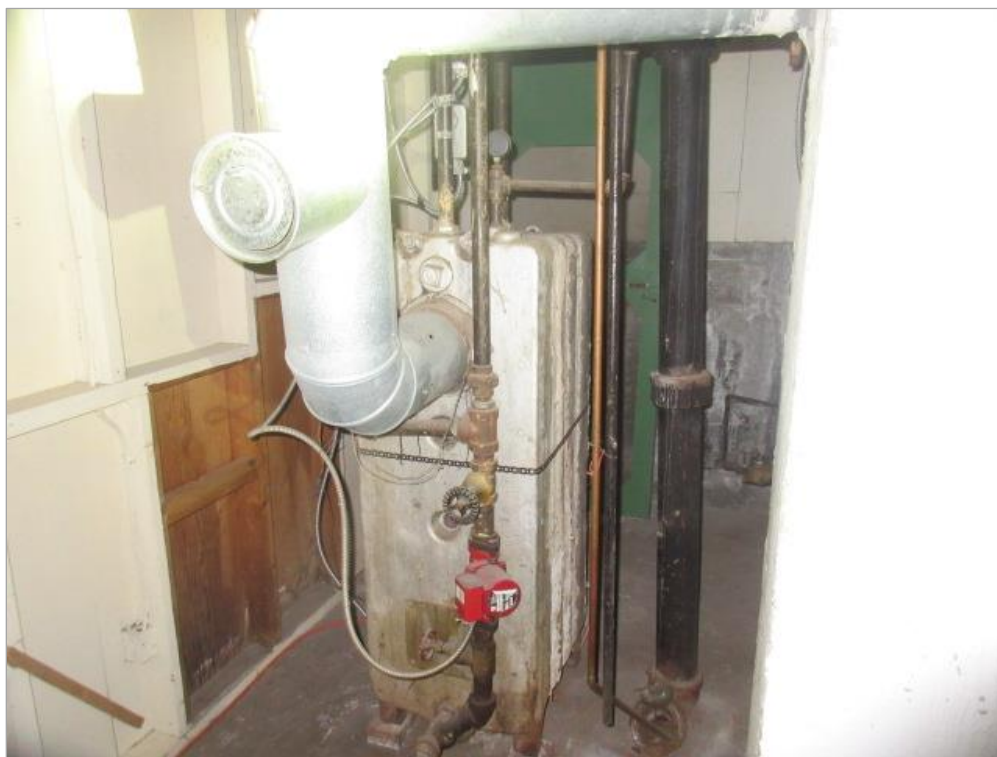
Mechanical room

| PLUMBING | Several small plumbing jobs are needed to optimize water management properly. Provide for the replacement of the shut-off valve and the installation of anti-siphon devices under each plumbing fixture. Note the lack of a plug at the cleanout manhole. Have the plumbing lines checked by a qualified plumber as there are some deficiencies. The water heater should be replaced. |
