APPRAISAL REPORT

46 Broadview Avenue
Pointe-Claire (Québec)

O/File 661736E

Subject	Valuation report for demolition purposes, relating to the new and depreciated replacement cost, as well as the estimate of the potential renovation costs
Location	46 Broadview Avenue, Pointe-Claire (Québec)
O/File	661736E

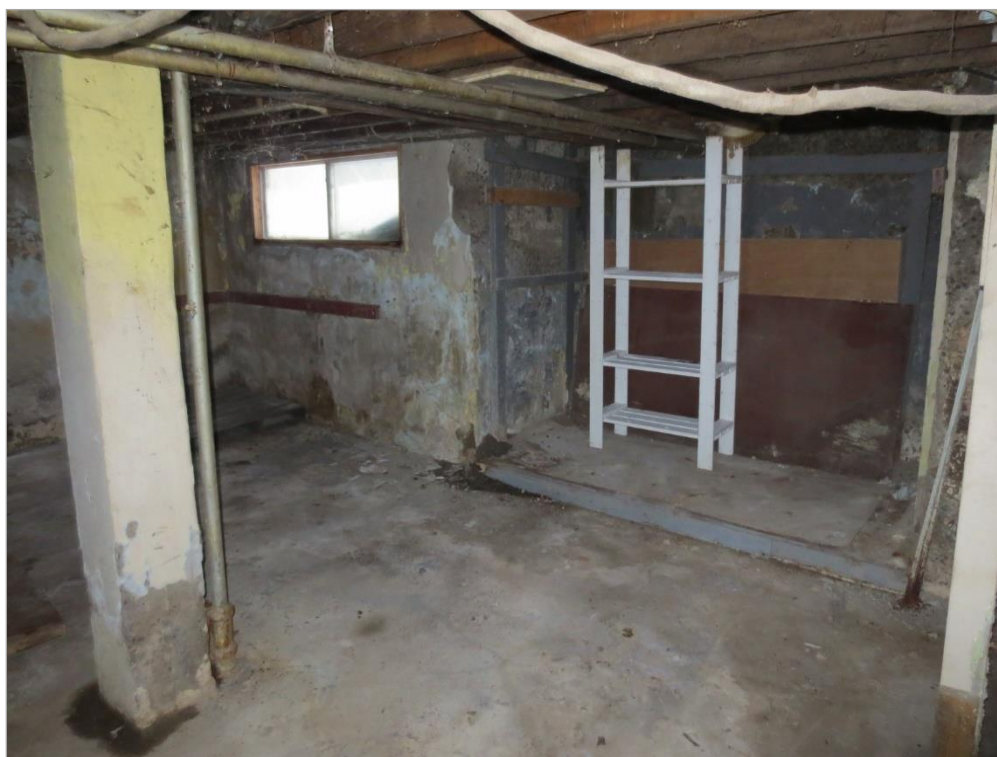
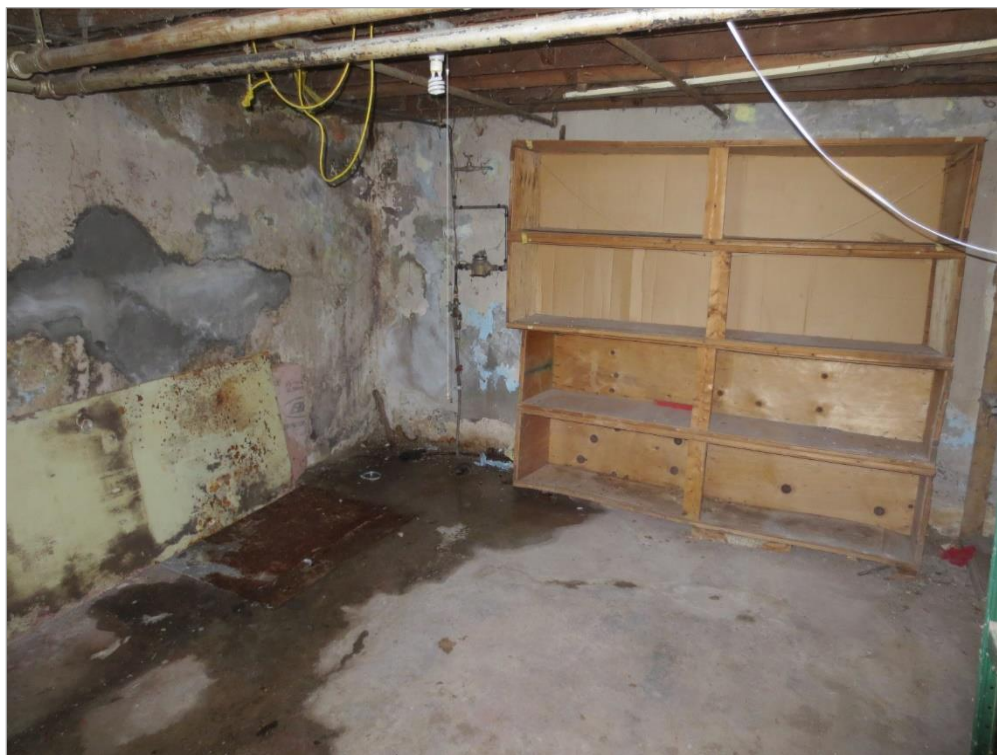
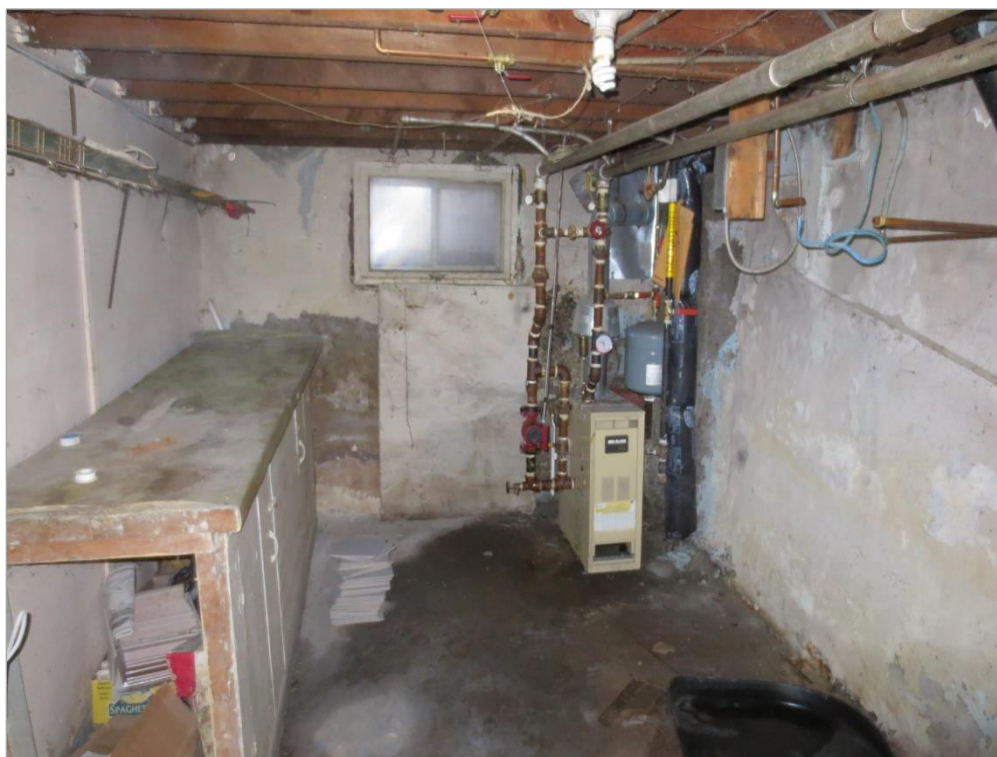
Basement

FOUNDATIONS	<p>The foundation walls are damaged in many places. A complementary report by a structural engineer, Mr. Raymond Richard, for Enspeco (expertise number 202210-12015), recommends the complete replacement of the foundation walls.</p>
FLOOR SLAB	<p>The slab could be a clean slab. Moisture is noticeable. Replace it during the foundation work.</p>
FLOOR JOISTS	<p>There are notches in the joists that could affect their integrity. Have the weakening corrected by a carpenter.</p> <p>You can also see traces of infiltration on the floor decking on the first floor. Make sure that the foundation walls are watertight, as well as the brick siding and windows.</p> <p>Stabilize the joist that is leaning against the beam. Install a cross beam.</p> <p>The dining room floor slopes to the right. Rectify the slope during foundation renovations.</p> <p>A joist is visible from the outside. Have this deficiency corrected when replacing foundation walls.</p> <p>Joists are possibly attacked by insects. Have an exterminator do a survey.</p> <p>There are traces of what could be mold on the joists. Anticipate the cost of cleaning.</p>
