APPRAISAL REPORT

575, Saint-Jean Boulevard
Pointe-Claire (Quebec)

Subject Demolition Assessment Report, covering the new and depreciated replacement cost, as well as the estimated potential renovation costs of the building located at 575, Saint-Jean Boulevard, Pointe-Claire (Quebec).

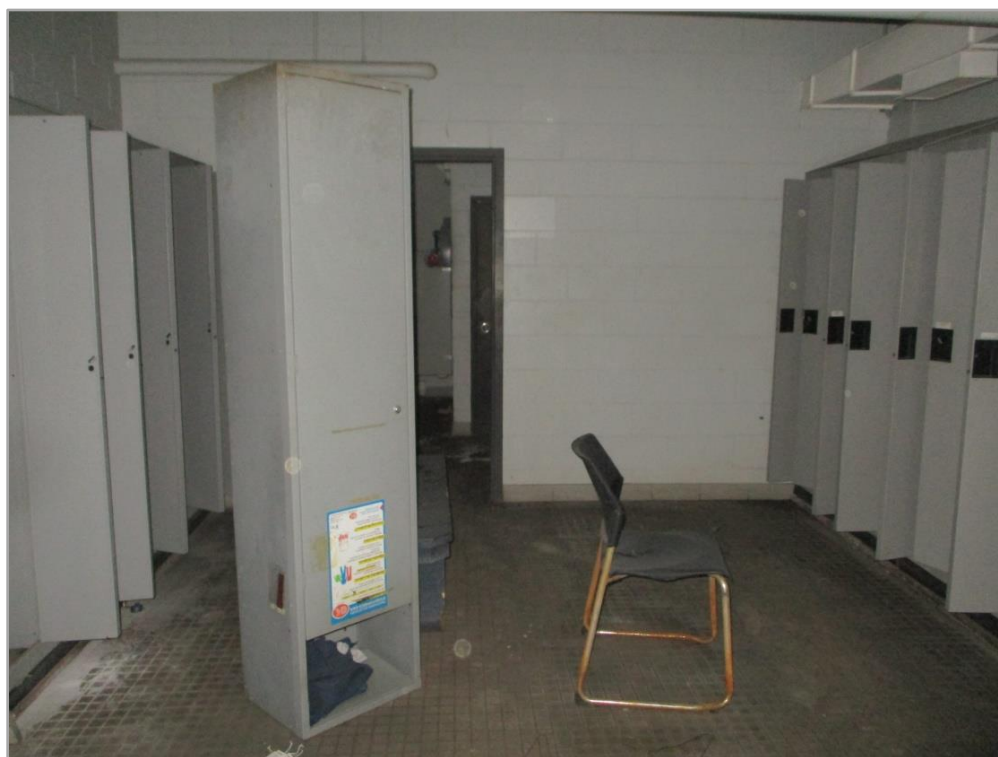
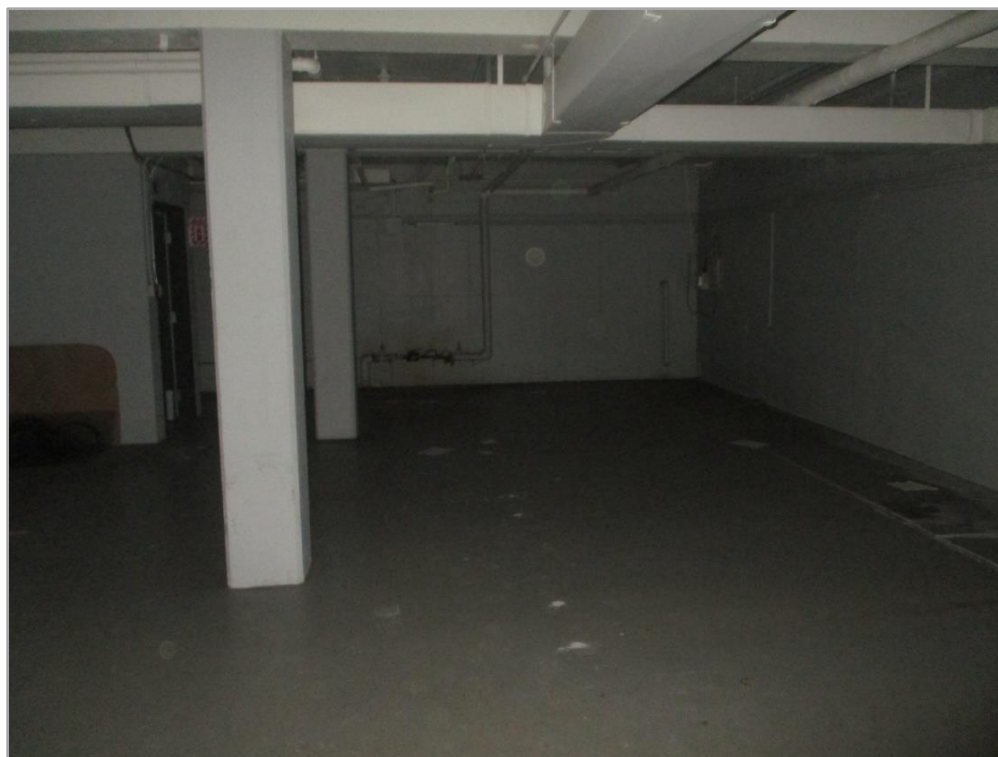
Basement

There are bloom stains on the foundation walls in the basement. Waterproof the walls from the inside if necessary.

We note a significant stain on the slab in the basement. It could be due to contamination. Perform an environmental test.

Signs of dried water are observed in the basement along the walls. This could be water infiltration. Install a French drain if necessary.

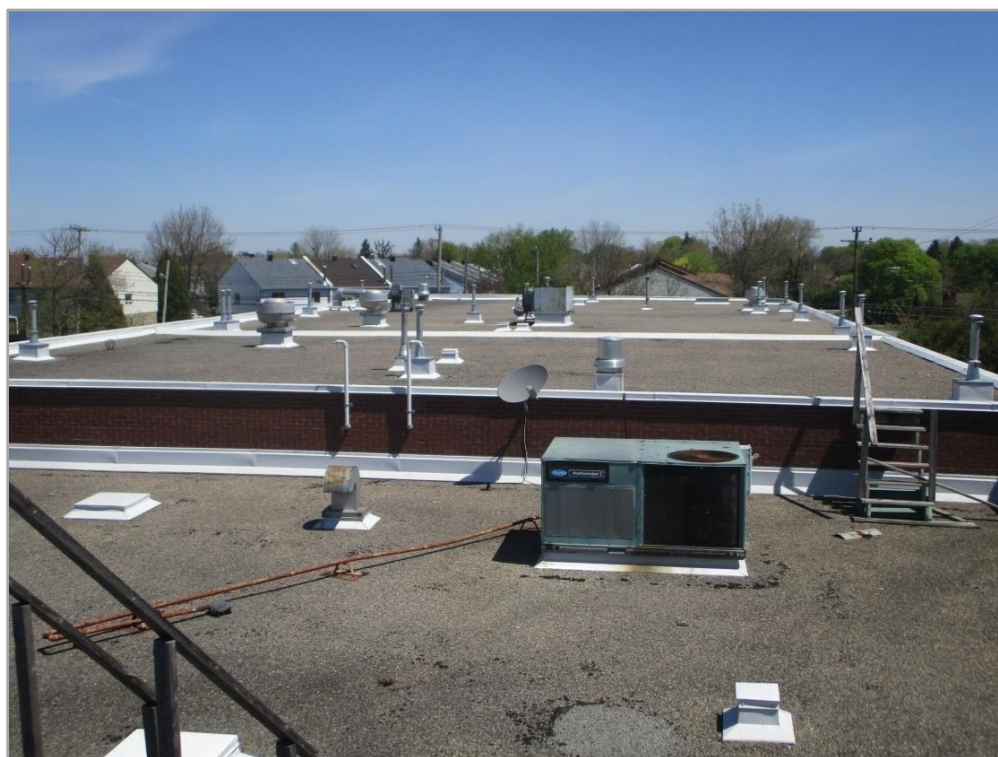
Roofing

- **Roof/roof structure:** Signs of water infiltration can be seen on the roof deck of the right extension. This roof requires complete and prompt replacement.

The showroom roof requires minor repairs and the addition of gravel.

The roof of the office section requires major repairs. Plan for complete replacement.

The roof of the garage section needs repairs and maintenance, additional gravel.
