APPRAISAL REPORT

117, de Dieppe Avenue
Pointe-Claire (Quebec)

Subject	Demolition Assessment Report, covering the new and depreciated replacement cost, as well as the estimated potential renovation costs of the building located at 117 de Dieppe Avenue, Pointe-Claire (Quebec).
O/File	648399E

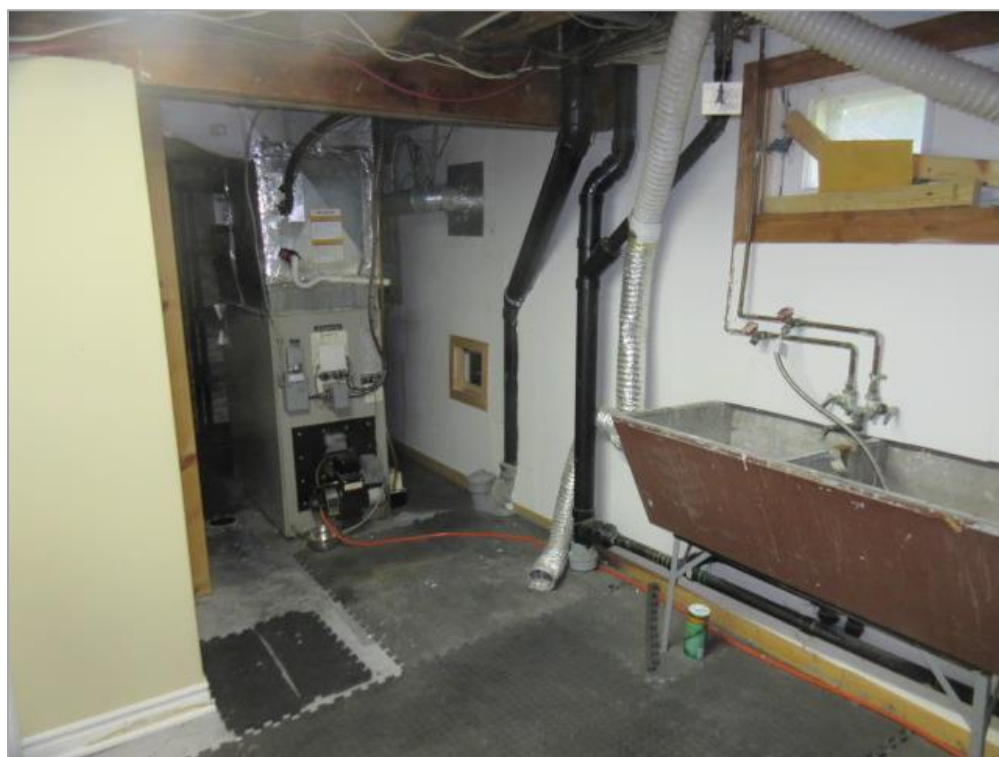
Basement and mechanical room

- **Concrete slab:** the mechanical room's slab is irregular.
- **Floor joists:** there are possible traces of mould on joists and floorboards in the basement. Plan to carry out an expert assessment and follow the recommendations.
Traces of mould are also observed on the floor structure along some exterior walls. Follow the recommendations in the "Exterior cladding" section.

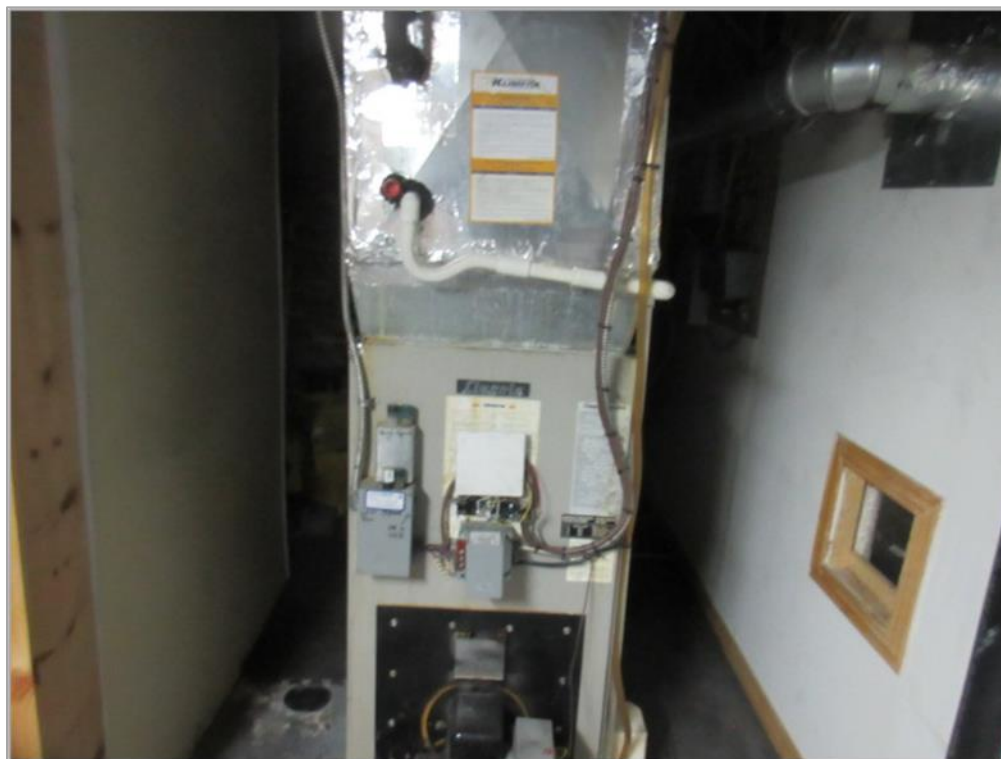
Hot air exhaust / Oil heating system
